Pit, Below-Grade Tank, or
Proposed Alternative Method Permit or Closure Plan Application

BELOW-GRADE TANK CLOSURE PLAN

VANDEWART A 005A

API No. 3004522363

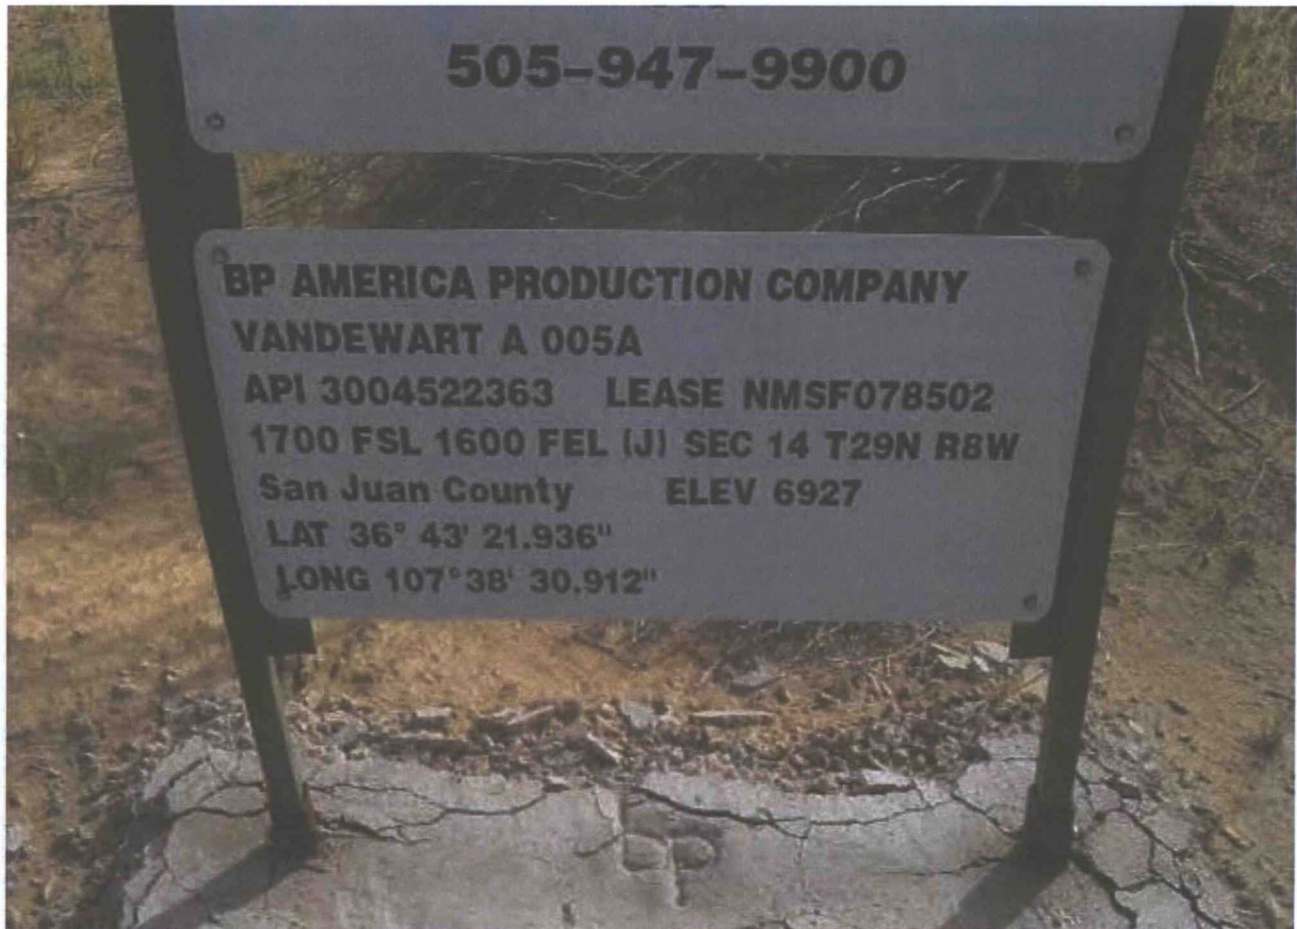
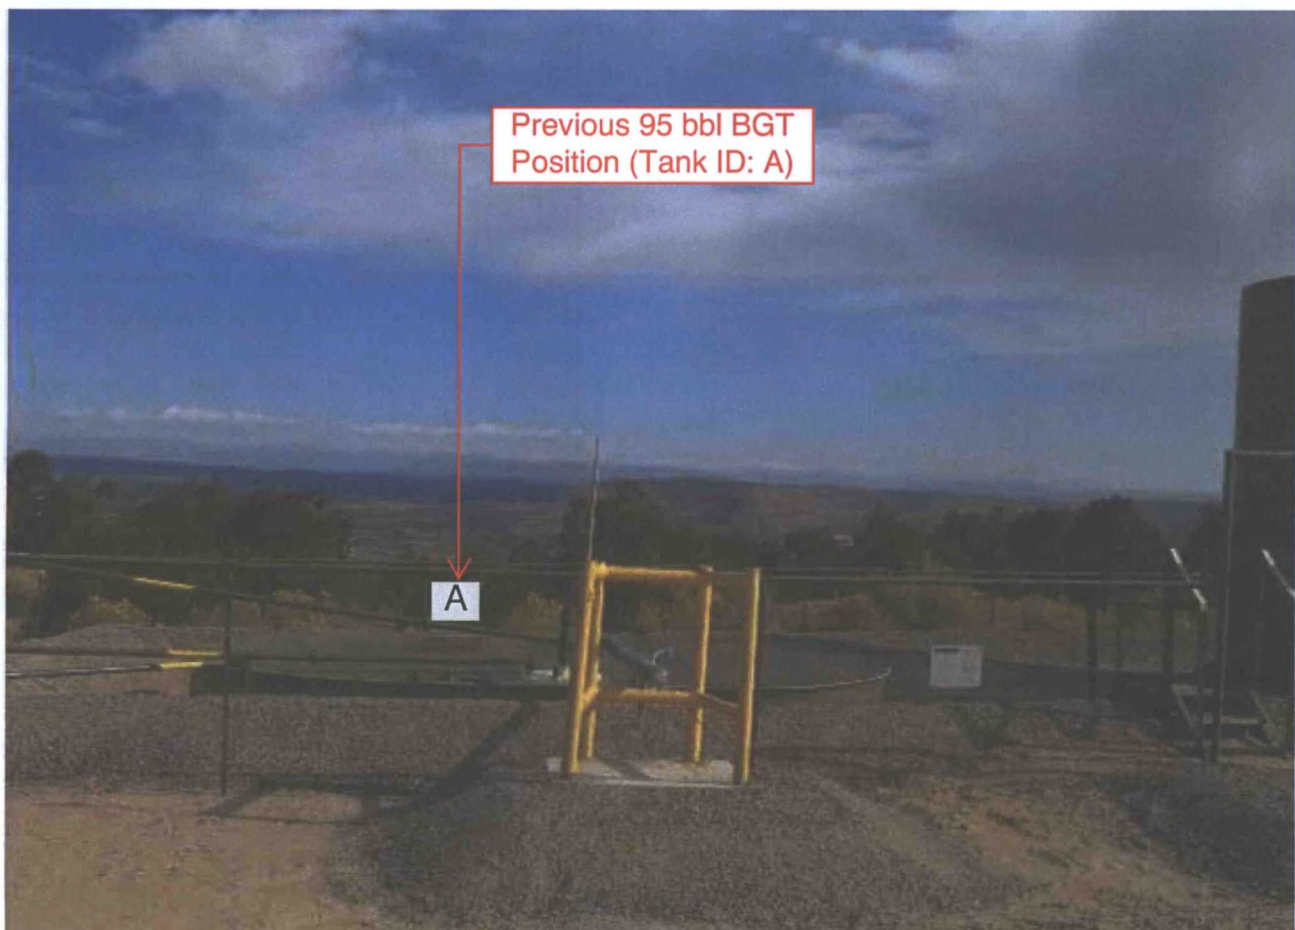
The area has been backfilled and a 105 BBL shallow low profile above-grade tank set atop BGT location. The location will be reclaimed once the well is plugged and abandoned.
