Pit, Below-Grade Tank, or
Proposed Alternative Method Permit or Closure Plan Application

BP AMERICA PRODUCTION COMPANY
SAN JUAN BASIN, NORTHWEST NEW MEXICO

BELOW-GRADE TANK CLOSURE PLAN

Fields Com LS #5A

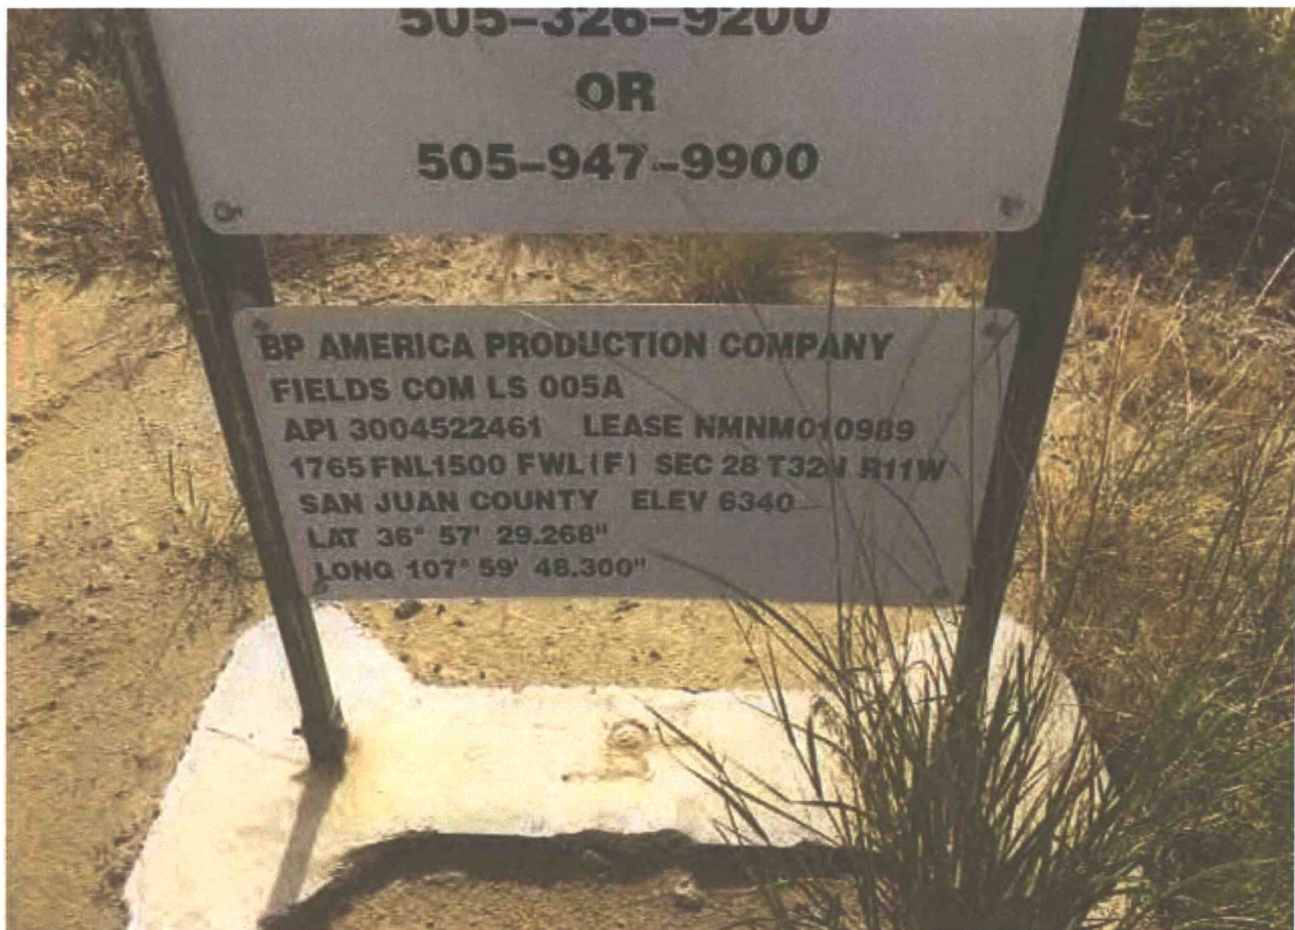
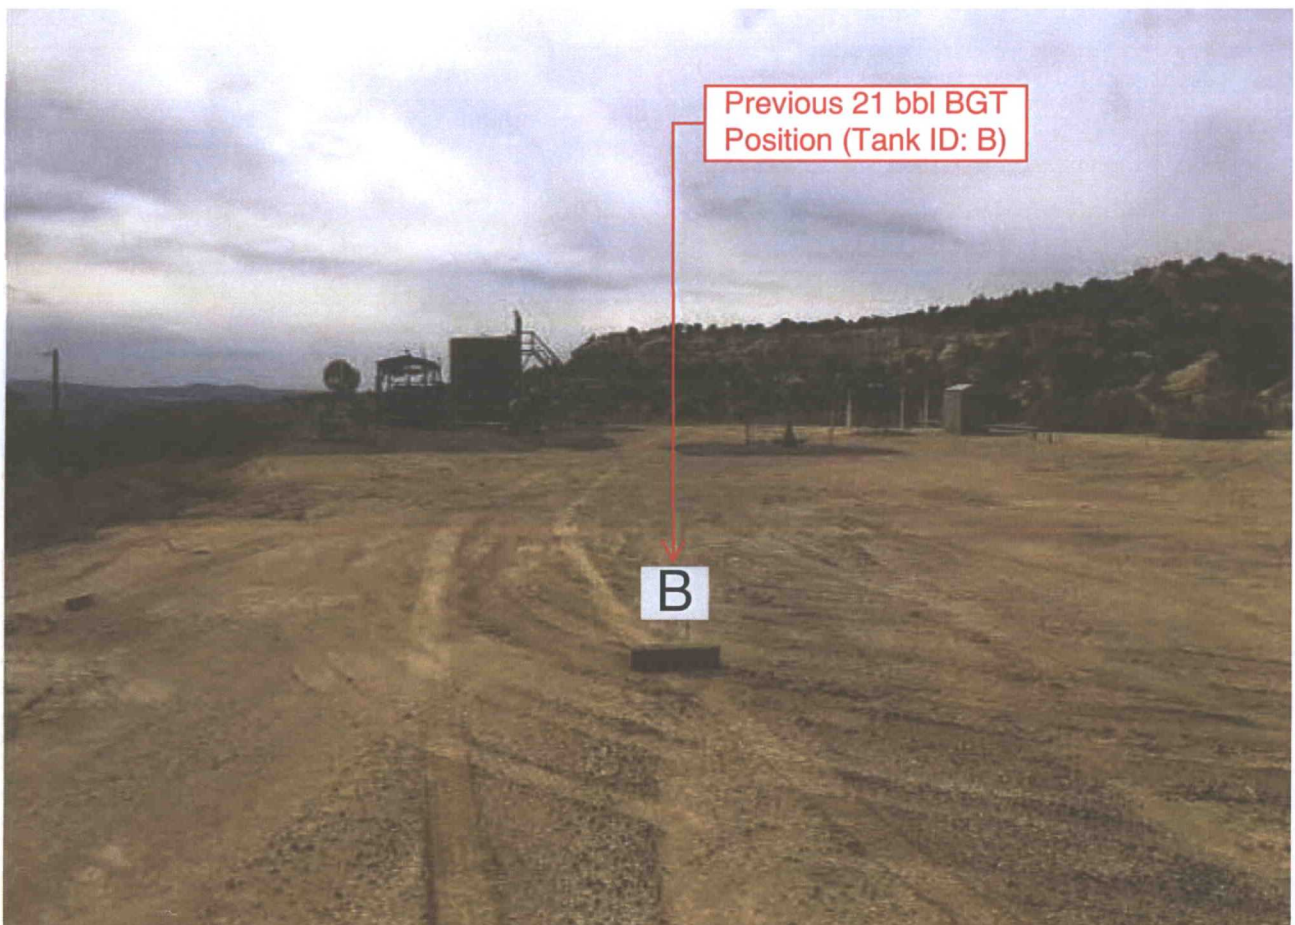
The area has been backfilled. The location will be reclaimed once the well is plugged and abandoned.

BP did not meet the 60 closure completion requirement due to an error in internal tracking. Closure report on C-144 form is included including photos of reclamation completion.
