BP AMERICA PRODUCTION COMPANY SAN JUAN BASIN, NORTHWEST NEW MEXICO

BELOW-GRADE TANK CLOSURE PLANATLANTIC D COM D LS 005AAPI No.3004522522

Unit Letter F Section 02 T 30N R 10W

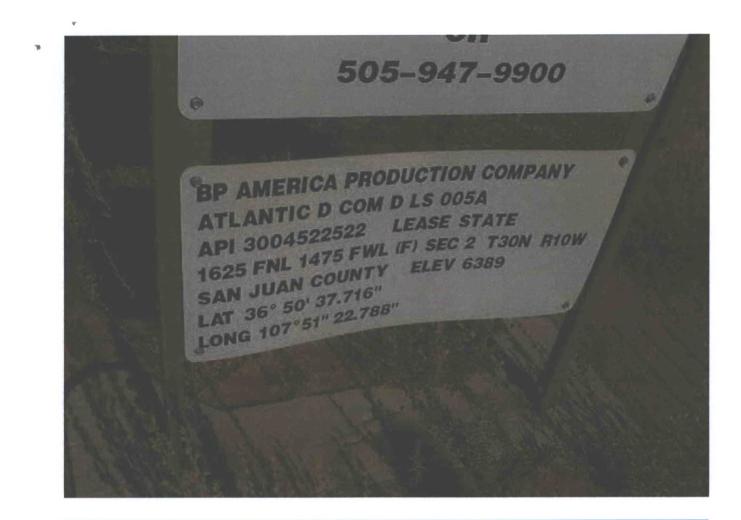
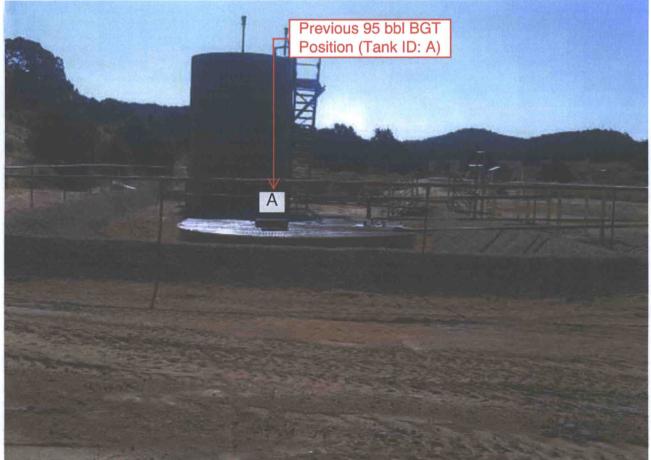
The area has been backfilled and a 105 BBL shallow low profile above-grade tank set atop BGT location. The location will be reclaimed once the well is plugged and abandoned.

BP did not meet the 60 closure completion requirement due to an error in internal tracking. Closure report on C-144 form is included including photos of reclamation completion.
