Pit, Below-Grade Tank, or
Proposed Alternative Method Permit or Closure Plan Application

BELOW-GRADE TANK CLOSURE PLAN

SCOTT LS 003A

API No. 3004522755

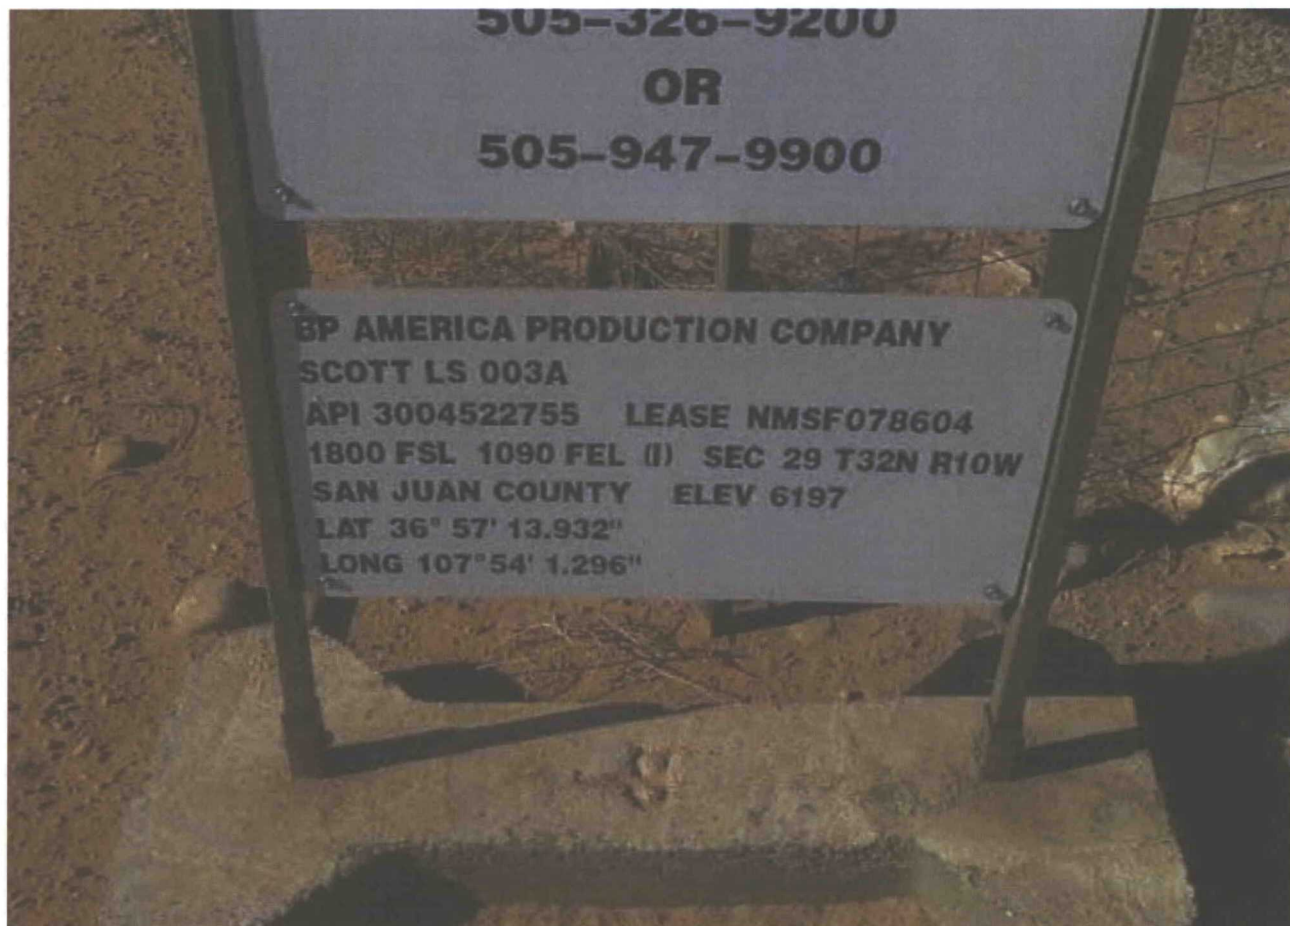
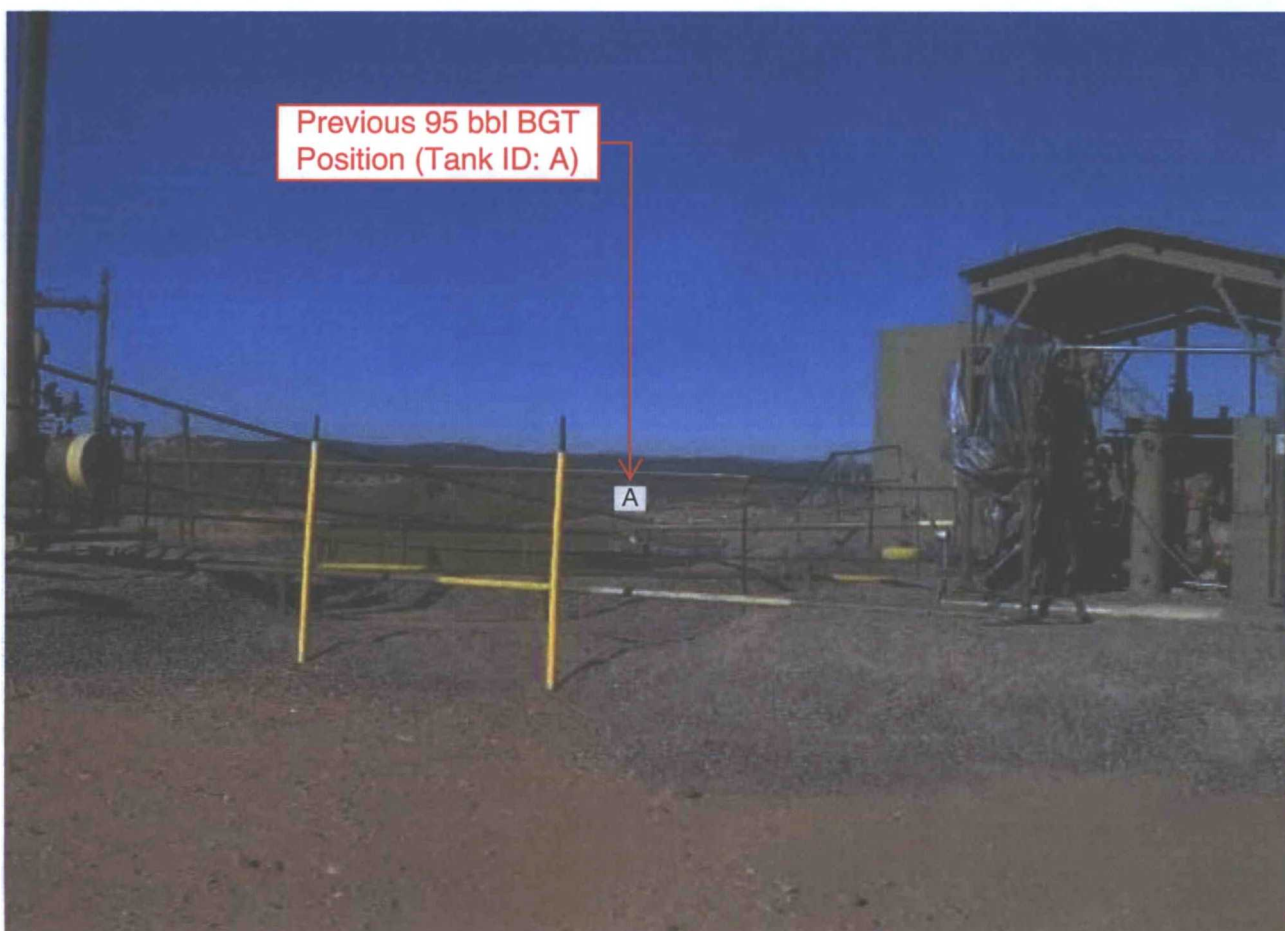
The area has been backfilled and a 105 BBL shallow low profile above-grade tank set atop BGT location. The location will be reclaimed once the well is plugged and abandoned.

BP did not meet the 60 closure completion requirement due to an error in internal tracking. Closure report on C-144 form is included including photos of reclamation completion.
