Pit, Below-Grade Tank, or
Proposed Alternative Method Permit or Closure Plan Application

BP AMERICA PRODUCTION COMPANY
SAN JUAN BASIN, NORTHWEST NEW MEXICO

BELOW-GRADE TANK CLOSURE PLAN

Koch LS #1A

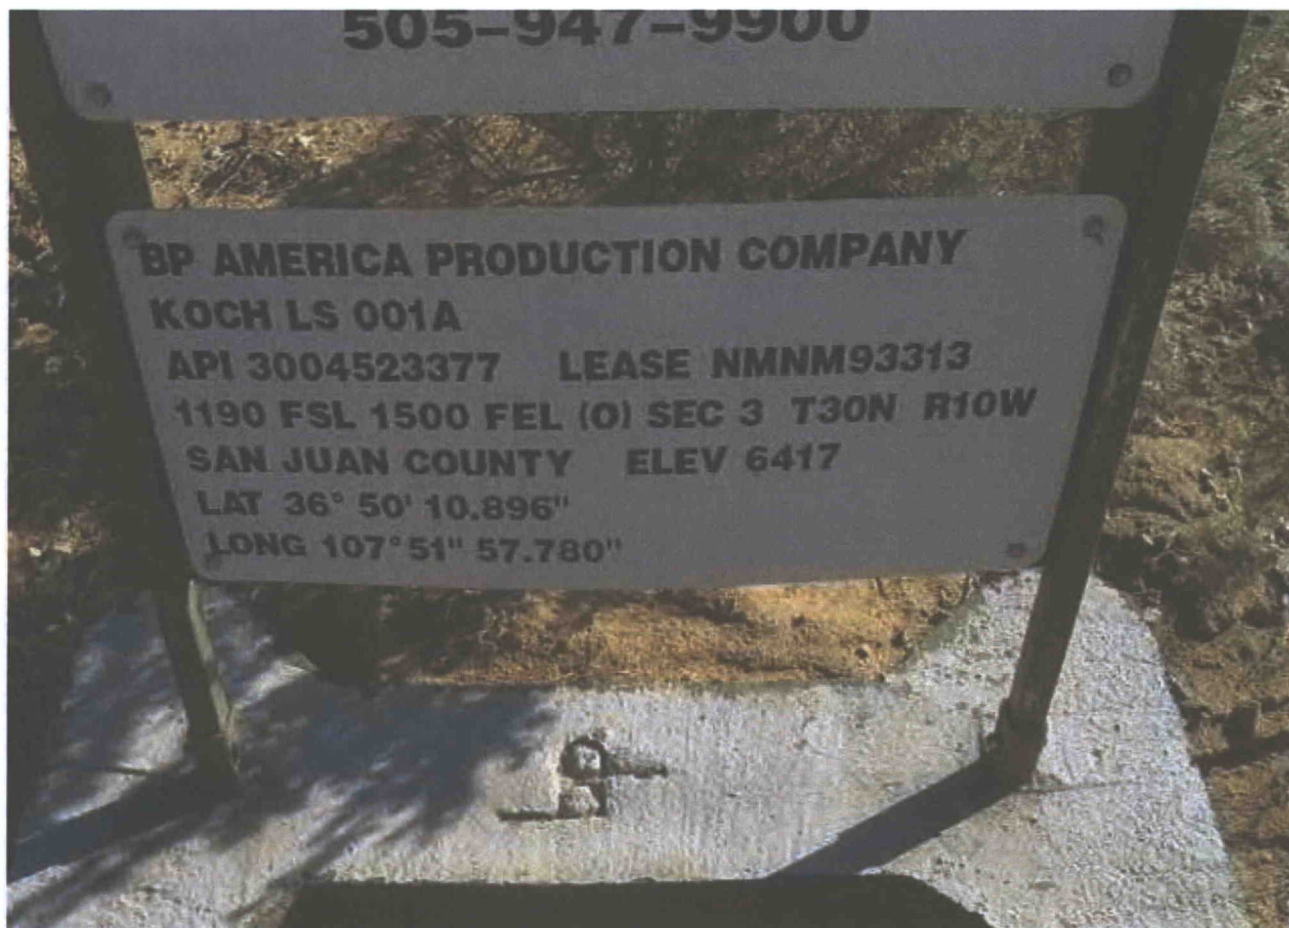
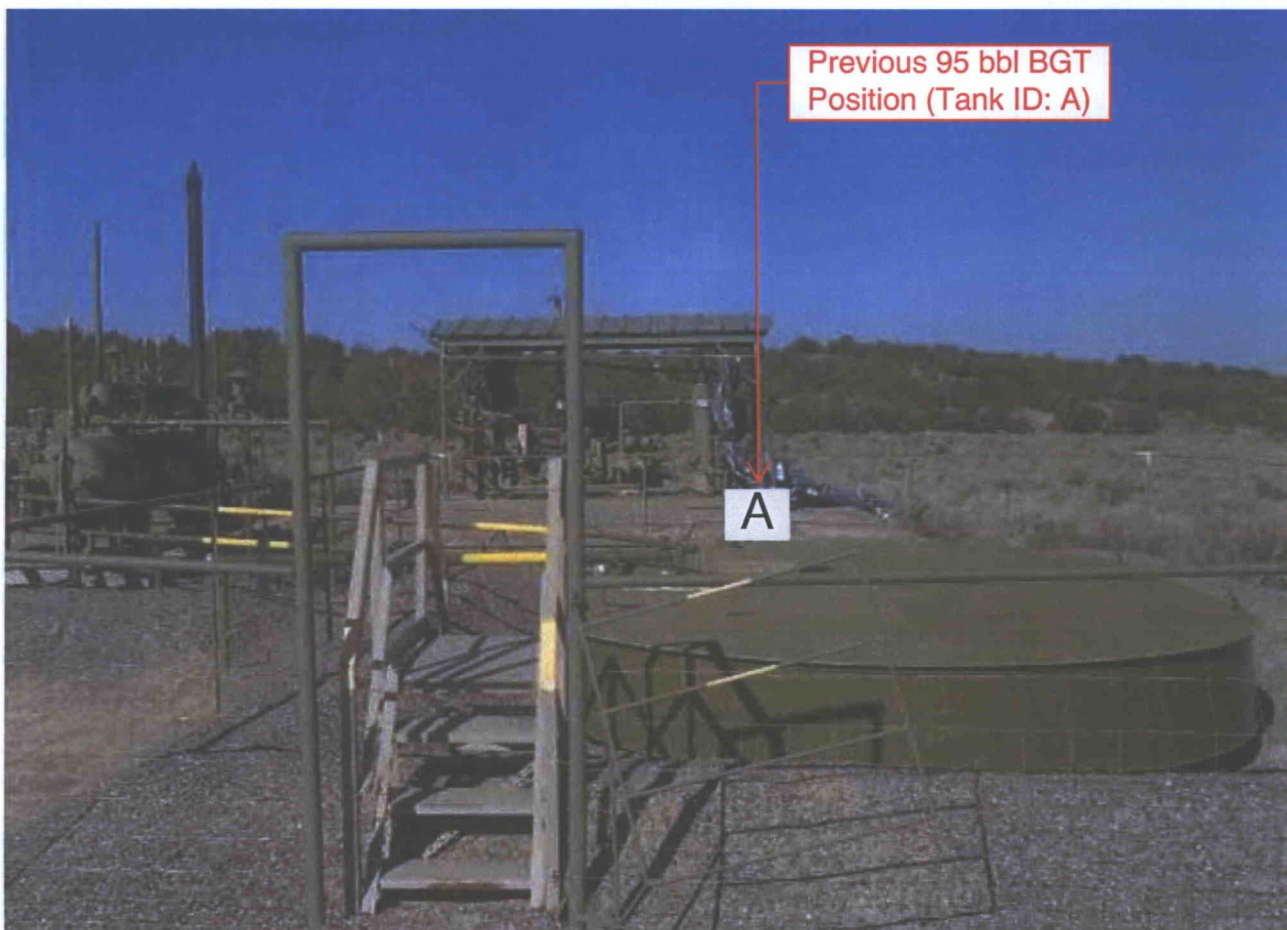
The area has been backfilled and a 105 BBL shallow low profile above-grade tank to be set atop BGT location. The location will be reclaimed once the well is plugged and abandoned.
