Pit, Below-Grade Tank, or
Proposed Alternative Method Permit or Closure Plan Application

BP AMERICA PRODUCTION COMPANY
SAN JUAN BASIN, NORTHWEST NEW MEXICO

BELOW-GRADE TANK CLOSURE PLAN

MOORE 006E

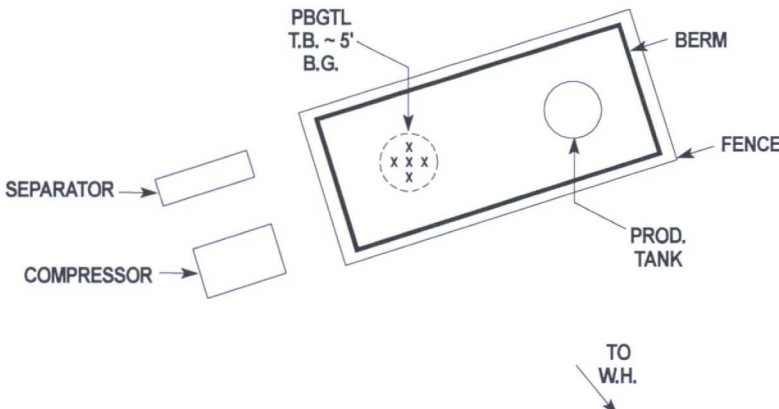
SAMPLING DATA: CHAIN OF CUSTODY RECORD(S) # OR LAB USED: HALL OVM READING (ppm) NA 1) SAMPLE ID: 5PC - TB @ 5' (95) SAMPLE DATE: 07/17/17 SAMPLE TIME: 1245 LAB ANALYSIS: 8015B/8021B/300.0 (CI) 2) SAMPLE ID: _____ SAMPLE DATE: _____ SAMPLE TIME: _____ LAB ANALYSIS: _____ 3) SAMPLE ID: _____ SAMPLE DATE: _____ SAMPLE TIME: _____ LAB ANALYSIS: _____ 4) SAMPLE ID: _____ SAMPLE DATE: _____ SAMPLE TIME: _____ LAB ANALYSIS: _____ 5) SAMPLE ID: _____ SAMPLE DATE: _____ SAMPLE TIME: _____ LAB ANALYSIS: _____		
SOIL DESCRIPTION: SOIL TYPE: SAND / SILTY SAND / SILT <u>SILTY CLAY</u> / CLAY / GRAVEL / OTHER _____ SOIL COLOR: MODERATE BROWN PLASTICITY (CLAYS): NON PLASTIC / SLIGHTLY PLASTIC <u>COHESIVE</u> / MEDIUM PLASTIC / HIGHLY PLASTIC COHESION (ALL OTHERS): NON COHESIVE / SLIGHTLY COHESIVE / COHESIVE / HIGHLY COHESIVE DENSITY (COHESIVE CLAYS & SILTS): SOFT / FIRM <u>STIFF</u> / VERY STIFF / HARD CONSISTENCY (NON COHESIVE SOILS): LOOSE / FIRM / DENSE / VERY DENSE HC ODOR DETECTED: YES <u>NO</u> EXPLANATION - _____ MOISTURE: DRY / <u>SLIGHTLY MOIST</u> / MOIST / WET / SATURATED / SUPER SATURATED ANY AREAS DISPLAYING WETNESS: YES <u>NO</u> EXPLANATION - _____ SAMPLE TYPE: GRAB / <u>COMPOSITE</u> # OF PTS. 5 DISCOLORATION/STAINING OBSERVED: YES <u>NO</u> EXPLANATION - _____

SITE OBSERVATIONS: LOST INTEGRITY OF EQUIPMENT: YES <u>NO</u> EXPLANATION - _____ APPARENT EVIDENCE OF A RELEASE OBSERVED AND/OR OCCURRED: YES <u>NO</u> EXPLANATION: _____ EQUIPMENT SET OVER RECLAIMED AREA: <u>YES</u> / NO EXPLANATION - 105 BBL SHALLOW LOW PROFILE ABOVE-GRADE TANK TO BE SET ATOP BGT LOCATION. OTHER: NMOCD OR BLM NOT PRESENT TO WITNESS CONFIRMATION SAMPLING.		
EXCAVATION DIMENSION ESTIMATION: <u>NA</u> ft. X <u>NA</u> ft. X <u>NA</u> ft. EXCAVATION ESTIMATION (Cubic Yards): <u>NA</u> DEPTH TO GROUNDWATER: <u>>100'</u> NEAREST WATER SOURCE: <u>>1,000'</u> NEAREST SURFACE WATER: <u><1,000'</u> NMOCD TPH CLOSURE STD: 1,000 ppm		
SITE SKETCH BGT Located : off / <u>on</u> site PLOT PLAN circle: <u>attached</u> <div style="display: flex; align-items: center;">

NOTES: BGT = BELOW-GRADE TANK; E.D. = EXCAVATION DEPRESSION; B.G. = BELOW GRADE; B = BELOW; T.H. = TEST HOLE; ~ = APPROX.; W.H. = WELL HEAD; T.B. = TANK BOTTOM; PBGTL = PREVIOUS BELOW-GRADE TANK LOCATION; SPD = SAMPLE POINT DESIGNATION; R.W. = RETAINING WALL; NA = NOT APPLICABLE OR NOT AVAILABLE; SW - SINGLE WALL; DW - DOUBLE WALL; SB - SINGLE BOTTOM; DB - DOUBLE BOTTOM.		MISCELL. NOTES WO: _____ REF #: P-862 VID: VHIXONEV11 PJ #: _____ Permit date(s): 06/09/10 OCD Appr. date(s): 07/02/17 Tank ID: A OVM = Organic Vapor Meter ppm = parts per million BGT Sidewalls Visible: <u>Y</u> / N BGT Sidewalls Visible: Y / N BGT Sidewalls Visible: Y / N Magnetic declination: 10° E
NOTES: GOOGLE EARTH IMAGERY DATE: 10/5/2016. ONSITE: 07/17/17
