BELOW-GRADE TANK CLOSURE PLAN

PRITCHARD B 003

API No. 3004510079

Unit Letter K Section 34 T 31N R 09W

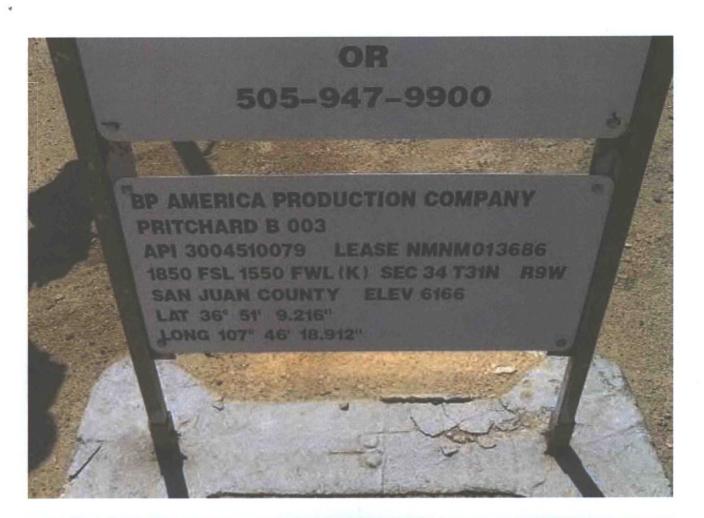
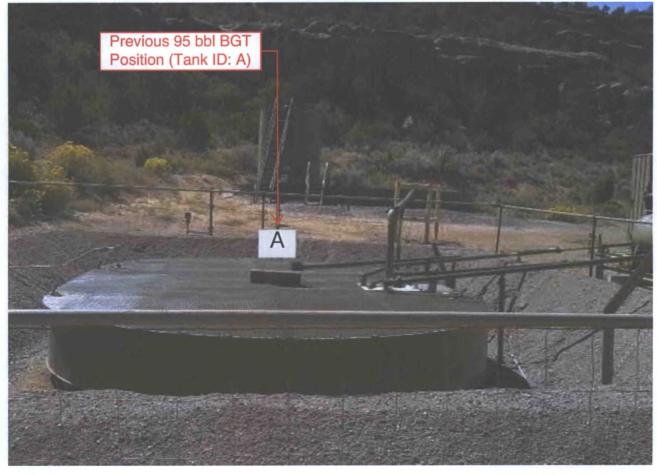
The area has been backfilled and a 105 BBL shallow low profile above-grade tank set atop BGT location. The location will be reclaimed once the well is plugged and abandoned.

BP did not meet the 60 closure completion requirement due to an error in internal tracking. Closure report on C-144 form is included including photos of reclamation completion.
