Pit, Below-Grade Tank, or  
Proposed Alternative Method Permit or Closure Plan Application

**BP AMERICA PRODUCTION COMPANY**  
**SAN JUAN BASIN, NORTHWEST NEW MEXICO**

BELOW-GRADE TANK CLOSURE PLAN

**ATLANTIC A LS 005**

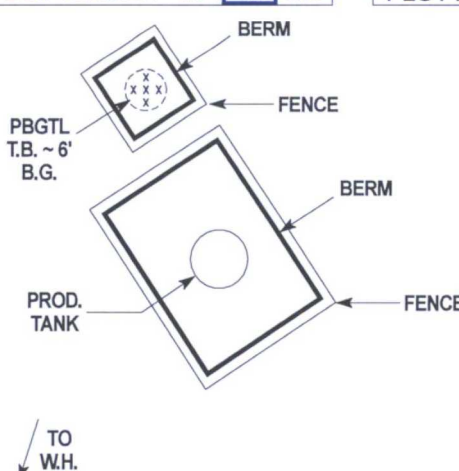
CLIENT: <b>BP</b>	<b>BLAGG ENGINEERING, INC.</b> <b>P.O. BOX 87, BLOOMFIELD, NM 87413</b> <b>(505) 632-1199</b>	API #: <b>3004510280</b> TANK ID (if applicable): <b>B</b>								
<b>FIELD REPORT:</b> (circle one): <u>BGT CONFIRMATION</u> / RELEASE INVESTIGATION / OTHER:		PAGE #: <b>1</b> of <b>1</b>								
SITE INFORMATION: SITE NAME: <b>ATLANTIC A LS # 5</b> QUAD/UNIT: <b>L SEC: 26 TWP: 31N RNG: 10W PM: NM CNTY: SJ ST: NM</b> 1/4 - 1/4 FOOTAGE: <b>1,650'S / 990'W NW/SW</b> LEASE TYPE: <u>FEDERAL</u> / STATE / FEE / INDIAN LEASE #: <b>NM0606</b> PROD. FORMATION: <b>MV</b> CONTRACTOR: <b>STRIKE BP - J. GONZALES</b>		DATE STARTED: <b>08/17/17</b> DATE FINISHED: _____ ENVIRONMENTAL SPECIALIST(S): <b>JCB</b>								
REFERENCE POINT: WELL HEAD (W.H.) GPS COORD.: <b>36.86683 X 107.85761</b> GL ELEV.: <b>6,300'</b> 1) <b>21 BGT (SW/DB)</b> GPS COORD.: <b>36.867055 X 107.857523</b> DISTANCE/BEARING FROM W.H.: <b>82', N18E</b> 2) _____ GPS COORD.: _____ DISTANCE/BEARING FROM W.H.: _____ 3) _____ GPS COORD.: _____ DISTANCE/BEARING FROM W.H.: _____ 4) _____ GPS COORD.: _____ DISTANCE/BEARING FROM W.H.: _____										
SAMPLING DATA: CHAIN OF CUSTODY RECORD(S) # OR LAB USED: <b>HALL</b> 1) SAMPLE ID: <b>21 BGT 5 - pt. @ 6'</b> SAMPLE DATE: <b>08/17/17</b> SAMPLE TIME: <b>1037</b> LAB ANALYSIS: <b>8015B/8021B/300.0 (CI)</b> OVM READING (ppm): <b>0.8</b> 2) SAMPLE ID: _____ SAMPLE DATE: _____ SAMPLE TIME: _____ LAB ANALYSIS: _____ 3) SAMPLE ID: _____ SAMPLE DATE: _____ SAMPLE TIME: _____ LAB ANALYSIS: _____ 4) SAMPLE ID: _____ SAMPLE DATE: _____ SAMPLE TIME: _____ LAB ANALYSIS: _____ 5) SAMPLE ID: _____ SAMPLE DATE: _____ SAMPLE TIME: _____ LAB ANALYSIS: _____										
SOIL DESCRIPTION: SOIL TYPE: SAND <u>SILTY SAND</u> SILT / SILTY CLAY / CLAY / GRAVEL / OTHER _____ SOIL COLOR: <b>DARK YELLOWISH ORANGE</b> PLASTICITY (CLAYS): NON PLASTIC / SLIGHTLY PLASTIC / COHESIVE / MEDIUM PLASTIC / HIGHLY PLASTIC COHESION (ALL OTHERS): NON COHESIVE <u>SLIGHTLY COHESIVE</u> COHESIVE / HIGHLY COHESIVE DENSITY (COHESIVE CLAYS & SILTS): SOFT / FIRM / STIFF / VERY STIFF / HARD CONSISTENCY (NON COHESIVE SOILS): <u>LOOSE</u> <u>FIRM</u> DENSE / VERY DENSE HC ODOR DETECTED: YES <u>NO</u> EXPLANATION - _____ MOISTURE: DRY / <u>SLIGHTLY MOIST</u> MOIST / WET / SATURATED / SUPER SATURATED SAMPLE TYPE: GRAB <u>COMPOSITE</u> # OF PTS. <b>5</b> ANY AREAS DISPLAYING WETNESS: YES <u>NO</u> EXPLANATION - _____ DISCOLORATION/STAINING OBSERVED: YES <u>NO</u> EXPLANATION - _____										
SITE OBSERVATIONS: LOST INTEGRITY OF EQUIPMENT: YES <u>NO</u> EXPLANATION - _____ APPARENT EVIDENCE OF A RELEASE OBSERVED AND/OR OCCURRED: YES <u>NO</u> EXPLANATION: _____ EQUIPMENT SET OVER RECLAIMED AREA: YES <u>NO</u> EXPLANATION - _____ OTHER: <b>BGT SET UPON PVC LINER. BACKHOE USED TO COLLECT SAMPLE POINTS BENEATH LINER.</b>										
EXCAVATION DIMENSION ESTIMATION: <b>NA</b> ft. X <b>NA</b> ft. X <b>NA</b> ft. EXCAVATION ESTIMATION (Cubic Yards): <b>NA</b> DEPTH TO GROUNDWATER: <b>&gt;100'</b> NEAREST WATER SOURCE: <b>&gt;1,000'</b> NEAREST SURFACE WATER: <b>&lt;1,000'</b> NMOCD TPH CLOSURE STD: <b>1,000</b> ppm										
SITE SKETCH BGT Located: off <u>on</u> site PLOT PLAN circle: <u>attached</u>

OVM CALIB. READ. = <b>100.1</b> ppm RF=1.00 OVM CALIB. GAS = <b>100</b> ppm TIME: <b>6:45</b> (am/pm) DATE: <b>08/17/17</b>								
NOTES: BGT = BELOW-GRADE TANK; E.D. = EXCAVATION DEPRESSION; B.G. = BELOW GRADE; B = BELOW; T.H. = TEST HOLE; ~ = APPROX.; W.H. = WELL HEAD; T.B. = TANK BOTTOM; PBGTL = PREVIOUS BELOW-GRADE TANK LOCATION; SPD = SAMPLE POINT DESIGNATION; R.W. = RETAINING WALL; NA - NOT APPLICABLE OR NOT AVAILABLE; SW - SINGLE WALL; DW - DOUBLE WALL; SB - SINGLE BOTTOM; DB - DOUBLE BOTTOM. NOTES: <b>GOOGLE EARTH IMAGERY DATE: 3/15/2015.</b> ONSITE: <b>08/17/17</b>		<b>MISCELL. NOTES</b> WO: REF #: <b>P-674</b> VID: <b>VHIXONEVB2</b> PJ #: Permit date(s): <b>06/14/10</b> OCD Appr. date(s): <b>04/08/16</b>
