Pit, Below-Grade Tank, or
Proposed Alternative Method Permit or Closure Plan Application

BP AMERICA PRODUCTION COMPANY
SAN JUAN BASIN, NORTHWEST NEW MEXICO

BELOW-GRADE TANK CLOSURE PLAN

FLORANCE M 047X

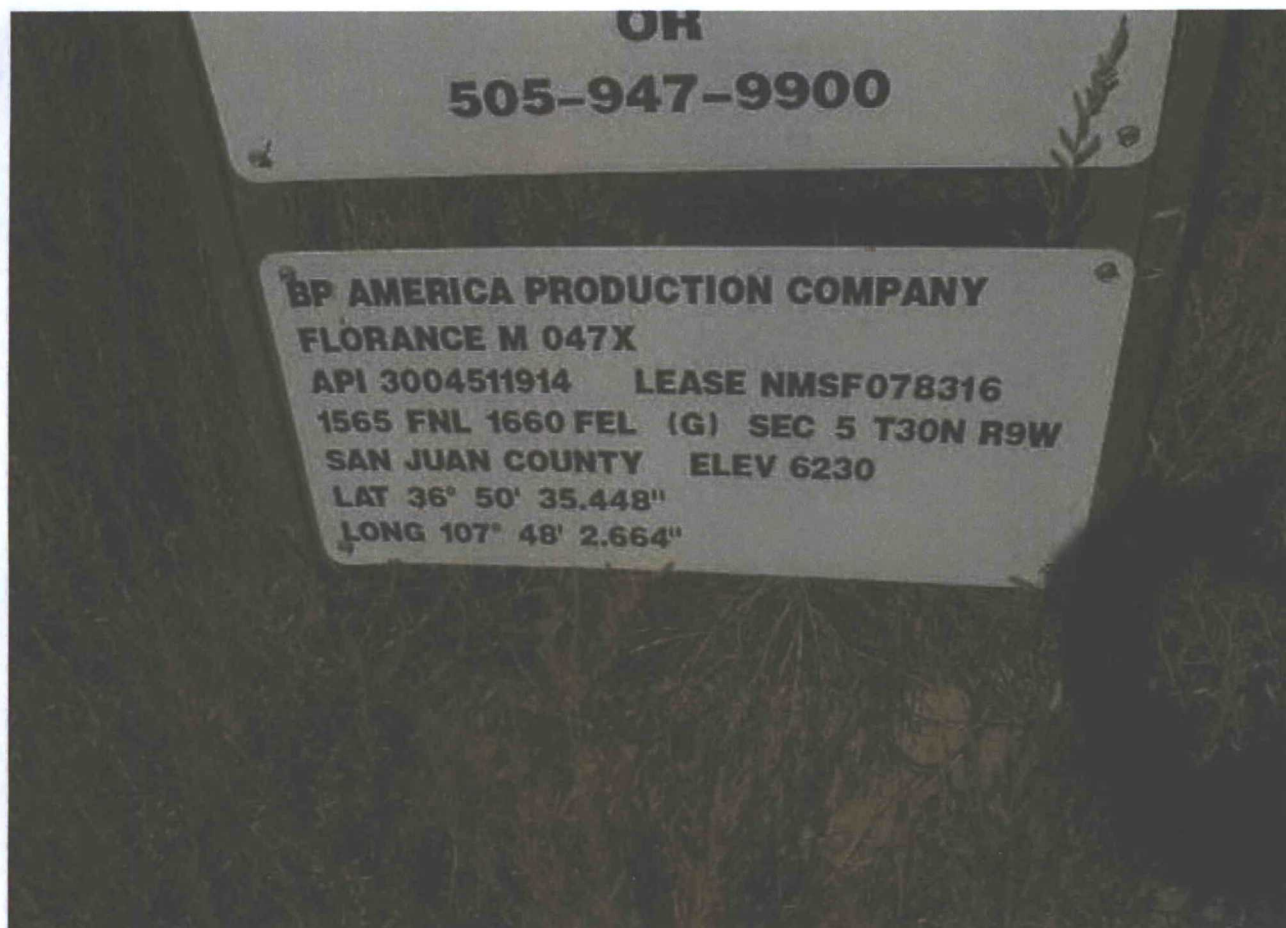
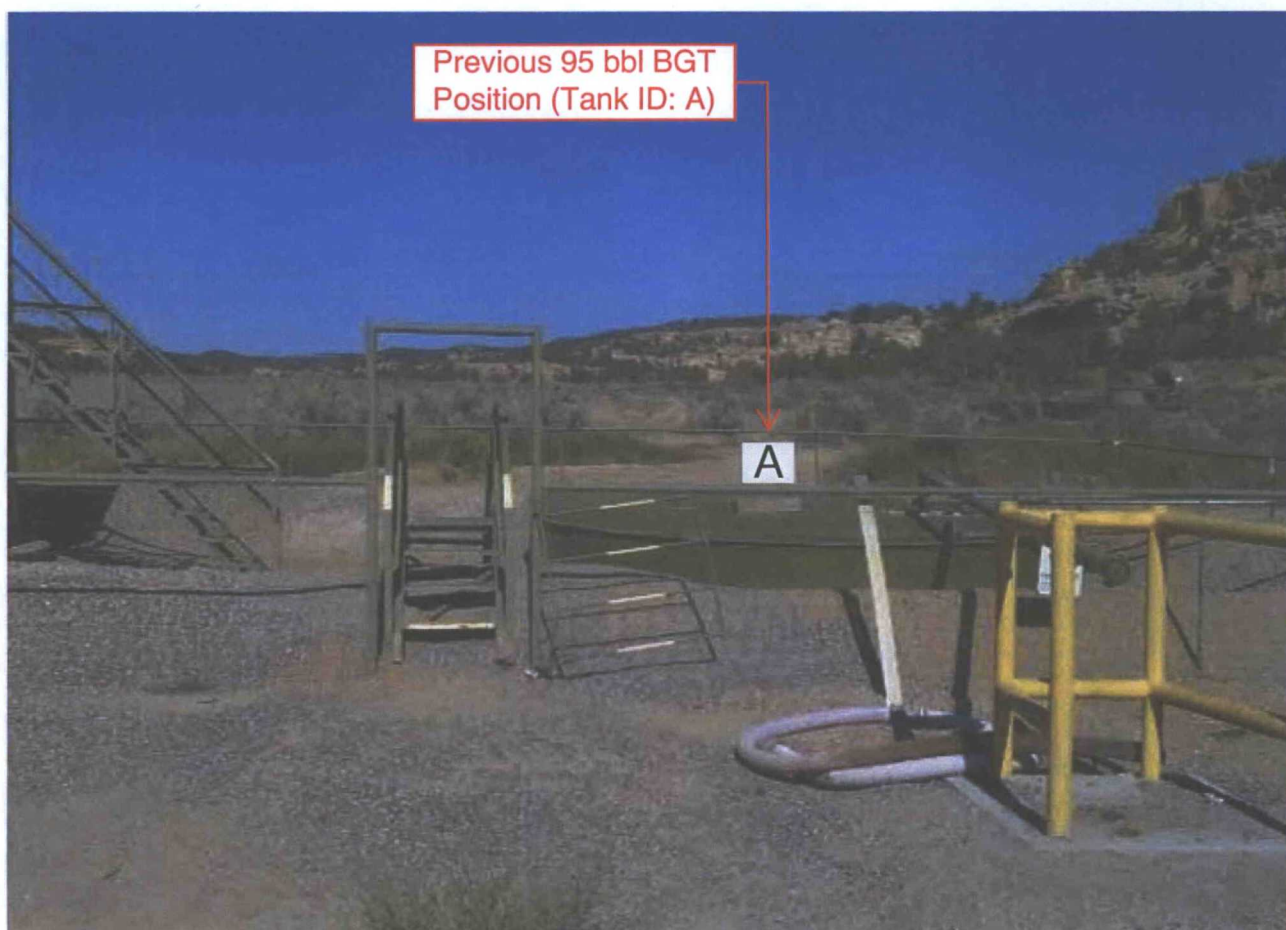
The area has been backfilled and a 105 BBL shallow low profile above-ground tank set atop the BGT location. The area will be reclaimed when the well is plugged and abandoned.
