Pit, Below-Grade Tank, or
Proposed Alternative Method Permit or Closure Plan Application

BELOW-GRADE TANK CLOSURE PLAN

ATLANTIC LS 002R

API No. 3004523984

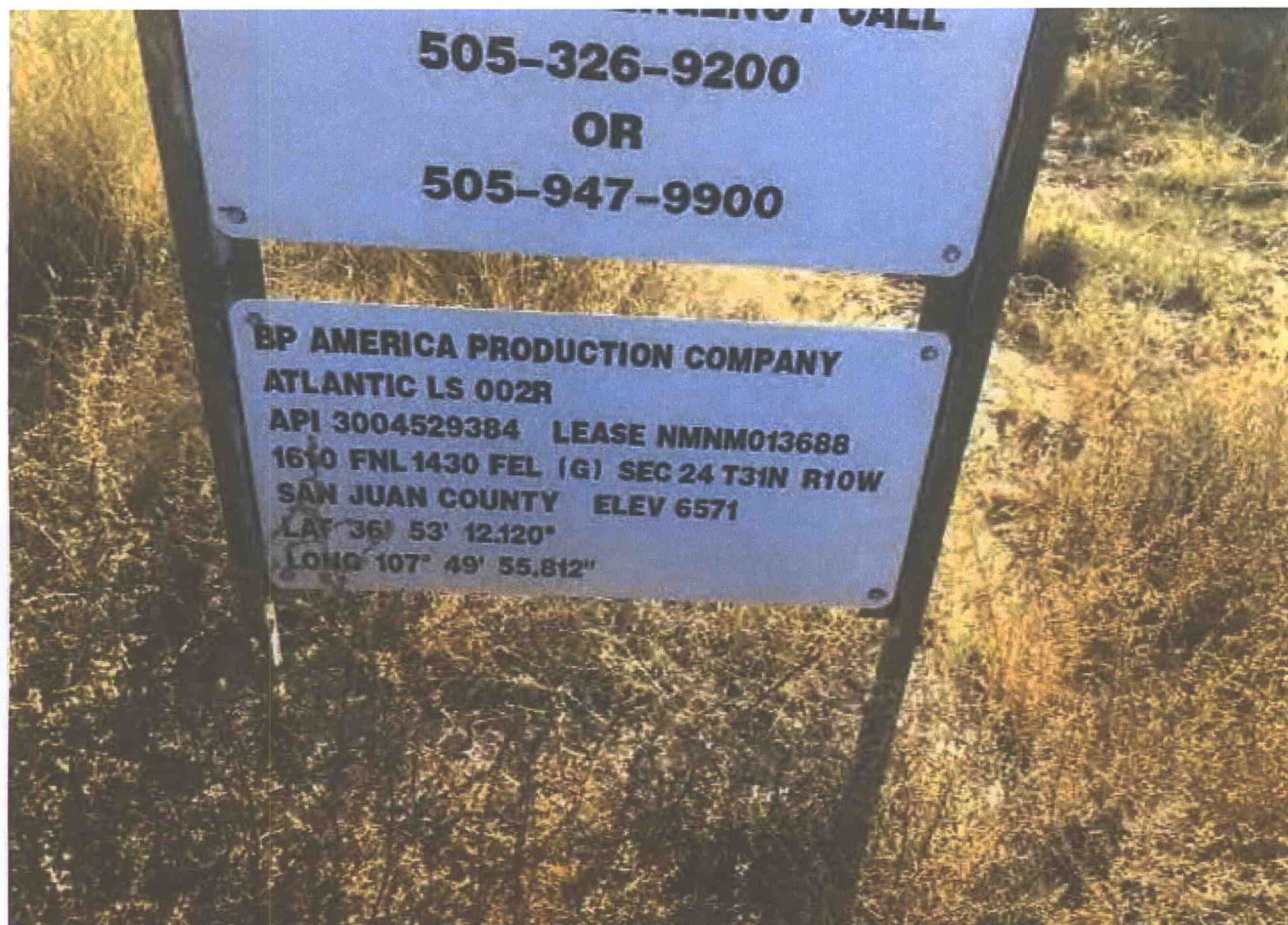
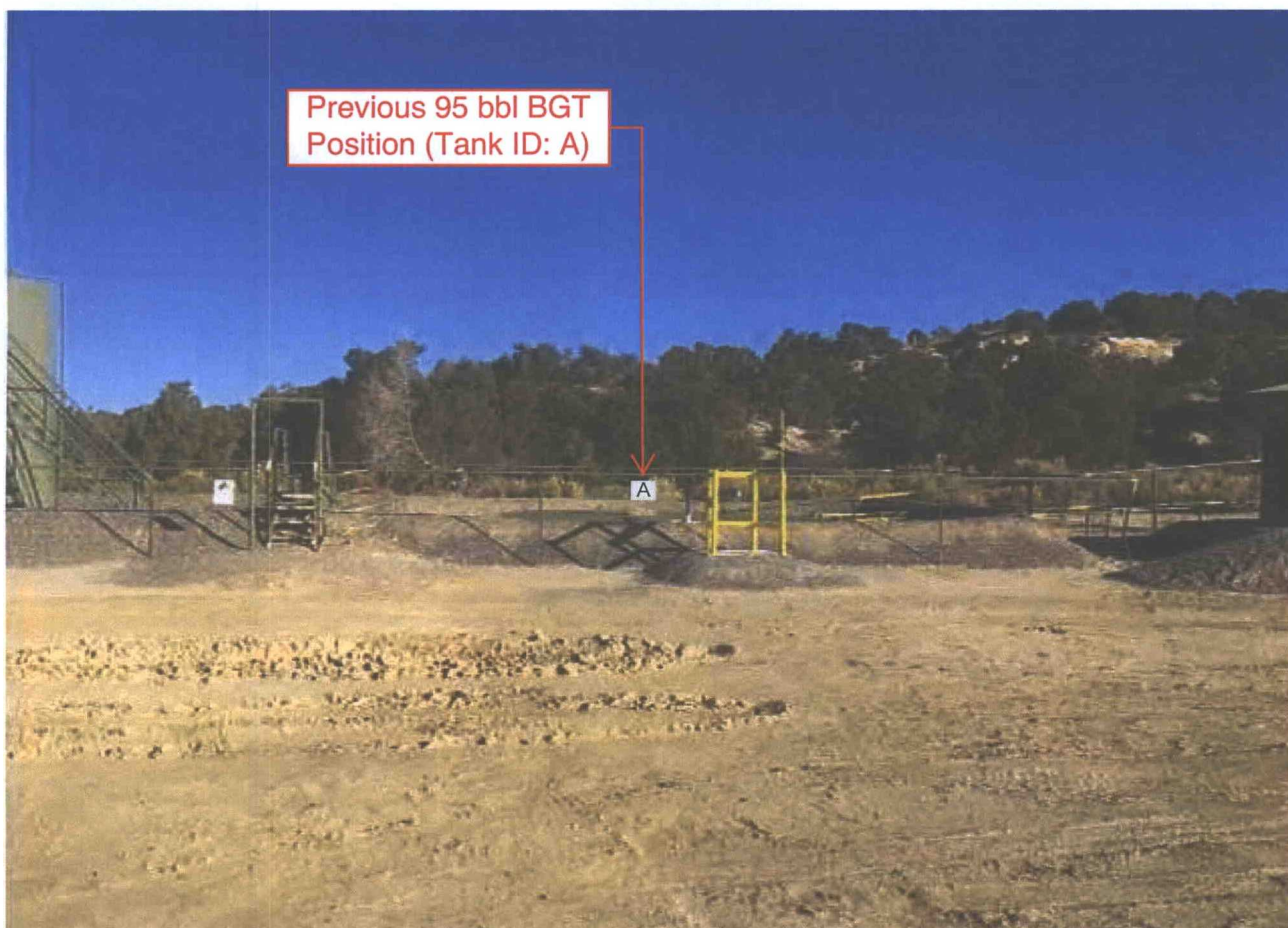
The area has been backfilled and a 105 BBL shallow low profile above-ground tank set atop the BGT location. The area will be reclaimed when the well is plugged and abandoned.
