# BP AMERICA PRODUCTION COMPANY

#### **BELOW-GRADE TANK CLOSURE PLAN**

# BARRETT LS 001C

API No. 3004531037

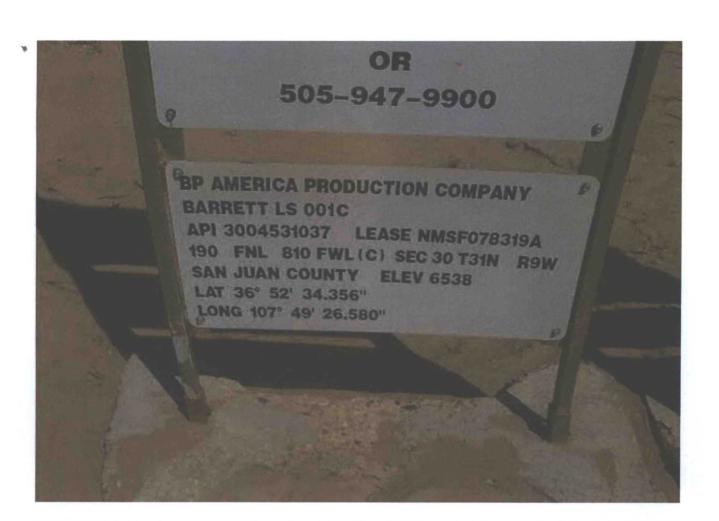
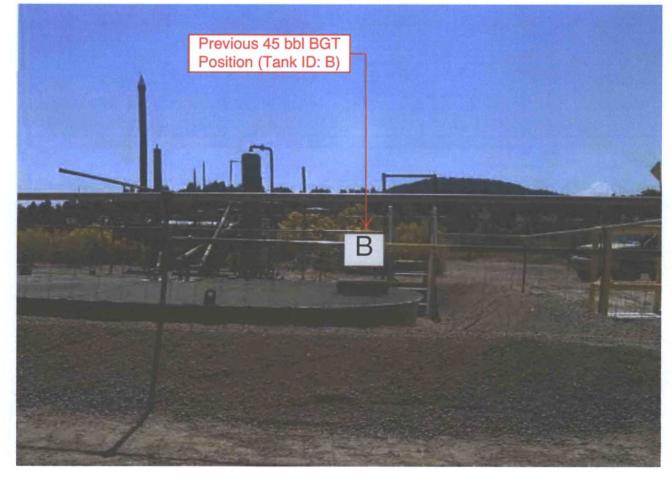
The area has been backfilled and a 105 BBL shallow low profile above-grade tank set atop BGT location. The location will be reclaimed once the well is plugged and abandoned.

BP did not meet the 60 closure completion requirement due to an error in internal tracking. Closure report on C-144 form is included including photos of reclamation completion.
