16166  
Pit, Below-Grade Tank, or  
Proposed Alternative Method Permit or Closure Plan Application

**BELOW-GRADE TANK CLOSURE PLAN**

**ATLANTIC B LS 006**

**API No. 3004510047**

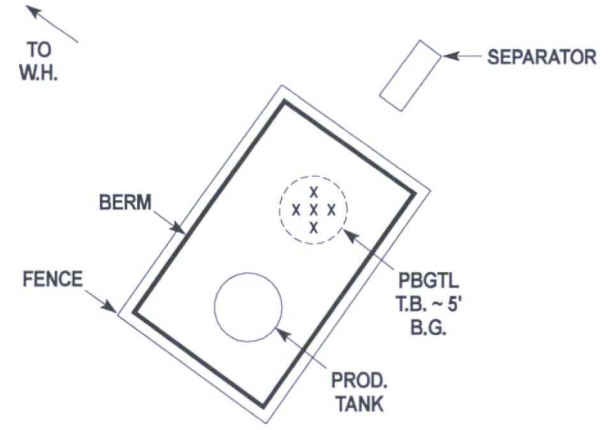
<b>SITE SKETCH</b>	BGT Located: off <u>on</u> site PLOT PLAN circle: <u>attached</u>

<b>SITE OBSERVATIONS:</b>	LOST INTEGRITY OF EQUIPMENT: YES <u>NO</u> EXPLANATION - APPARENT EVIDENCE OF A RELEASE OBSERVED AND/OR OCCURRED: YES <u>NO</u> EXPLANATION: EQUIPMENT SET OVER RECLAIMED AREA: <u>YES</u> NO EXPLANATION - <b>105 BBL SHALLOW LOW PROFILE ABOVE-GRADE TANK TO BE SET ATOP 95 BGT LOCATION.</b> OTHER: <b>NMOCD OR REPS. NOT PRESENT TO WITNESS CONFIRMATION SAMPLING. SANDSTONE - COMPETENT, SLIGHTLY FRIABLE (SAMPLED).</b>
---------------------------	--
