Pit, Below-Grade Tank, or
Proposed Alternative Method Permit or Closure Plan Application

BELOW-GRADE TANK CLOSURE PLAN

NEBU 345

API No. 3003930315

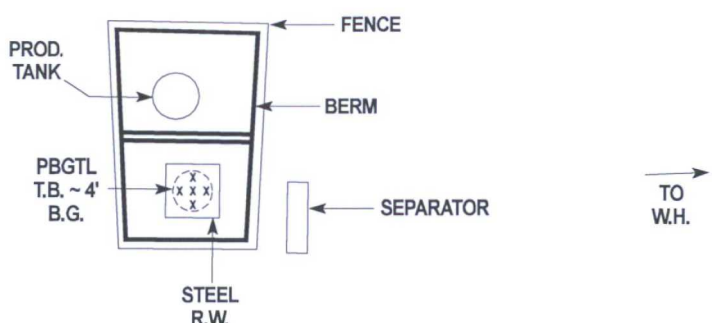
SITE OBSERVATIONS: LOST INTEGRITY OF EQUIPMENT: YES <u>NO</u> EXPLANATION - _____ APPARENT EVIDENCE OF A RELEASE OBSERVED AND/OR OCCURRED: YES <u>NO</u> EXPLANATION: _____ EQUIPMENT SET OVER RECLAIMED AREA: <u>YES</u> <u>NO</u> EXPLANATION - 105 BBL SHALLOW LOW PROFILE ABOVE-GRADE TANK TO BE SET ATOP BGT LOCATION. OTHER: NMOCD OR BLM NOT PRESENT TO WITNESS CONFIRMATION SAMPLING. IMPORTED ROCK GRAVEL BASE IMMEDIATELY BELOW BGT. COLLECTED SAMPLE FROM BEDROCK SURFACE - COMPETENT, WELL CEMENTED. EXCAVATION DIMENSION ESTIMATION: NA ft. X NA ft. X NA ft. EXCAVATION ESTIMATION (Cubic Yards): NA DEPTH TO GROUNDWATER: >100' NEAREST WATER SOURCE: >1,000' NEAREST SURFACE WATER: <1,000' NMOCD TPH CLOSURE STD: 1,000 ppm		
SITE SKETCH BGT Located: off <u>on</u> site PLOT PLAN circle: <u>attached</u> <div style="display: flex; align-items: center;">

<div style="margin-left: 20px;"> MISCELL. NOTES WO: REF #: P-898 VID: VHIXONEV11 PJ #: Permit date(s): 09/12/08 OCD Appr. date(s): 10/20/09 Tank ID: A OVM = Organic Vapor Meter ppm = parts per million BGT Sidewalls Visible: <u>Y</u> / N BGT Sidewalls Visible: Y / N BGT Sidewalls Visible: Y / N Magnetic declination: 10° E </div> </div>

NOTES: BGT = BELOW-GRADE TANK; E.D. = EXCAVATION DEPRESSION; B.G. = BELOW GRADE; B = BELOW; T.H. = TEST HOLE; ~ = APPROX.; W.H. = WELL HEAD; T.B. = TANK BOTTOM; PBGTL = PREVIOUS BELOW-GRADE TANK LOCATION; SPD = SAMPLE POINT DESIGNATION; R.W. = RETAINING WALL; NA - NOT APPLICABLE OR NOT AVAILABLE; SW - SINGLE WALL; DW - DOUBLE WALL; SB - SINGLE BOTTOM; DB - DOUBLE BOTTOM. NOTES: GOOGLE EARTH IMAGERY DATE: 10/5/2016. ONSITE: 09/14/17
