Pit, Below-Grade Tank, or
Proposed Alternative Method Permit or Closure Plan Application

BP AMERICA PRODUCTION COMPANY
SAN JUAN BASIN, NORTHWEST NEW MEXICO

BELOW-GRADE TANK CLOSURE PLAN

RIDDLE C LS 003

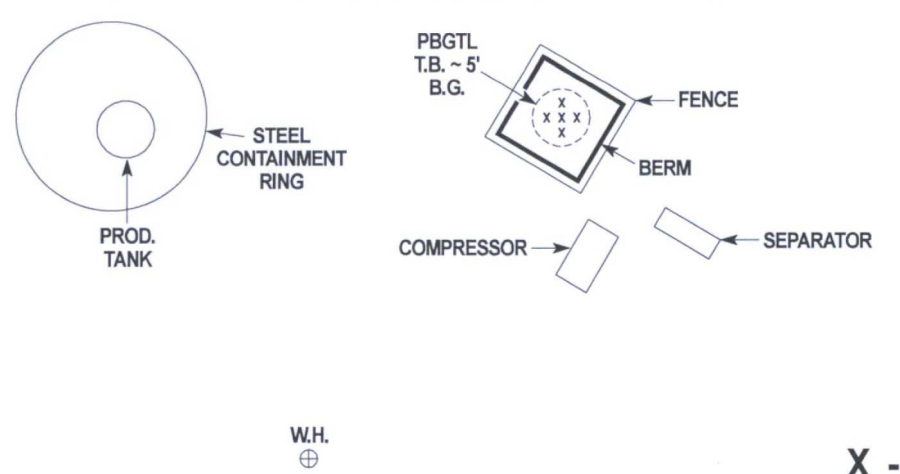
SITE OBSERVATIONS: LOST INTEGRITY OF EQUIPMENT: YES <u>NO</u> EXPLANATION - _____ APPARENT EVIDENCE OF A RELEASE OBSERVED AND/OR OCCURRED: YES <u>NO</u> EXPLANATION: _____ EQUIPMENT SET OVER RECLAIMED AREA: <u>YES</u> / NO EXPLANATION - 105 BBL SHALLOW LOW PROFILE ABOVE-GRADE TANK TO BE SET ATOP BGT LOCATION. OTHER: NMOCD OR BLM NOT PRESENT TO WITNESS CONFIRMATION SAMPLING.		
EXCAVATION DIMENSION ESTIMATION: <u>NA</u> ft. X <u>NA</u> ft. X <u>NA</u> ft. EXCAVATION ESTIMATION (Cubic Yards): <u>NA</u> DEPTH TO GROUNDWATER: >100' NEAREST WATER SOURCE: >1,000' NEAREST SURFACE WATER: <1,000' NMOCD TPH CLOSURE STD: 1,000 ppm		
SITE SKETCH BGT Located : off / <u>on</u> site PLOT PLAN circle: <u>attached</u> <div style="display: flex; align-items: center;">

<div style="margin-left: 20px;"> OVM CALIB. READ. = <u>NA</u> ppm RF=1.00 OVM CALIB. GAS = <u>NA</u> ppm TIME: <u>NA</u> am/pm DATE: <u>NA</u> </div> </div> <div style="border: 1px solid black; padding: 5px; margin-top: 10px;"> MISCELL. NOTES WO: REF #: P-693 VID: VHIXONEVB2 PJ #: Permit date(s): 06/02/10 OCD Appr. date(s): 09/12/16 Tank ID: A OVM = Organic Vapor Meter ppm = parts per million BGT Sidewalls Visible: Y / <u>N</u> BGT Sidewalls Visible: Y / N BGT Sidewalls Visible: Y / N Magnetic declination: 10° E </div>

NOTES: BGT = BELOW-GRADE TANK; E.D. = EXCAVATION DEPRESSION; B.G. = BELOW GRADE; B = BELOW; T.H. = TEST HOLE; ~ = APPROX.; W.H. = WELL HEAD; T.B. = TANK BOTTOM; PBGTL = PREVIOUS BELOW-GRADE TANK LOCATION; SPD = SAMPLE POINT DESIGNATION; R.W. = RETAINING WALL; NA - NOT APPLICABLE OR NOT AVAILABLE; SW - SINGLE WALL; DW - DOUBLE WALL; SB - SINGLE BOTTOM; DB - DOUBLE BOTTOM. NOTES: GOOGLE EARTH IMAGERY DATE: 10/5/2016. ONSITE: 09/11/17
