Pit, Below-Grade Tank, or
Proposed Alternative Method Permit or Closure Plan Application

BELOW-GRADE TANK CLOSURE PLAN

JACQUES LS 001 A

API No. 3004522427

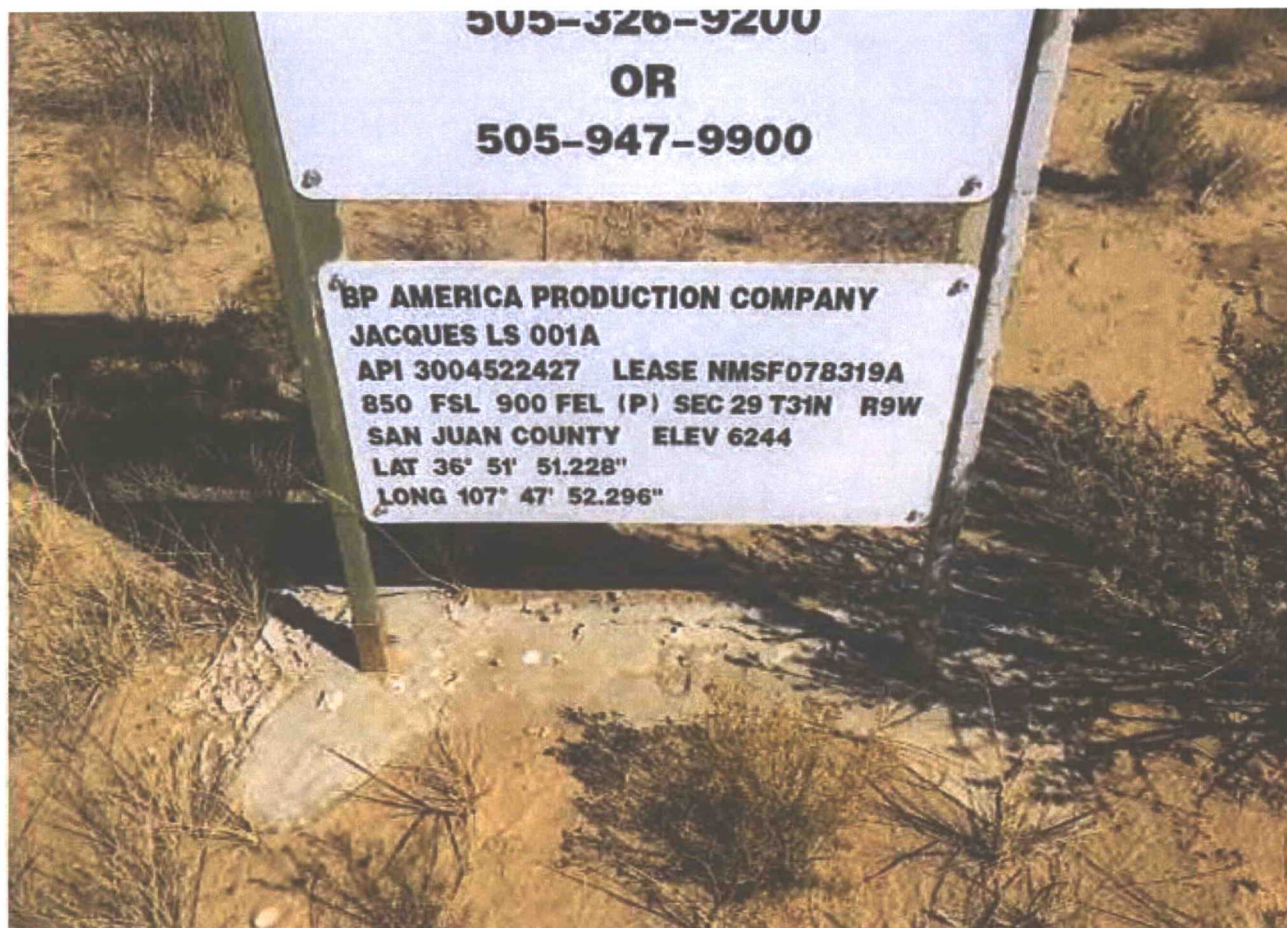
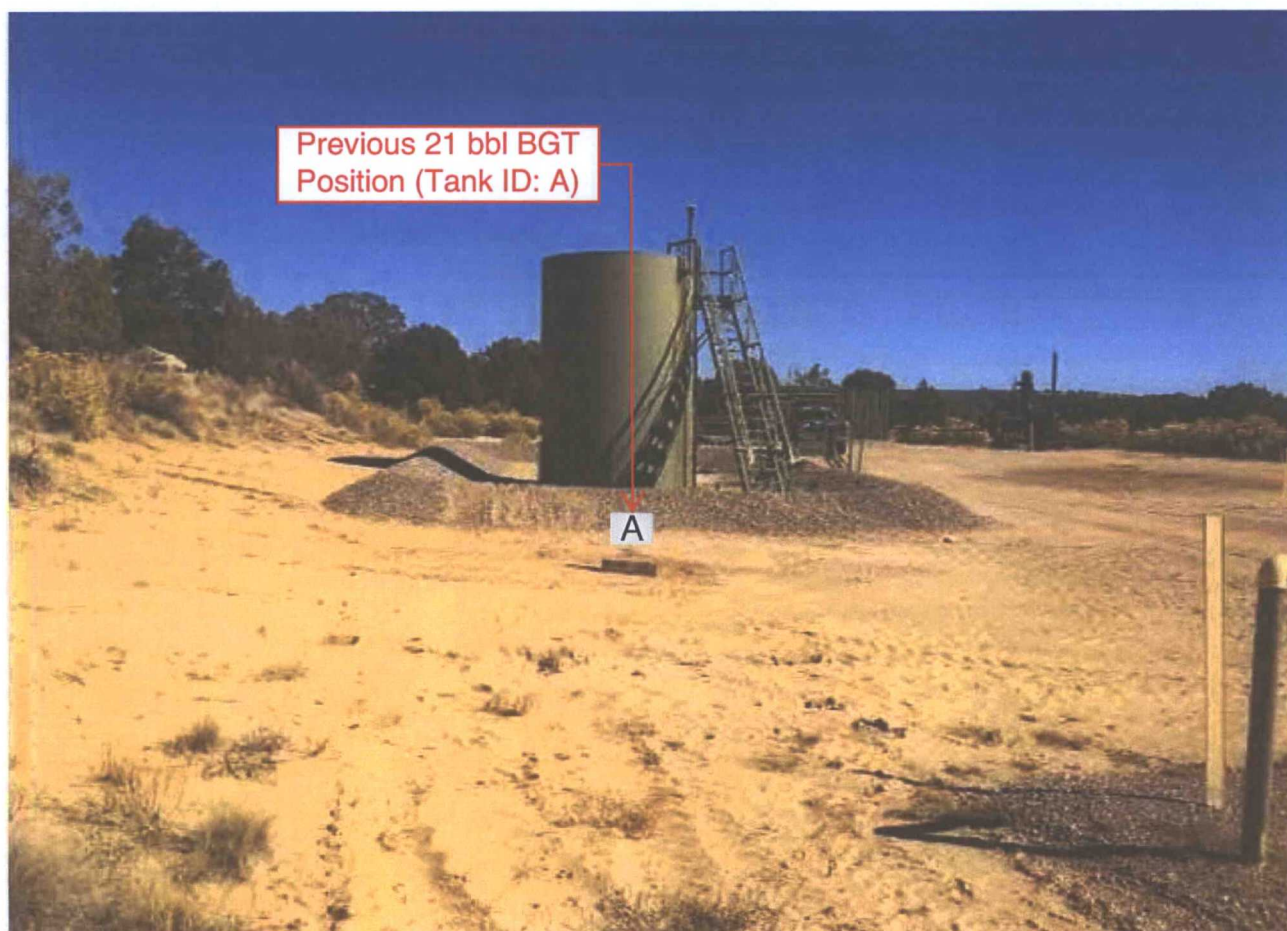
The area has been backfilled. The location will be reclaimed once the well is plugged and abandoned.

BP did not meet the 60 closure completion requirement due to an error in internal tracking. Closure report on C-144 form is included including photos of reclamation completion.
