16171
Pit, Below-Grade Tank, or
Proposed Alternative Method Permit or Closure Plan Application

BP AMERICA PRODUCTION COMPANY
SAN JUAN BASIN, NORTHWEST NEW MEXICO

BELOW-GRADE TANK CLOSURE PLAN

SANDOVAL GC A 001A

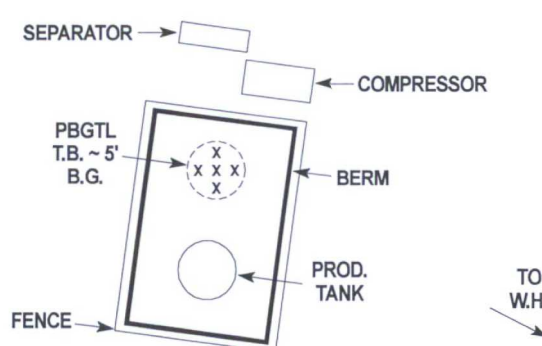
SITE SKETCH	BGT Located : off / <u>on</u> site PLOT PLAN circle: <u>attached</u>

SITE OBSERVATIONS:	LOST INTEGRITY OF EQUIPMENT: YES <u>NO</u> EXPLANATION - APPARENT EVIDENCE OF A RELEASE OBSERVED AND/OR OCCURRED: <u>YES</u> NO EXPLANATION: PHYSICALLY FROM DISCOLORED SOILS & HYDROCARBON ODOR. EQUIPMENT SET OVER RECLAIMED AREA: <u>YES</u> NO EXPLANATION - 105 BBL SHALLOW LOW PROFILE ABOVE-GRADE TANK TO BE SET ATOP BGT LOCATION. OTHER: NMOC D OR BLM NOT PRESENT TO WITNESS CONFIRMATION SAMPLING. ABANDONED FIBERGLASS LINE DISCOVERED WITHIN AREA OF IMPACTED SOILS. EXCAVATION DIMENSION ESTIMATION: _____ ft. X _____ ft. X _____ ft. EXCAVATION ESTIMATION (Cubic Yards): _____ DEPTH TO GROUNDWATER: <100' NEAREST WATER SOURCE: >1,000' NEAREST SURFACE WATER: >1,000' NMOC D TPH CLOSURE STD: 1,000 ppm
---------------------------	---
