16175
Pit, Below-Grade Tank, or
Proposed Alternative Method Permit or Closure Plan Application

BELOW-GRADE TANK CLOSURE PLAN

ATLANTIC B LS 008A

API No. 3004522975

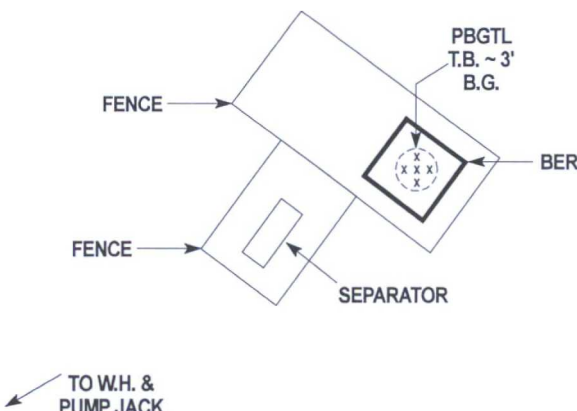
SITE SKETCH	BGT Located: off <input checked="" type="checkbox"/> on site PLOT PLAN circle: <input checked="" type="checkbox"/> attached

SITE OBSERVATIONS:	LOST INTEGRITY OF EQUIPMENT: YES <input checked="" type="checkbox"/> NO EXPLANATION - APPARENT EVIDENCE OF A RELEASE OBSERVED AND/OR OCCURRED: YES <input checked="" type="checkbox"/> NO EXPLANATION: EQUIPMENT SET OVER RECLAIMED AREA: <input checked="" type="checkbox"/> YES / <input type="checkbox"/> NO EXPLANATION - 105 BBL SHALLOW LOW PROFILE ABOVE-GRADE TANK TO BE SET ATOP BGT LOCATION. OTHER: NMOC D REP. NOT PRESENT TO WITNESS CONFIRMATION SAMPLING. COLLECTED SAMPLES FROM BEDROCK SURFACE - PALE YELLOWISH BROWN, COMPETENT & FRIABLE. EXCAVATION DIMENSION ESTIMATION: NA ft. X NA ft. X NA ft. EXCAVATION ESTIMATION (Cubic Yards): NA DEPTH TO GROUNDWATER: >100' NEAREST WATER SOURCE: >1,000' NEAREST SURFACE WATER: <1,000' NMOC D TPH CLOSURE STD: 1,000 ppm
---------------------------	---

TO W.H. & PUMP JACK
--------------------	---
