BP AMERICA PRODUCTION COMPANY
SAN JUAN BASIN, NORTHWEST NEW MEXICO

BELOW-GRADE TANK CLOSURE PLAN

ATLANTIC B LS 003A

API No. 3004522989

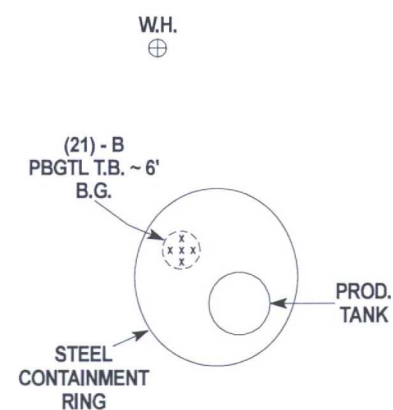
SITE SKETCH BGT Located : off <u>on</u> site PLOT PLAN circle: <u>attached</u>

SOIL DESCRIPTION:	SOIL TYPE: SAND <u>SILTY SAND</u> SILT / SILTY CLAY / CLAY / GRAVEL <u>OTHER</u> BEDROCK (SANDSTONE) SOIL COLOR: MODERATE BROWN COHESION (ALL OTHERS): NON COHESIVE <u>SLIGHTLY COHESIVE</u> COHESIVE <u>HIGHLY COHESIVE</u> CONSISTENCY (NON COHESIVE SOILS): LOOSE <u>FIRM</u> DENSE <u>VERY DENSE</u> MOISTURE: DRY <u>SLIGHTLY MOIST</u> MOIST / WET / SATURATED / SUPER SATURATED SAMPLE TYPE: GRAB <u>COMPOSITE</u> # OF PTS. 5 DISCOLORATION/STAINING OBSERVED: <u>YES</u> NO EXPLANATION - BLACK TO LIGHT GRAY PLASTICITY (CLAYS): NON PLASTIC / SLIGHTLY PLASTIC / COHESIVE / MEDIUM PLASTIC / HIGHLY PLASTIC DENSITY (COHESIVE CLAYS & SILTS): SOFT / FIRM / STIFF / VERY STIFF / HARD HC ODOR DETECTED: <u>YES</u> NO EXPLANATION - DISCOLORED SOILS/BEDROCK ANY AREAS DISPLAYING WETNESS: YES <u>NO</u> EXPLANATION -
--------------------------	--

SITE OBSERVATIONS:	LOST INTEGRITY OF EQUIPMENT: <u>YES</u> NO EXPLANATION - INSPECTION PORT 90 DEGREE ELBOW FITTING APPARENT EVIDENCE OF A RELEASE OBSERVED AND/OR OCCURRED: <u>YES</u> NO EXPLANATION: DISCOLORATION & HYDROCARBON ODOR EQUIPMENT SET OVER RECLAIMED AREA: YES <u>NO</u> EXPLANATION - OTHER: NMOC OR REPS. NOT PRESENT TO WITNESS CONFIRMATION SAMPLING. SANDSTONE ENCOUNTERED AT 8 FT. BELOW GRADE (SAMPLED).
---------------------------	---

EXCAVATION DIMENSION ESTIMATION: _____ ft. X _____ ft. X _____ ft. DEPTH TO GROUNDWATER: >100' NEAREST WATER SOURCE: >1,000' NEAREST SURFACE WATER: >1,000' NMOC TPH CLOSURE STD: 5,000 ppm	EXCAVATION ESTIMATION (Cubic Yards): _____
---	--
