Pit, Below-Grade Tank, or  
Proposed Alternative Method Permit or Closure Plan Application

BELOW-GRADE TANK CLOSURE PLAN

ATLANTIC B LS 004A

API No. 3004523379

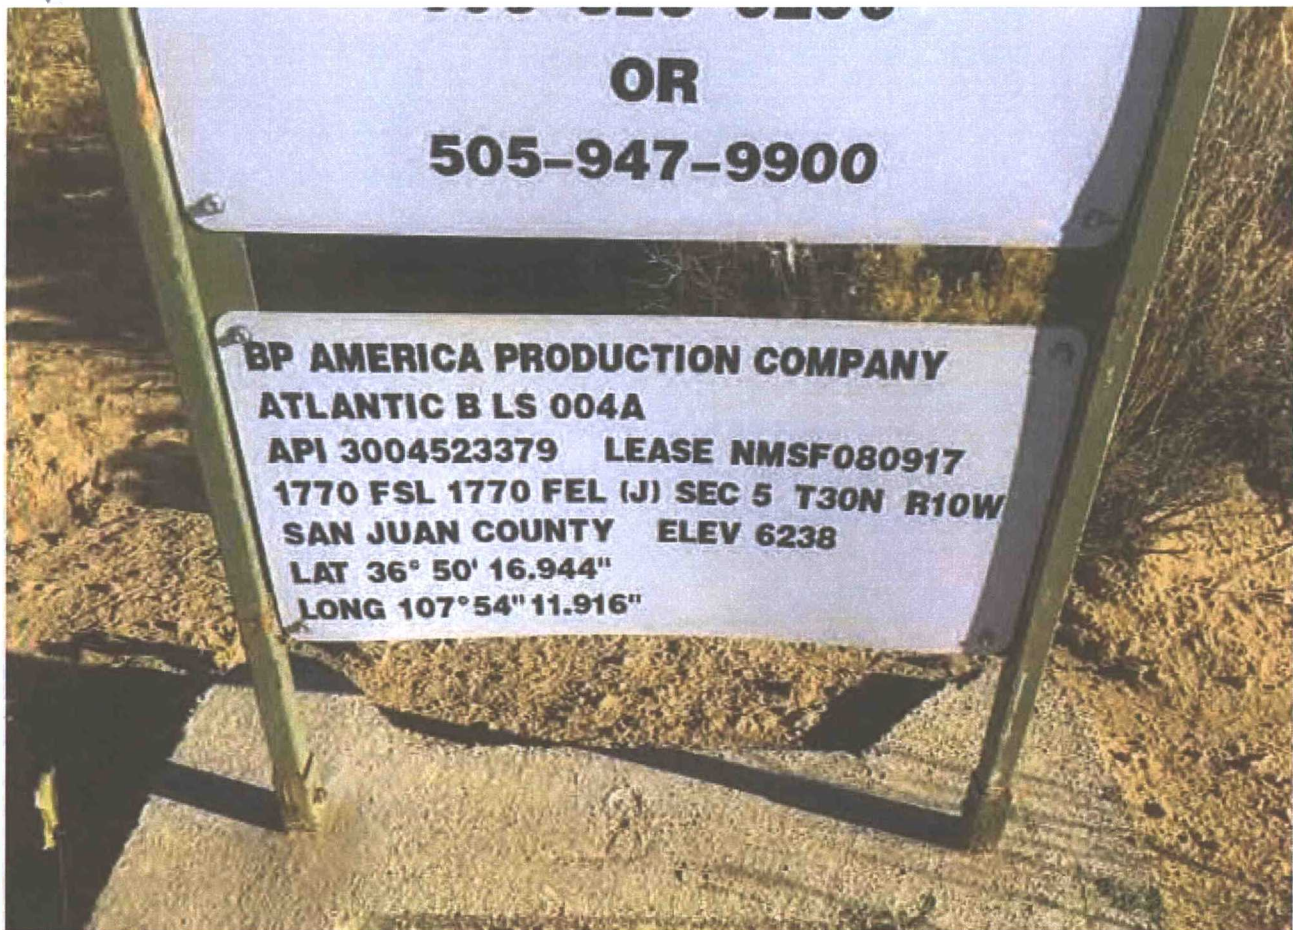
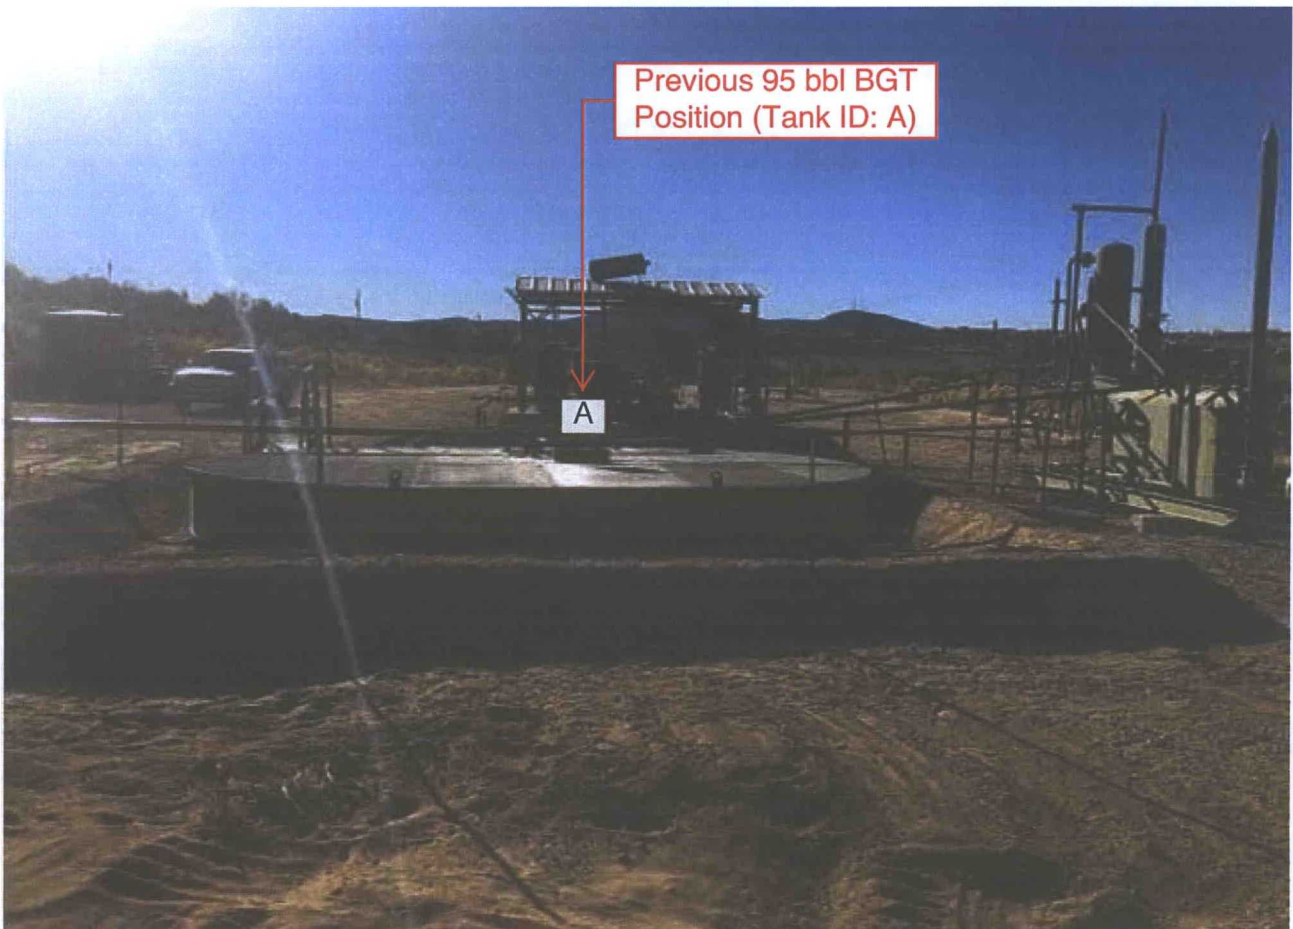
**Closure report on C-144 form is included including photos of reclamation completion.**

10. BP shall reclaim the BGT location and all areas associated with the BGT including associated access roads to a safe and stable condition that blends with the surrounding undisturbed area. BP shall substantially restore the impacted surface area to the condition that existed prior to oil and gas operations by placement of the soil cover as provided in Subsection H of 19.15.17.13 NMAC, re-contour the location and associated areas to a contour that approximates the original contour and blends with the surrounding topography and re-vegetate according to Subsection I of 19.15.17.13 NMAC.
