WPX Energy Production Co., LLC San Juan Basin: New Mexico Assets Below-Grade Tank Removal Closure Report Rosa Unit #056 (API #30-039-21114) Unit Letter E, Section 35, T31N, R05W Rio Arriba County, NM

Below-Grade Tank Removal Plan/Closure Report WPX Energy Production, LLC

WPX Energy Production, LLC Rosa Unit #056 BGT Closure Report Photograph Log

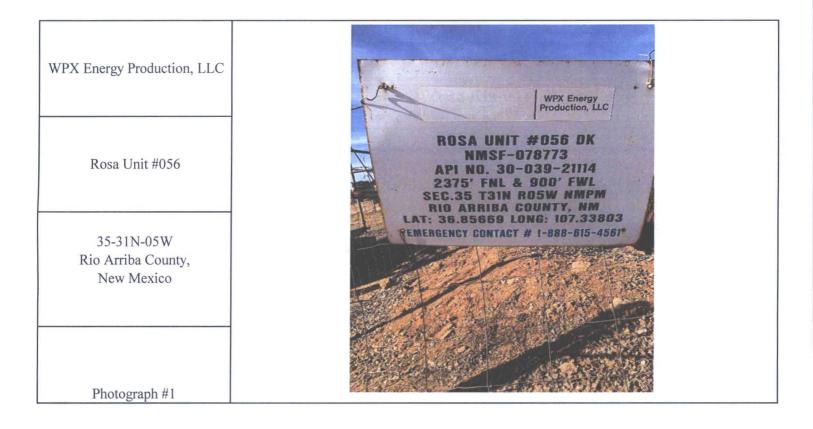
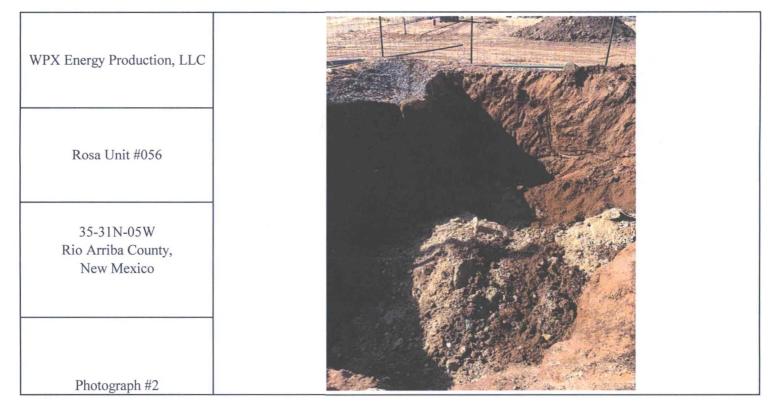
A five-point composite sample (BGT-1) was collected from beneath the BGT following BGT removal on November 22, 2017. No obvious stained soils were observed beneath the BGT.

The BGT location was backfilled with clean soil and compacted during following BGT removal. The BGT location will be reclaimed when it is no longer needed for production operations.
