Pit, Below-Grade Tank, or
Proposed Alternative Method Permit or Closure Plan Application

BP AMERICA PRODUCTION COMPANY
SAN JUAN BASIN, NORTHWEST NEW MEXICO

BELOW-GRADE TANK CLOSURE PLAN

FLETCHER 001

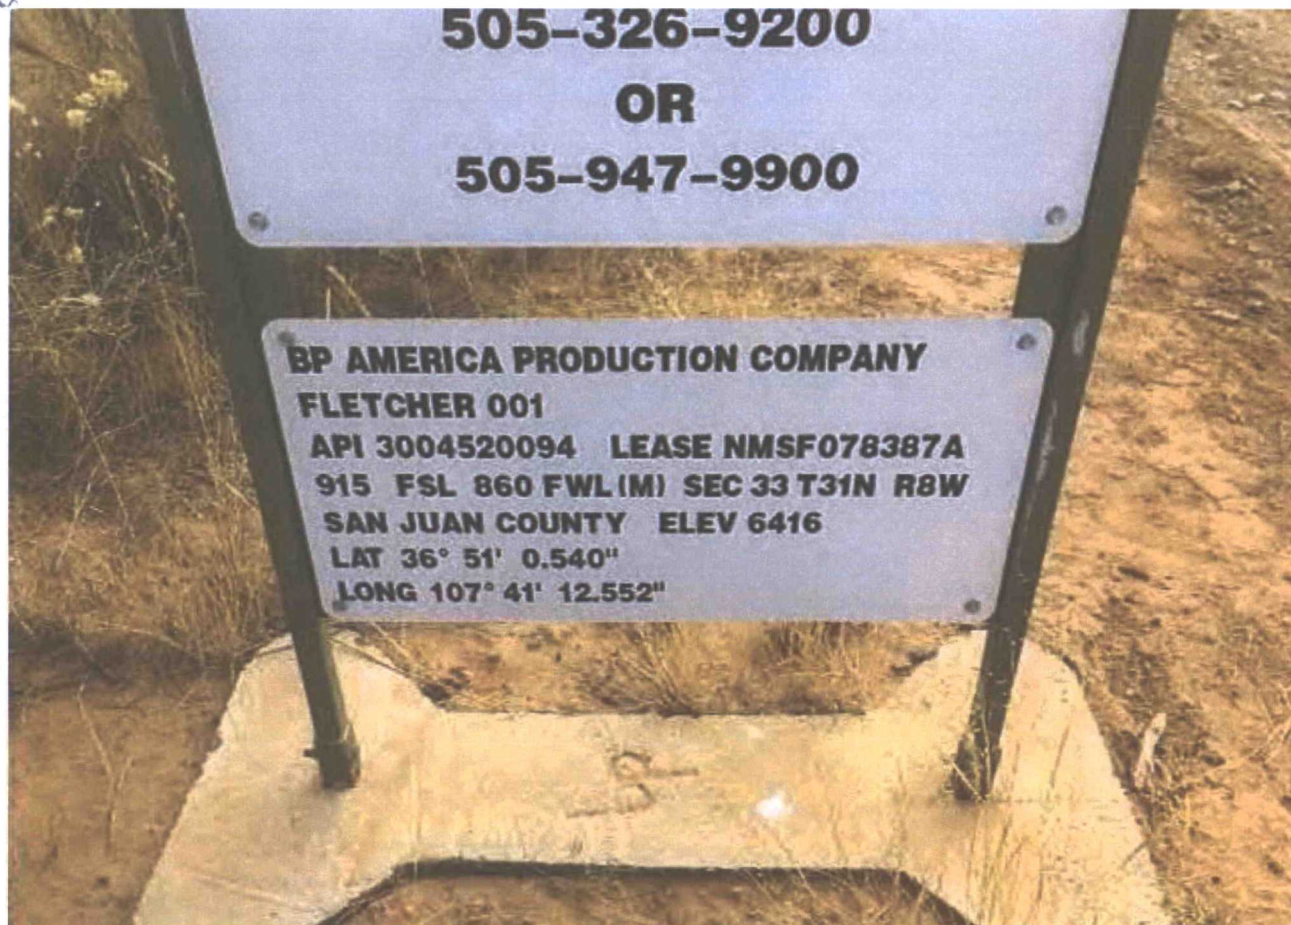
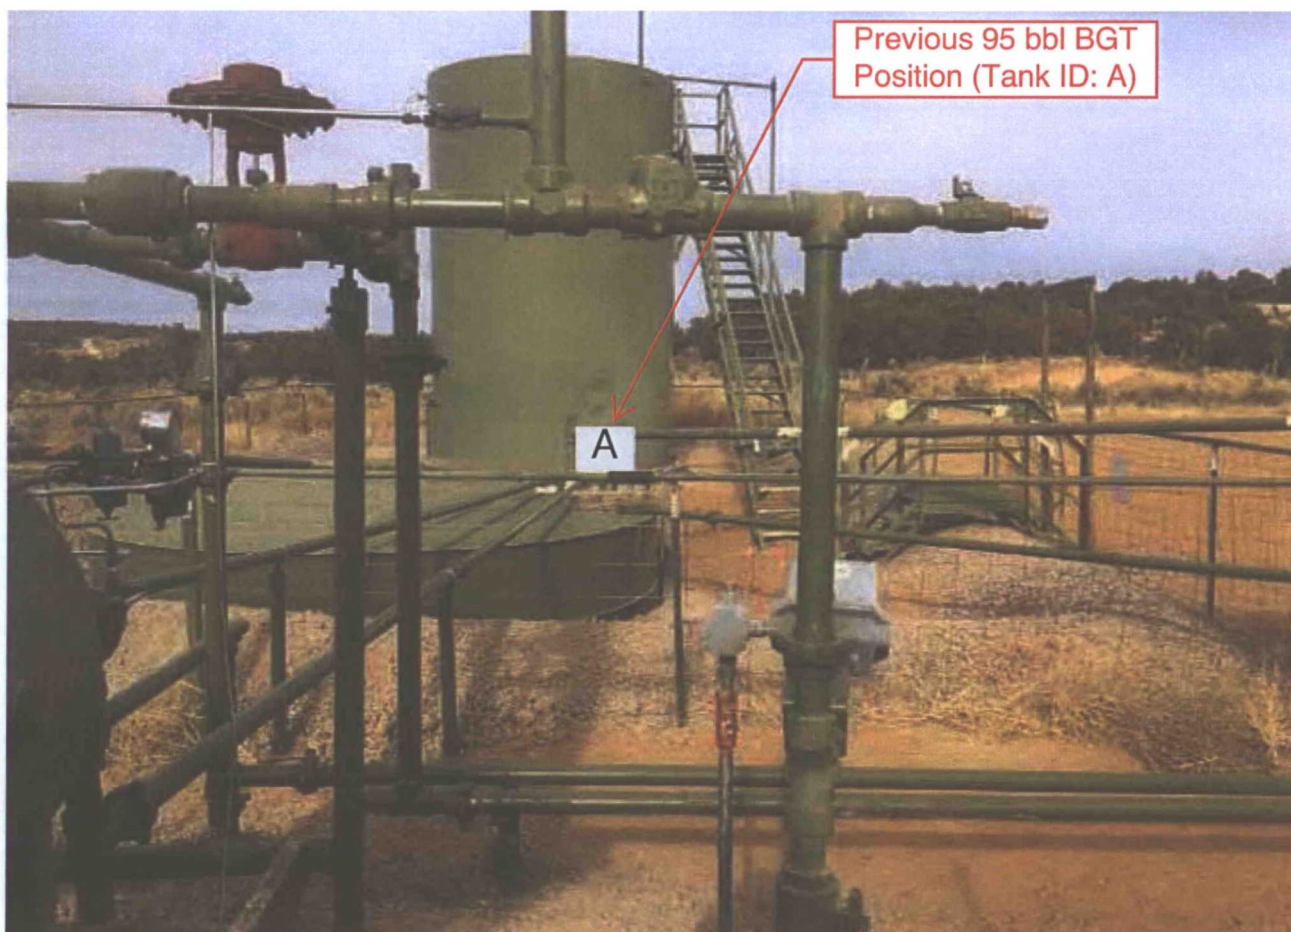
The area has been backfilled and a 105 BBL shallow low profile above-grade tank set atop BGT location. The location will be reclaimed once the well is plugged and abandoned.

Closure report on C-144 form is included including photos of reclamation completion.
