Pit, Below-Grade Tank, or  
Proposed Alternative Method Permit or Closure Plan Application

**BELOW-GRADE TANK CLOSURE PLAN**

**FLORANCE GC E 009A**

**API No. 3004521882**

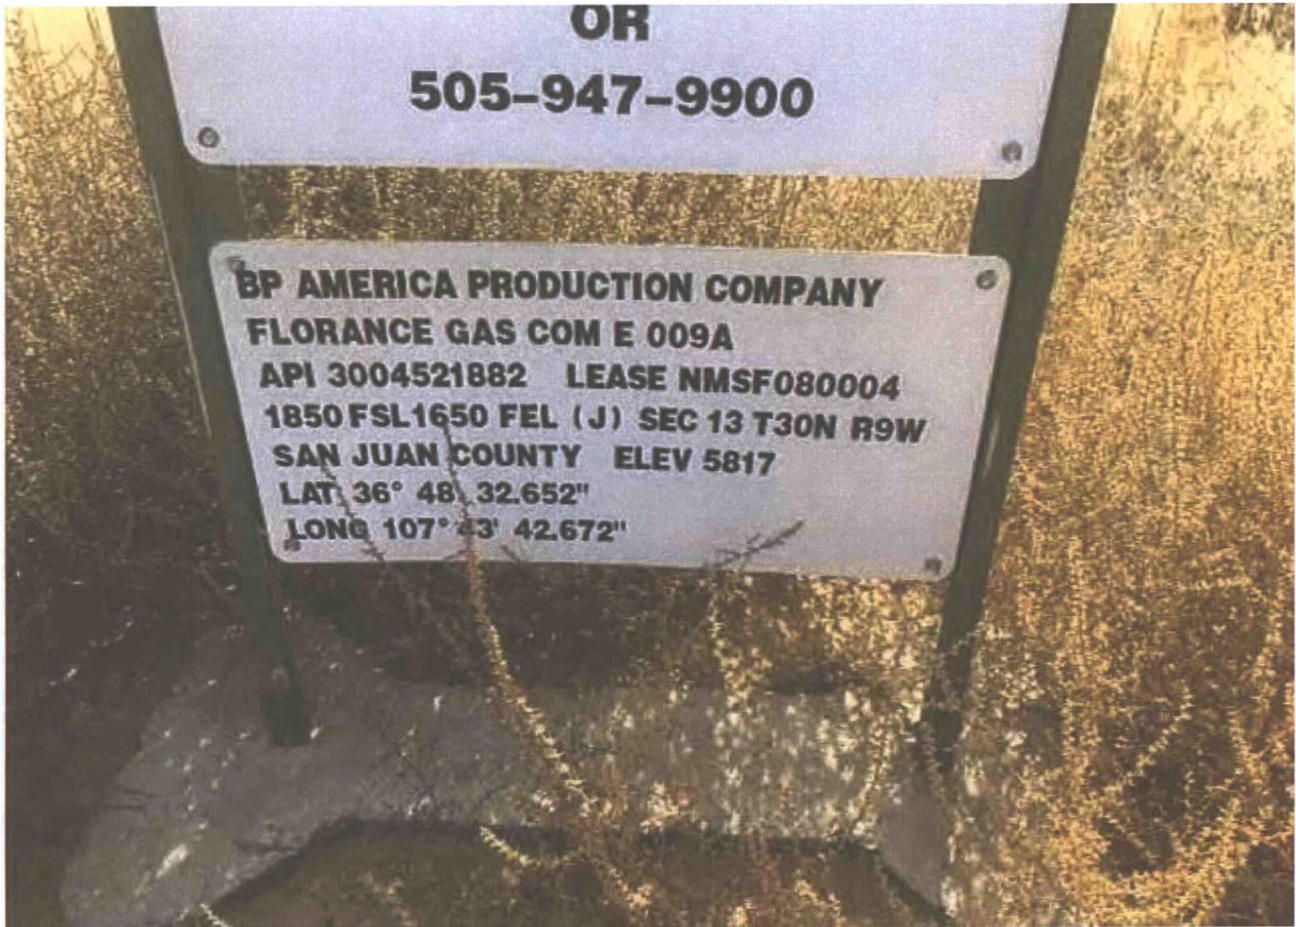
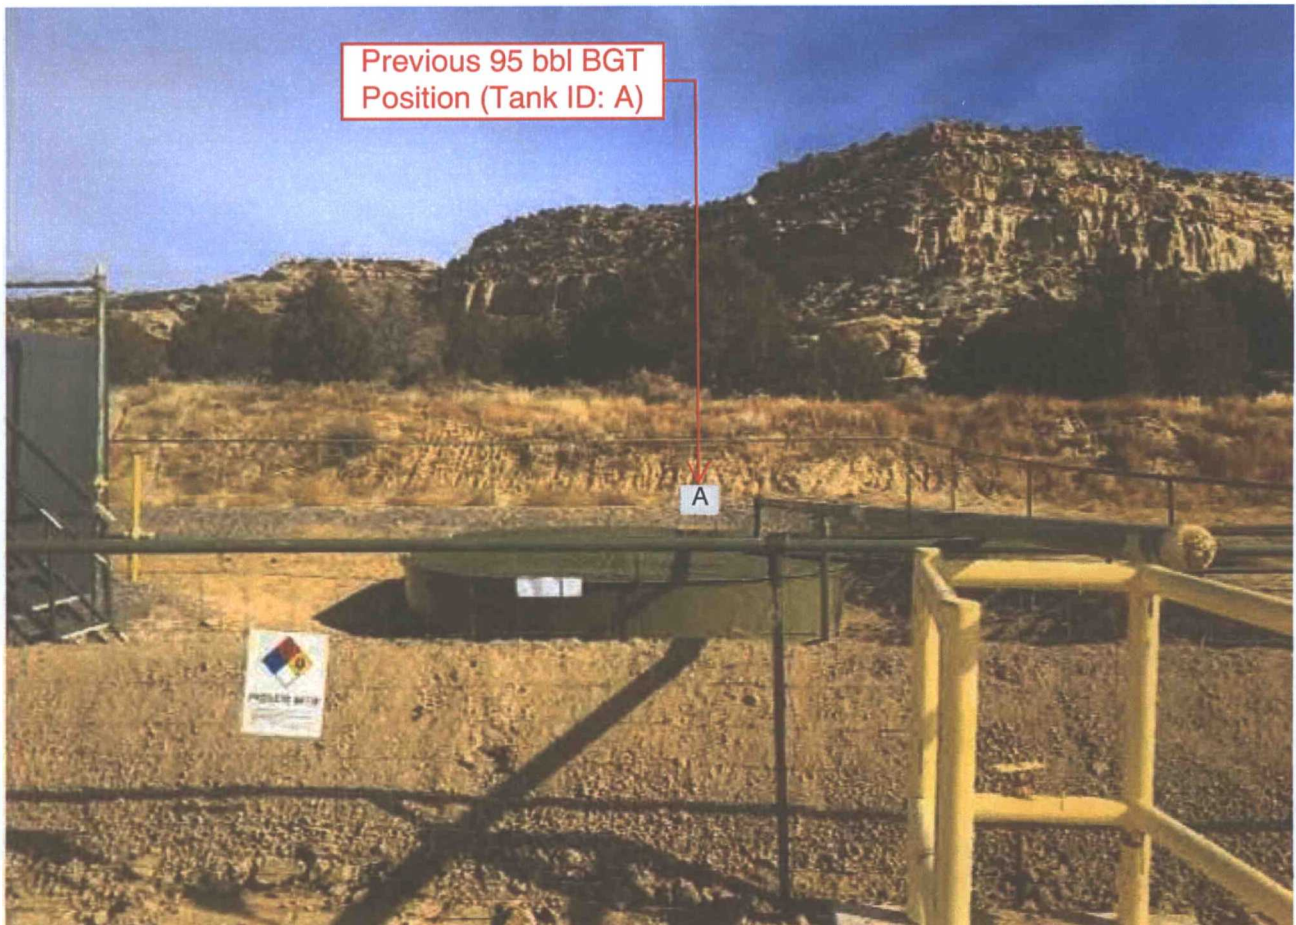
**The area has been backfilled and a 105 BBL shallow low profile above-grade tank set atop BGT location. The location will be reclaimed once the well is plugged and abandoned.**

**Closure report on C-144 form is included including photos of reclamation completion.**
