BELOW-GRADE TANK CLOSURE PLAN

E.E. ELLIOTT A 001A

API No. 3004522058

Unit Letter O Section 15 T 30N R 09W

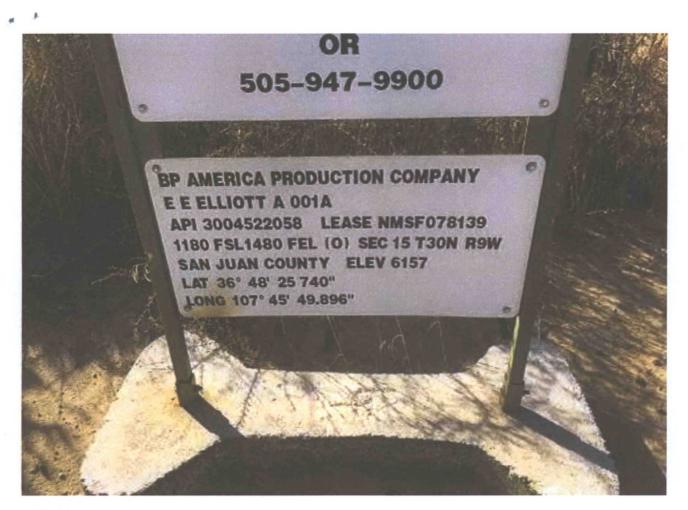
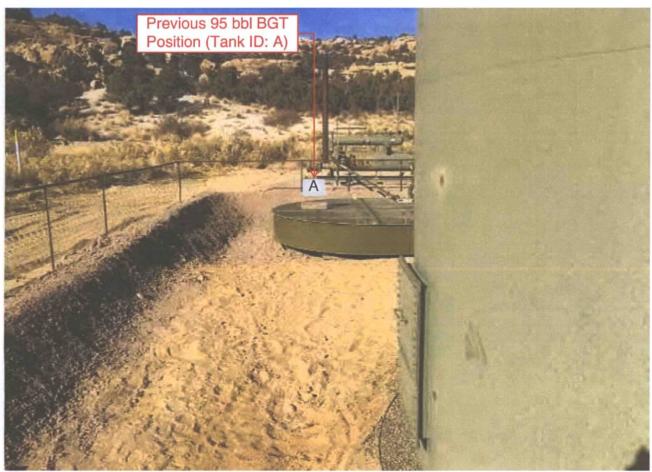
The area has been backfilled and a 105 BBL shallow low profile above-grade tank set atop BGT location. The location will be reclaimed once the well is plugged and abandoned.

BP did not meet the 60 closure completion requirement due to the holidays. Closure report on C-144 form is included including photos of reclamation completion.
