Proposed Alternative Method Permit or Closure Plan Application

BELOW-GRADE TANK CLOSURE PLAN

HARDIE LS 002

API No. 3004507761

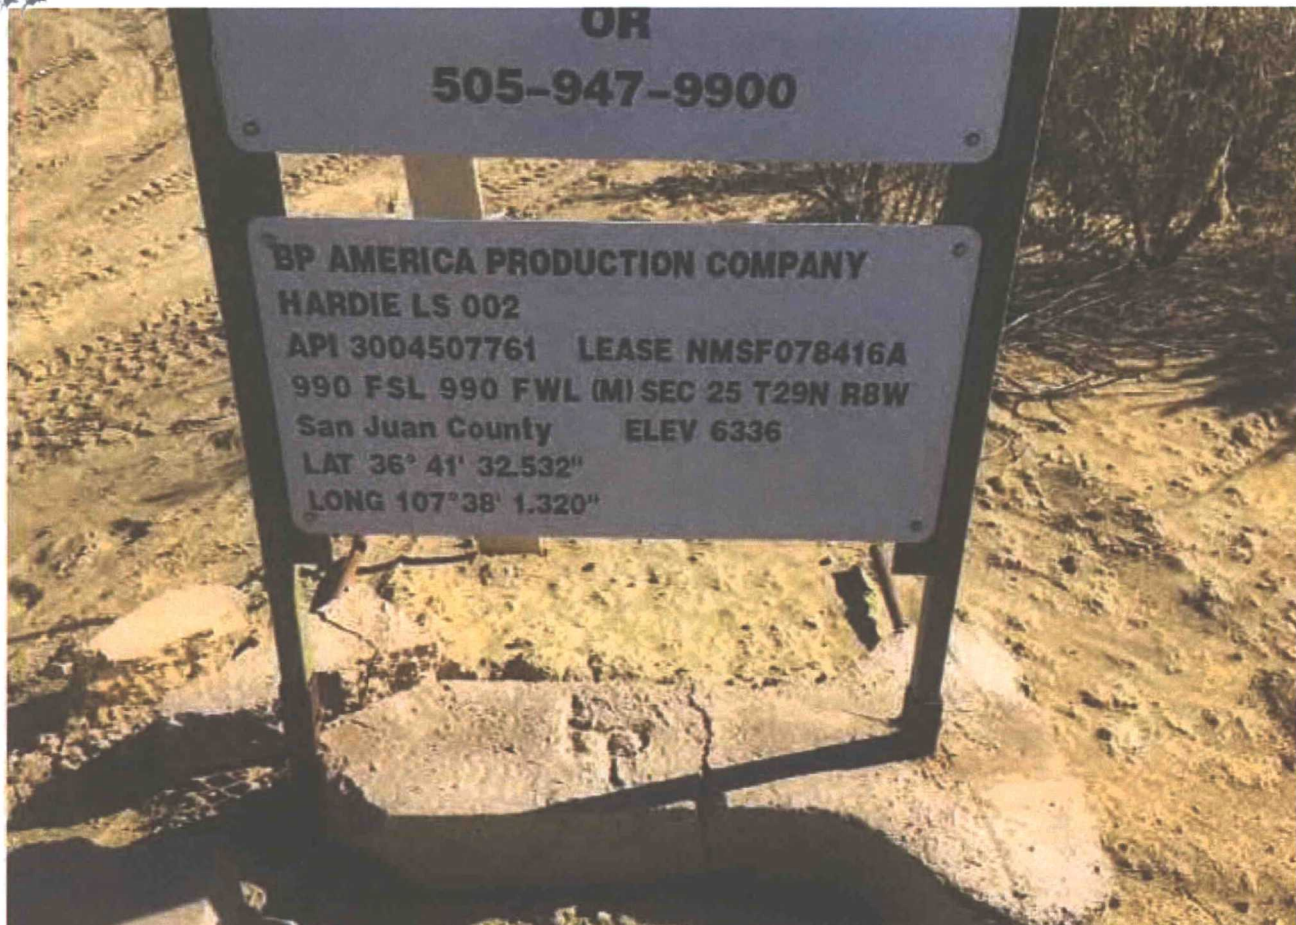
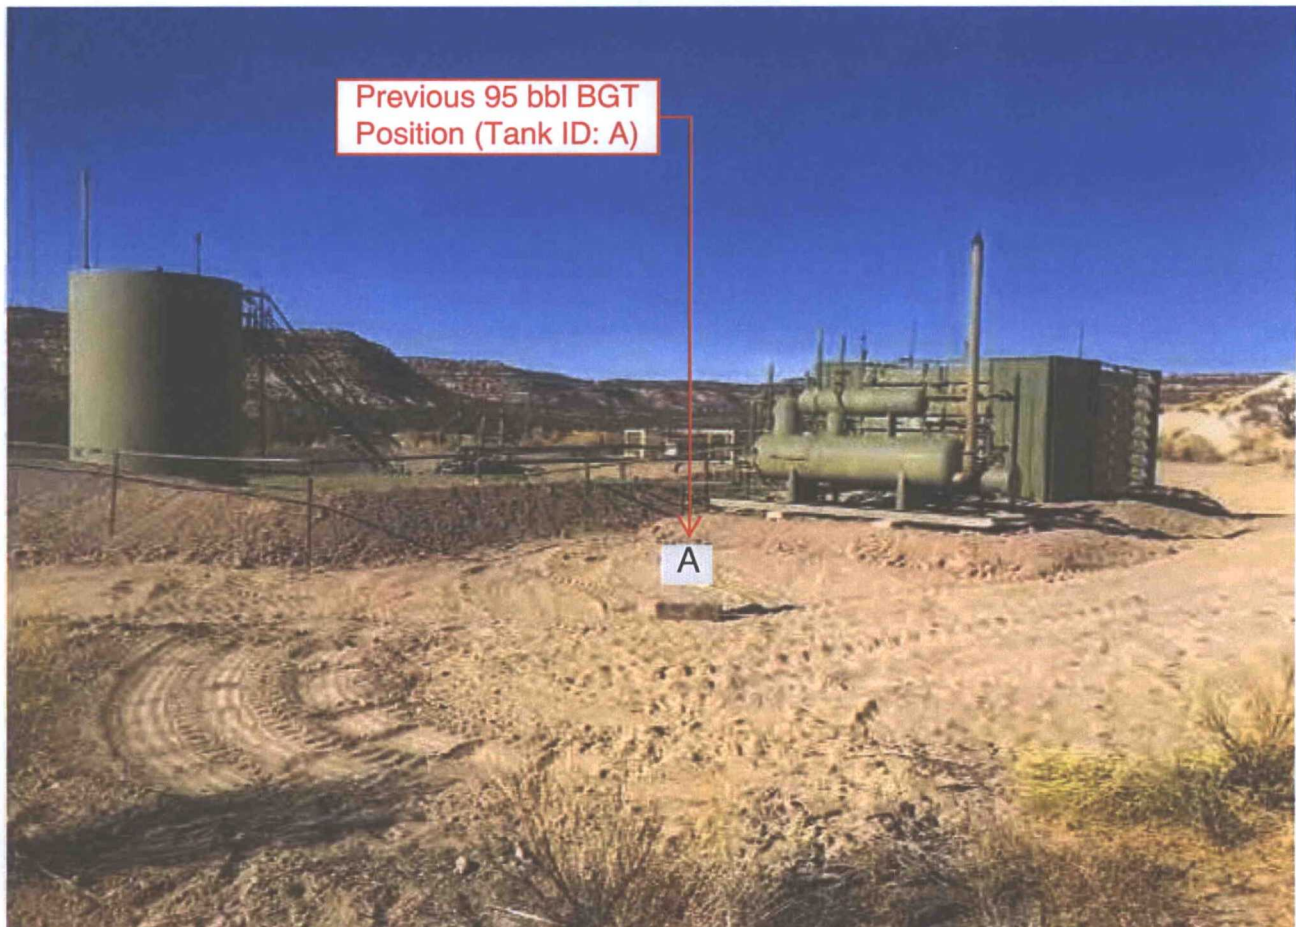
The area has been backfilled and a 105 BBL shallow low profile above-grade tank set atop BGT location. The location will be reclaimed once the well is plugged and abandoned.

Closure report on C-144 form is included including photos of reclamation completion.
