Pit, Below-Grade Tank, or
Proposed Alternative Method Permit or Closure Plan Application

1.
Operator: BP America Production Company OGRID #: 778
Address: 200 Energy Court, Farmington, NM 87401
Facility or well name: PRITCHARD A 002A
API Number: 3004522020 OCD Permit Number: _____
U/L or Qtr/Qtr I Section 01 Township 30N Range 09W County: San Juan
Center of Proposed Design: Latitude 36.83780 Longitude -107.727025 NAD83
Surface Owner: ☒ Federal ☐ State ☐ Private ☐ Tribal Trust or Indian Allotment

BELOW-GRADE TANK CLOSURE PLAN

PRITCHARD A 002A

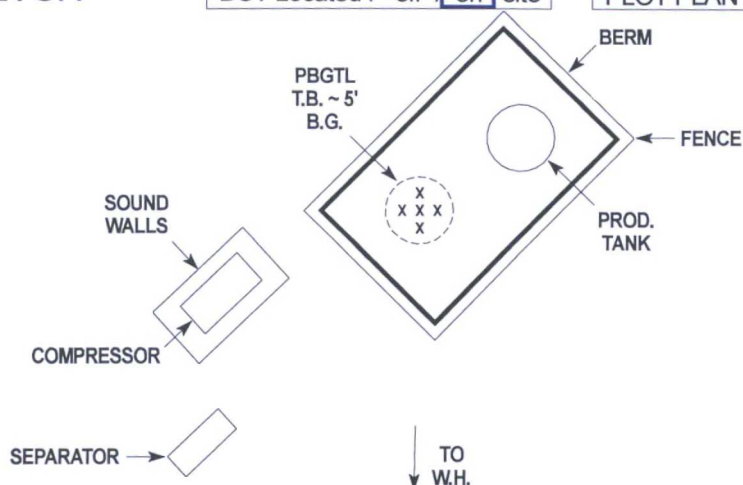
SOIL DESCRIPTION:SOIL TYPE: SAND **SILTY SAND** SILT / SILTY CLAY / CLAY / GRAVEL / OTHER _____SOIL COLOR: **DARK YELLOWISH ORANGE**COHESION (ALL OTHERS): **NON COHESIVE** SLIGHTLY COHESIVE / COHESIVE / HIGHLY COHESIVECONSISTENCY (NON COHESIVE SOILS): **LOOSE** FIRM / DENSE / VERY DENSEMOISTURE: DRY **SLIGHTLY MOIST** MOIST / WET / SATURATED / SUPER SATURATEDSAMPLE TYPE: GRAB **COMPOSITE** # OF PTS. **5**DISCOLORATION/STAINING OBSERVED: YES **NO** EXPLANATION - _____

HC ODOR DETECTED: YES **NO** EXPLANATION - _____ANY AREAS DISPLAYING WETNESS: YES **NO** EXPLANATION - _____**SITE OBSERVATIONS:**LOST INTEGRITY OF EQUIPMENT: YES **NO** EXPLANATION - _____APPARENT EVIDENCE OF A RELEASE OBSERVED AND/OR OCCURRED: YES **NO** EXPLANATION: _____EQUIPMENT SET OVER RECLAIMED AREA: **YES** NO EXPLANATION - **105 BBL SHALLOW LOW PROFILE ABOVE-GRADE TANK TO BE SET ATOP BGT LOCATION.**

EXCAVATION DIMENSION ESTIMATION: **NA** ft. X **NA** ft. X **NA** ft. EXCAVATION ESTIMATION (Cubic Yards): **NA**DEPTH TO GROUNDWATER: **>100'** NEAREST WATER SOURCE: **>1,000'** NEAREST SURFACE WATER: **>1,000'** NMOCD TPH CLOSURE STD: **5,000** ppm**SITE SKETCH**BGT Located: off **on** sitePLOT PLAN circle: **attached**

OVM CALIB. READ. = 100.2 ppm	RF = 1.00
OVM CALIB. GAS = 100 ppm	
TIME: 12:00 am/pm	DATE: 11/27/17
