Pit, Below-Grade Tank, or
Proposed Alternative Method Permit or Closure Plan Application

BP AMERICA PRODUCTION COMPANY
SAN JUAN BASIN, NORTHWEST NEW MEXICO

BELOW-GRADE TANK CLOSURE PLAN

FLORANCE 021A

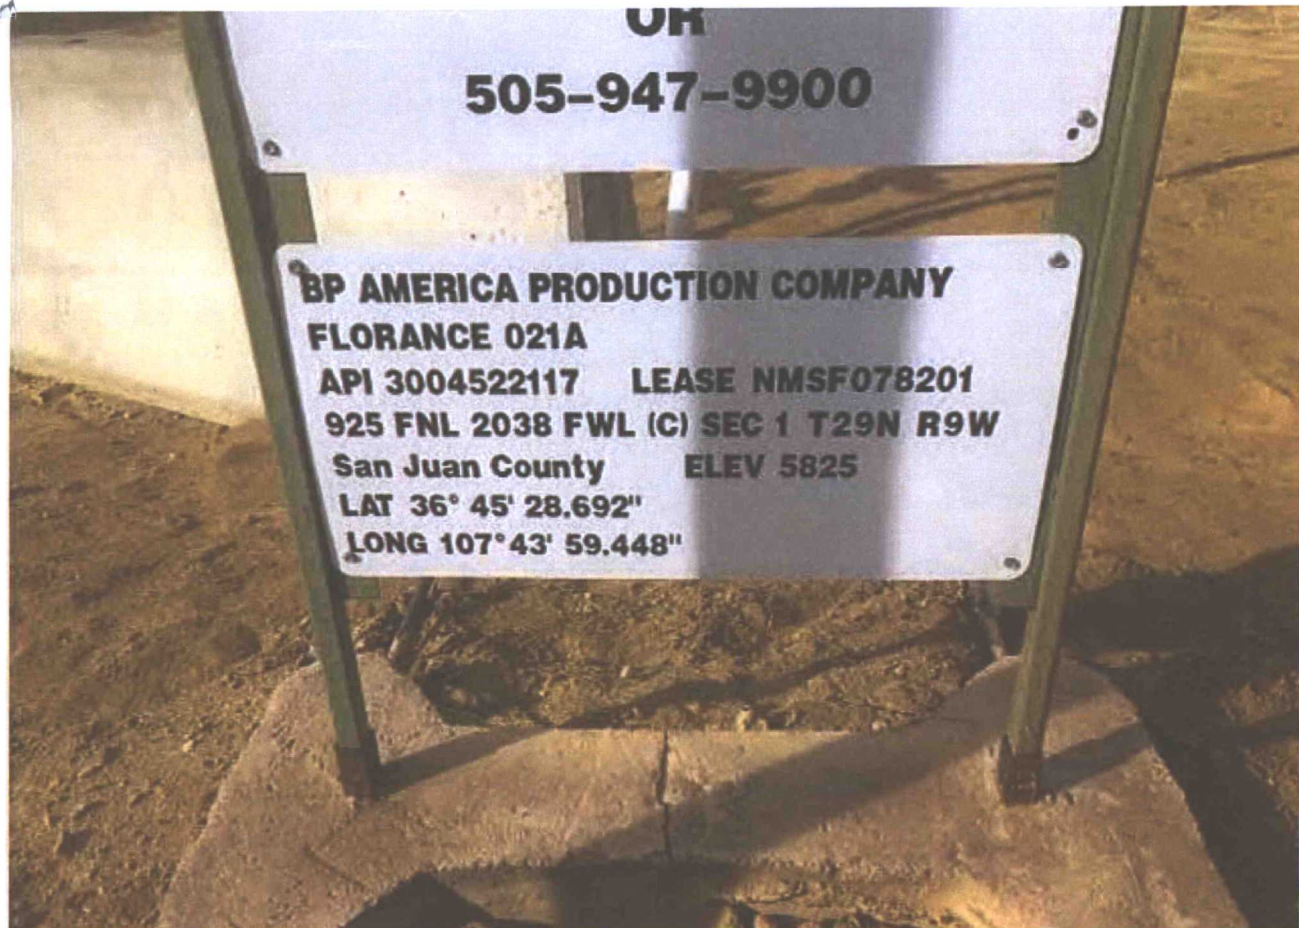
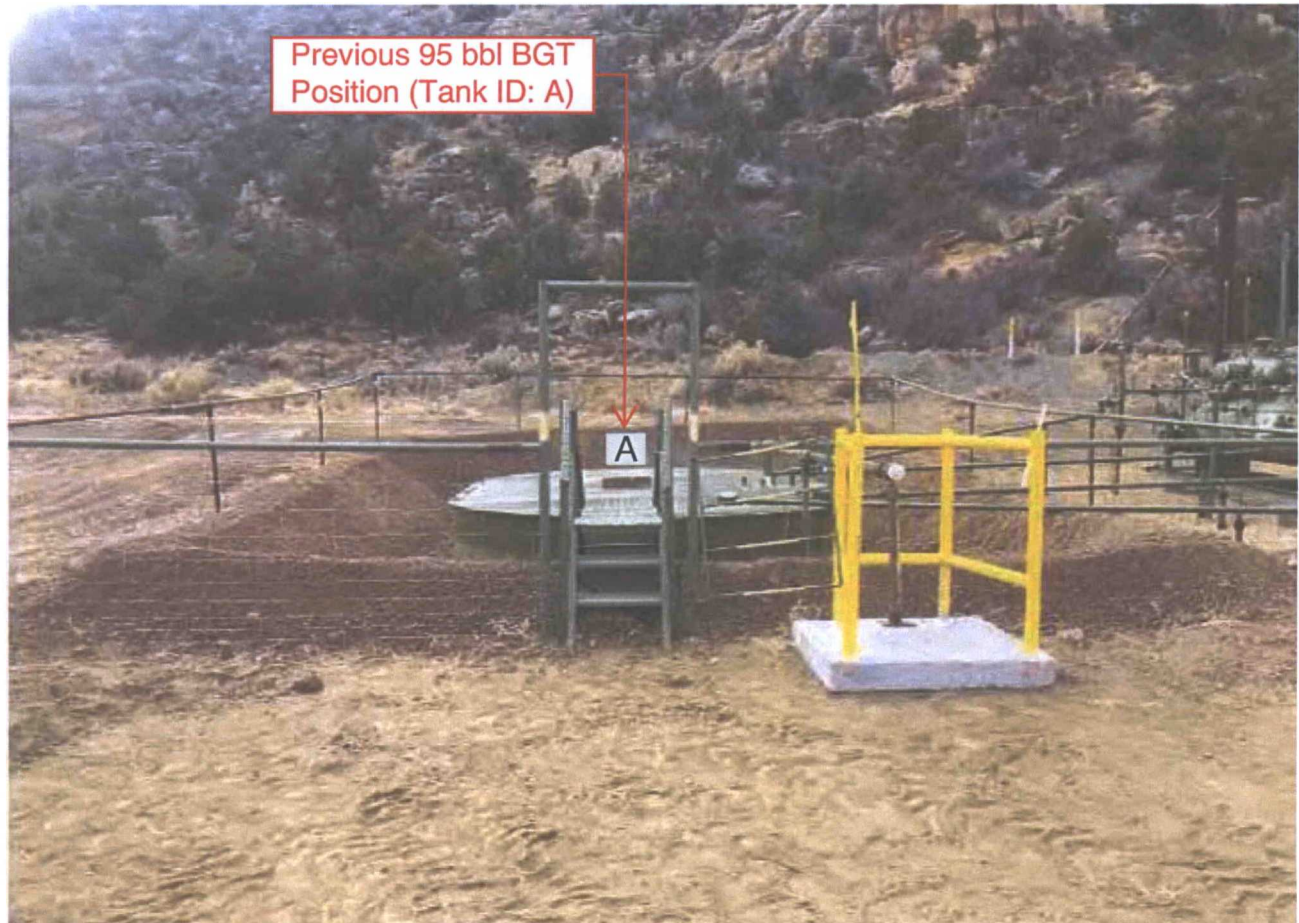
The area has been backfilled and a 105 BBL shallow low profile above-grade tank set atop BGT location. The location will be reclaimed once the well is plugged and abandoned.

Closure report on C-144 form is included including photos of reclamation completion.
