Release Notification and Corrective Action

Name of Company: BP	Contact: Steve Moskal	
Address: 200 Energy Court, Farmington, NM 87401	Telephone No.: 505-326-9497	
Facility Name: Tapp LS 003 A	Facility Type: Natural gas well	
Surface Owner: Federal	Mineral Owner: Federal	API No. 300452369500

BP Remediation Plan

To: Cory Smith, Vanessa Fields(NMOCD), Whitney Thomas (BLM)
From: John Ritchie (BP)
CC: Jeff Blagg (Blagg Engineering)
Date: 12/19/2017
Re: Tapp LS 3A - Ex-situ Soil Remediation – Soil Shredding
(I) S-15, T28N, R08W; API #30-045-23695

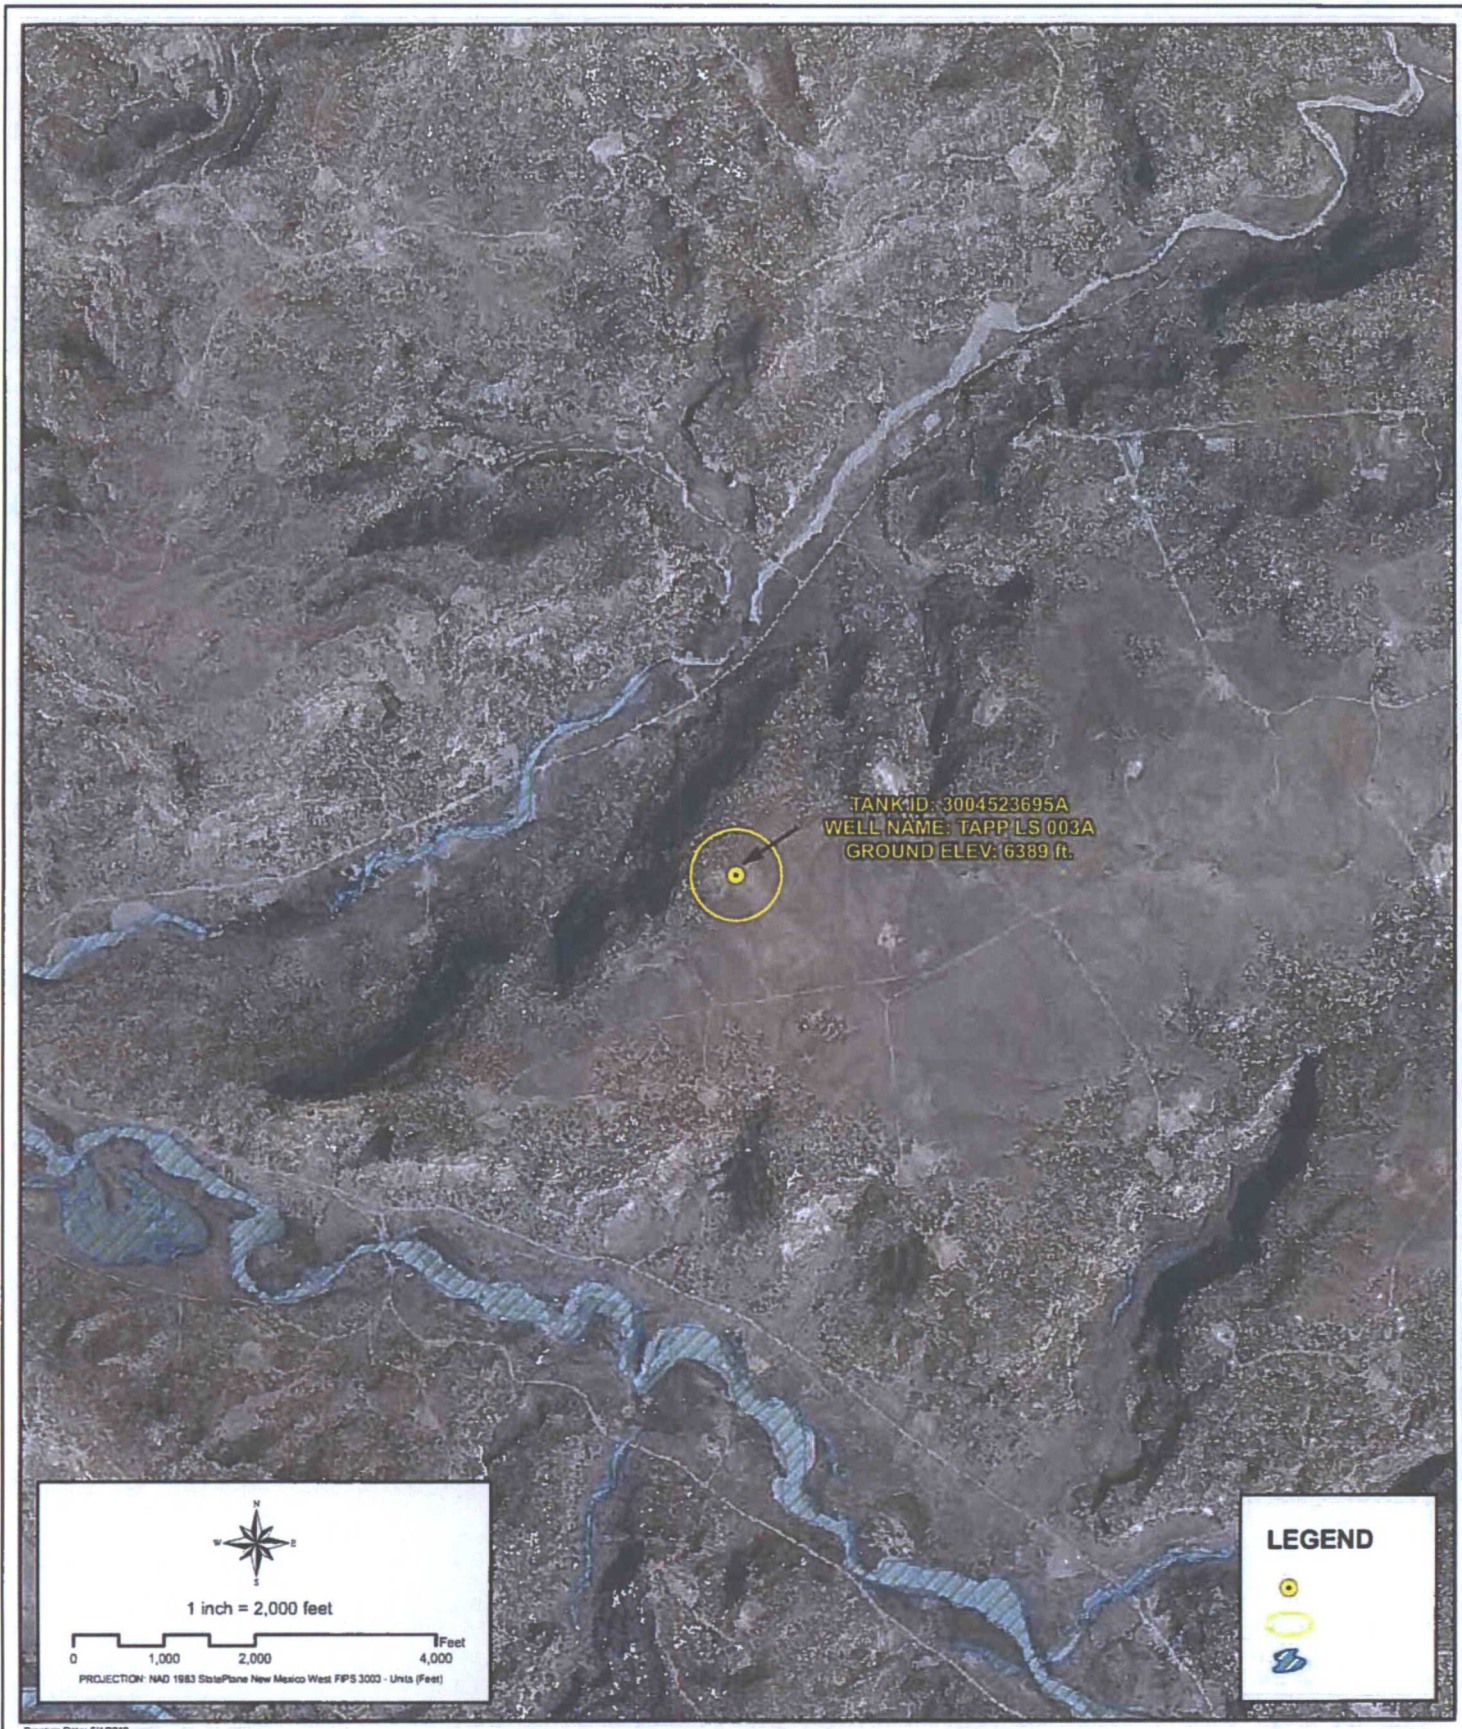
FIGURE
6

PROXIMITY TO WETLANDS
