> San Juan 30-4 #55 Unit I, Section 9, T30N, R4W Rio Arriba County, New Mexico East Blanco Pictured Cliffs (72400) & Basin Fruitland Coal (71629) **DHC 1868AZ** API# 30-039-27280

Energen Resources recently finished a pay add and down hole commingling operations on the subject well. In accordance with the approved Notice of Intent dated April 12, 2005 in accordance with Order#R-11363. DHC 1848A

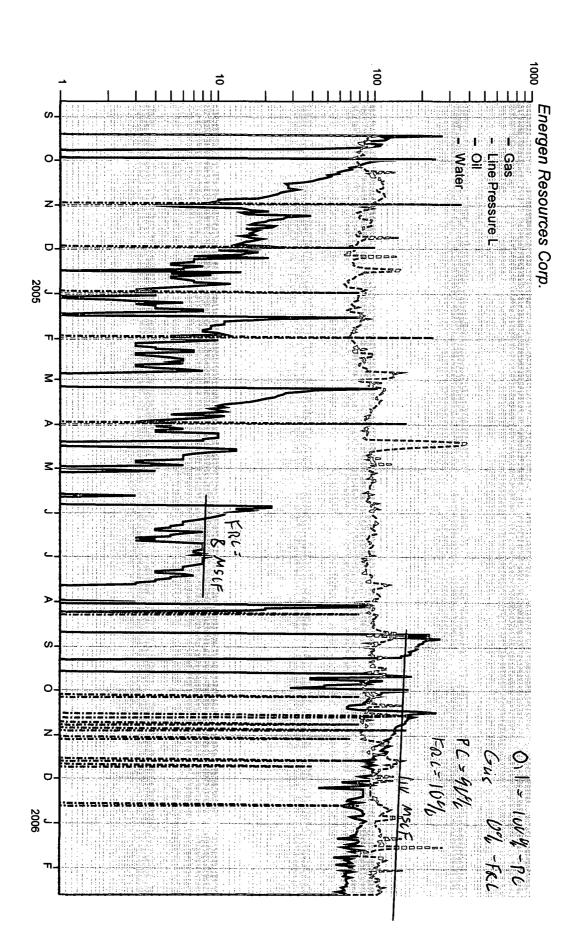
SAN JUAN 30-4 UNIT 55 PC/FRC

Prior to commingling operations, the Fruitland Coal was producing at a stabilized rate of about 8 MCFPD and about 0 BOPD. The Pictured Cliffs was added in September 23, 2005. The well had stabilized at a rate of about 110 MCPD and about 0 BOPD. The following allocation is recommended (see attached production plot):

Oil Gas 100% **Pictured Cliffs** 90% **Fruitland Coal** 10% N/A
