Pit, Below-Grade Tank, or
Proposed Alternative Method Permit or Closure Plan Application

BP AMERICA PRODUCTION COMPANY
SAN JUAN BASIN, NORTHWEST NEW MEXICO

BELOW-GRADE TANK CLOSURE PLAN

FLORANCE C LS 005

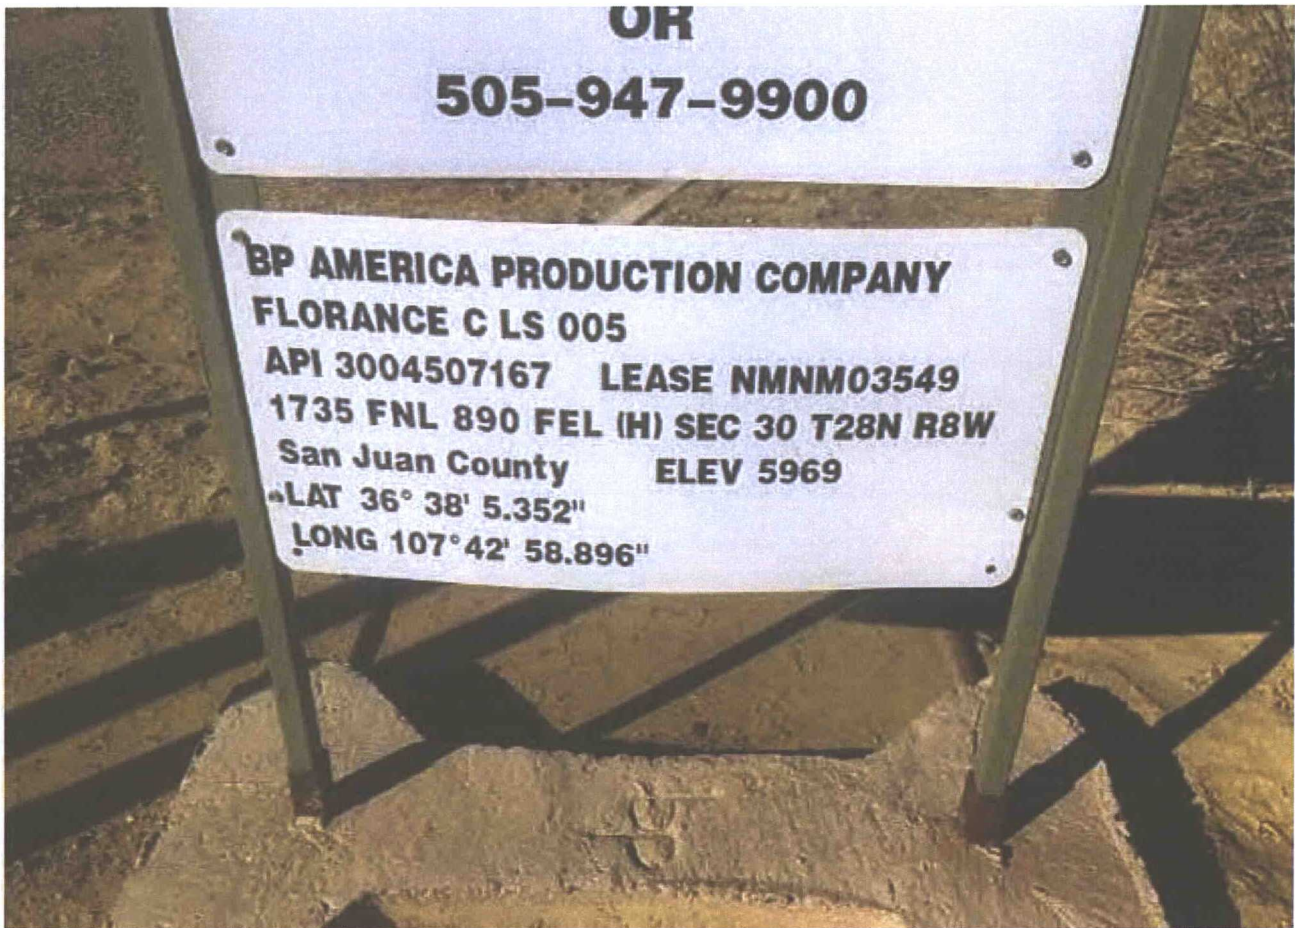
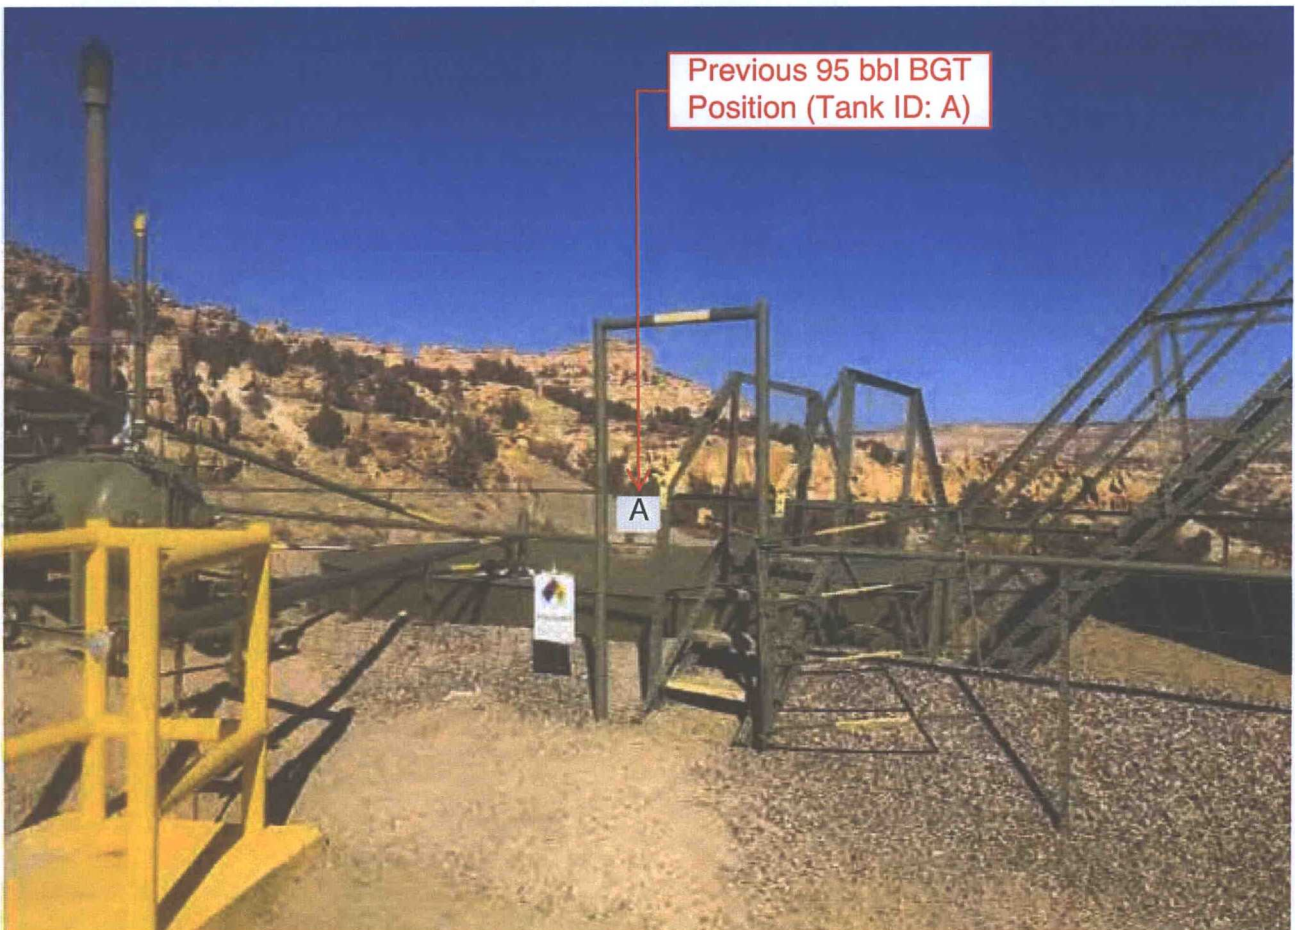
The area has been backfilled and a 105 BBL shallow low profile above-grade tank set atop BGT location. The location will be reclaimed once the well is plugged and abandoned.
