16235
Pit, Below-Grade Tank, or
Proposed Alternative Method Permit or Closure Plan Application

BELOW-GRADE TANK CLOSURE PLAN

GCU 336

API No. 3004525470

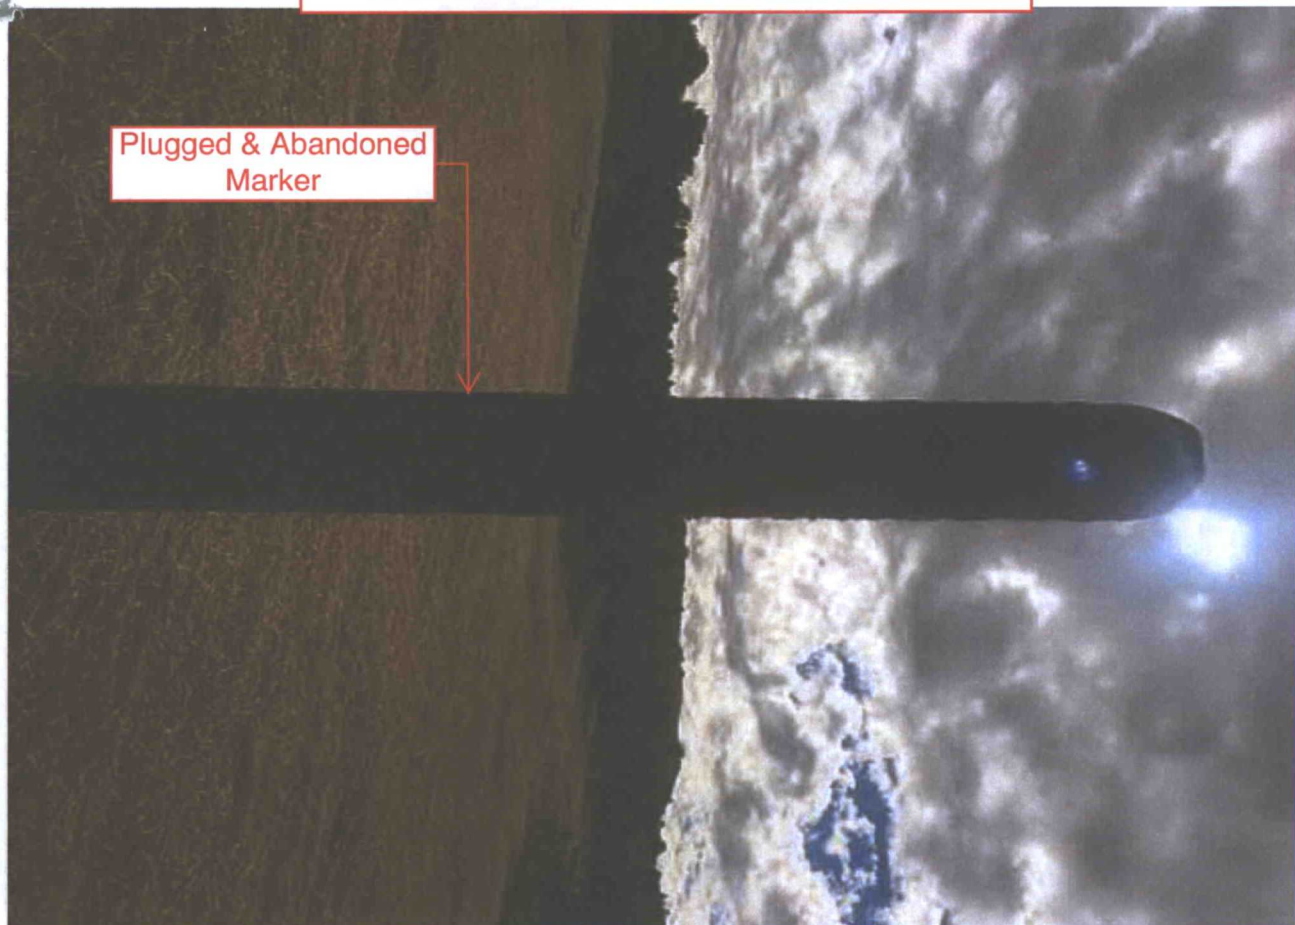
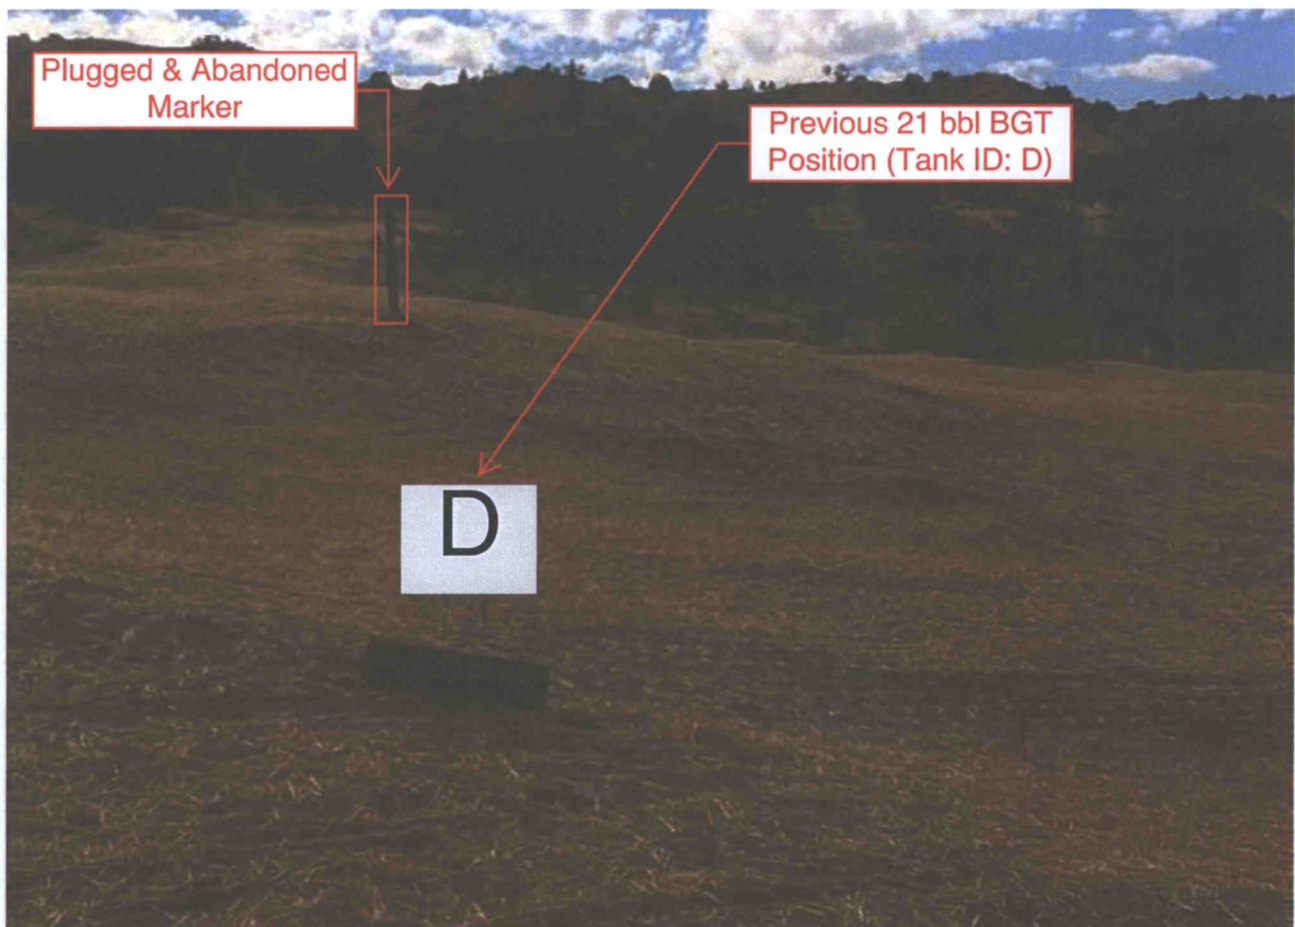
GALLEGOS CANYON UNIT 336

The area has been backfilled. The location was reclaimed as the well has been plugged and abandoned.

Closure report on C-144 form is included including photos of reclamation completion.
