BP AMERICA PRODUCTION COMPANY SAN JUAN BASIN, NORTHWEST NEW MEXICO

BELOW-GRADE TANK CLOSURE PLAN

McCULLEY LS 003

API No. 3004507295

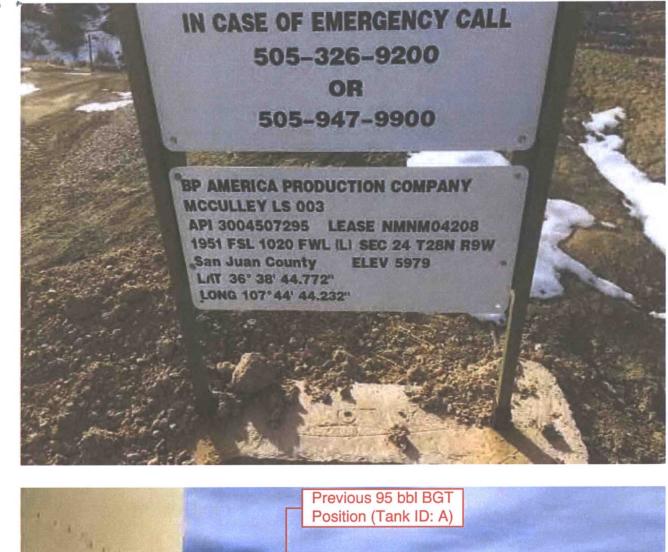
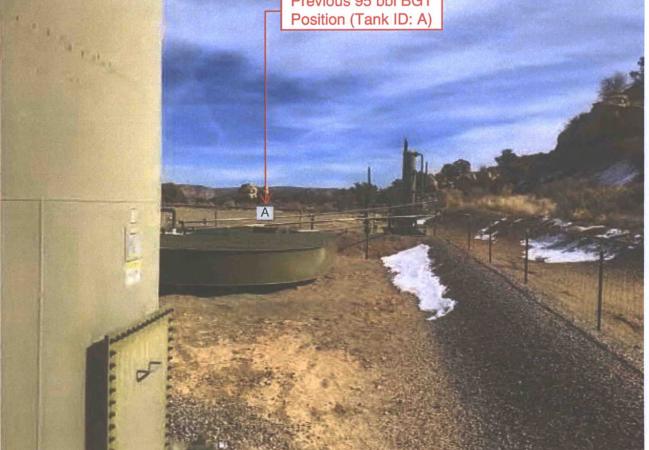
The area has been backfilled and a 105 bbl shallow low profile above-ground tank set atop BGT location. The location will be reclaimed once the well is plugged and abandoned.

Closure report on C-144 form is included including photos of reclamation completion.
