BP AMERICA PRODUCTION COMPANY SAN JUAN BASIN, NORTHWEST NEW MEXICO

BELOW-GRADE TANK CLOSURE PLAN

E.E. ELLIOTT B 003A

API No. 3004522059

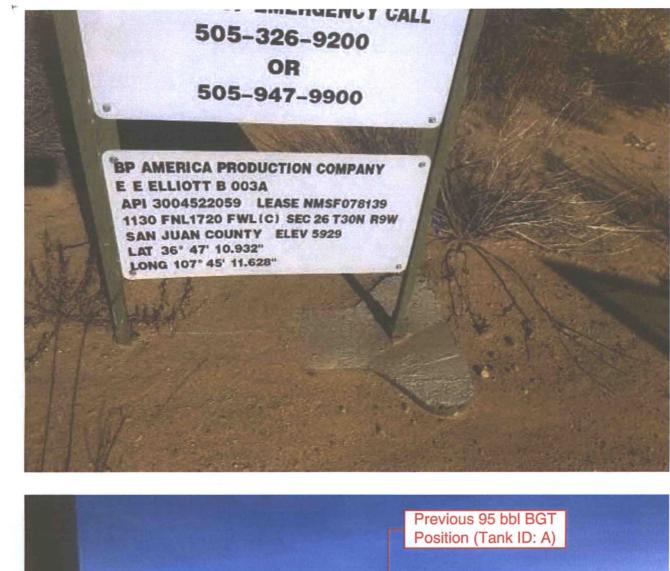
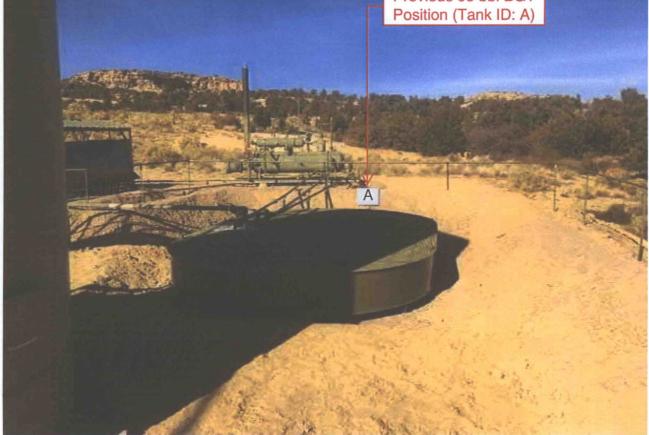
The area has been backfilled and a 105 BBL shallow low profile above-grade tank set atop BGT location. The location will be reclaimed once the well is plugged and abandoned.

BP did not meet the 60 closure completion requirement due the holidays. Closure report on C-144 form is included including photos of reclamation completion.
