Pit, Below-Grade Tank, or
Proposed Alternative Method Permit or Closure Plan Application

1.
Operator: BP America Production Company OGRID #: 778
Address: 200 Energy Court, Farmington, NM 87401
Facility or well name: BOLACK 002
API Number: 3004523257 OCD Permit Number:
U/L or Qtr/Qtr G Section 19 Township 28N Range 08W County: San Juan
Center of Proposed Design: Latitude 36.64713 Longitude -107.71897 NAD83
Surface Owner: ☒ Federal ☐ State ☐ Private ☐ Tribal Trust or Indian Allotment

BELOW-GRADE TANK CLOSURE PLAN

BOLACK 002

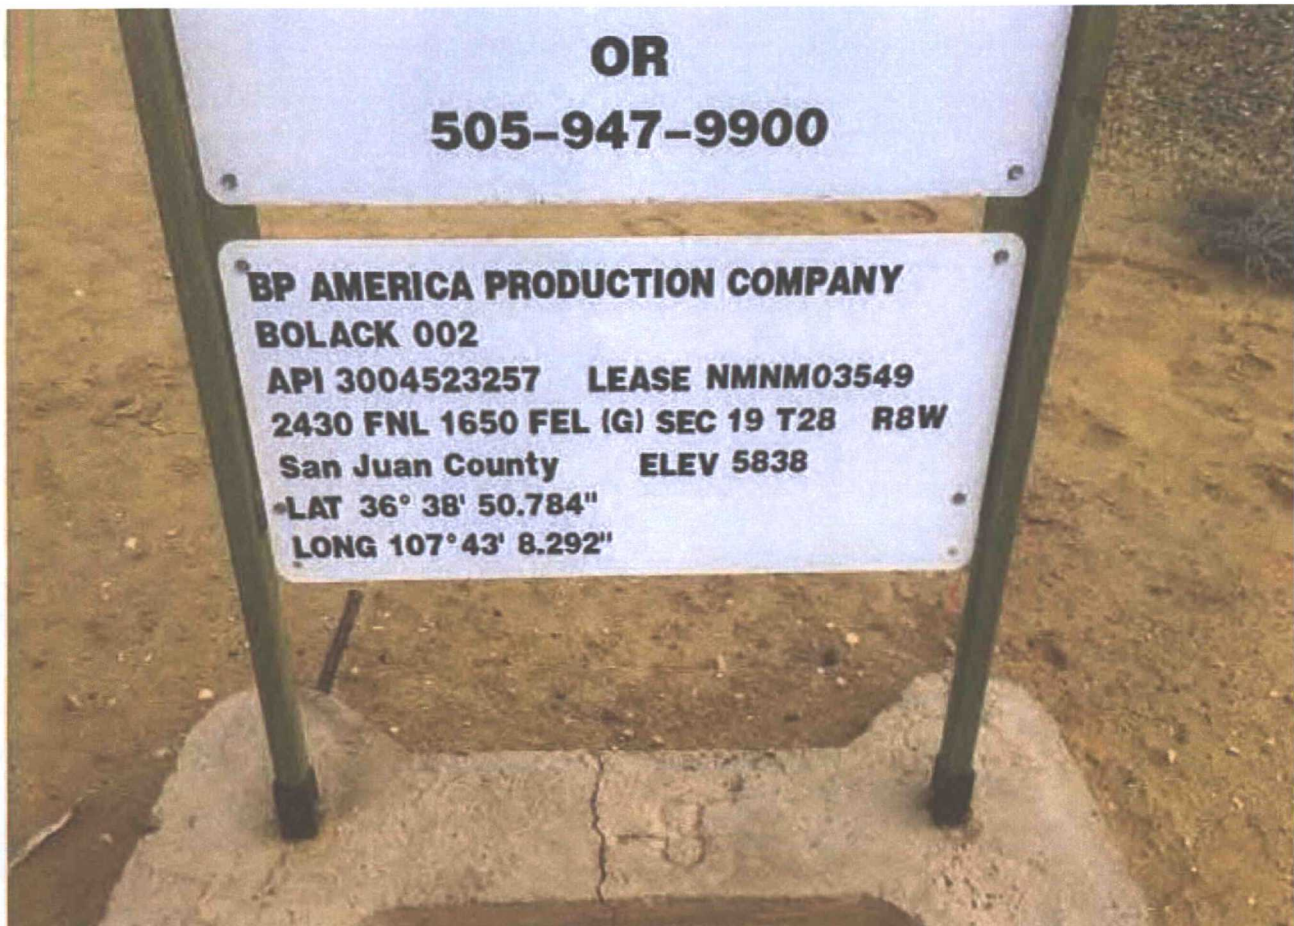
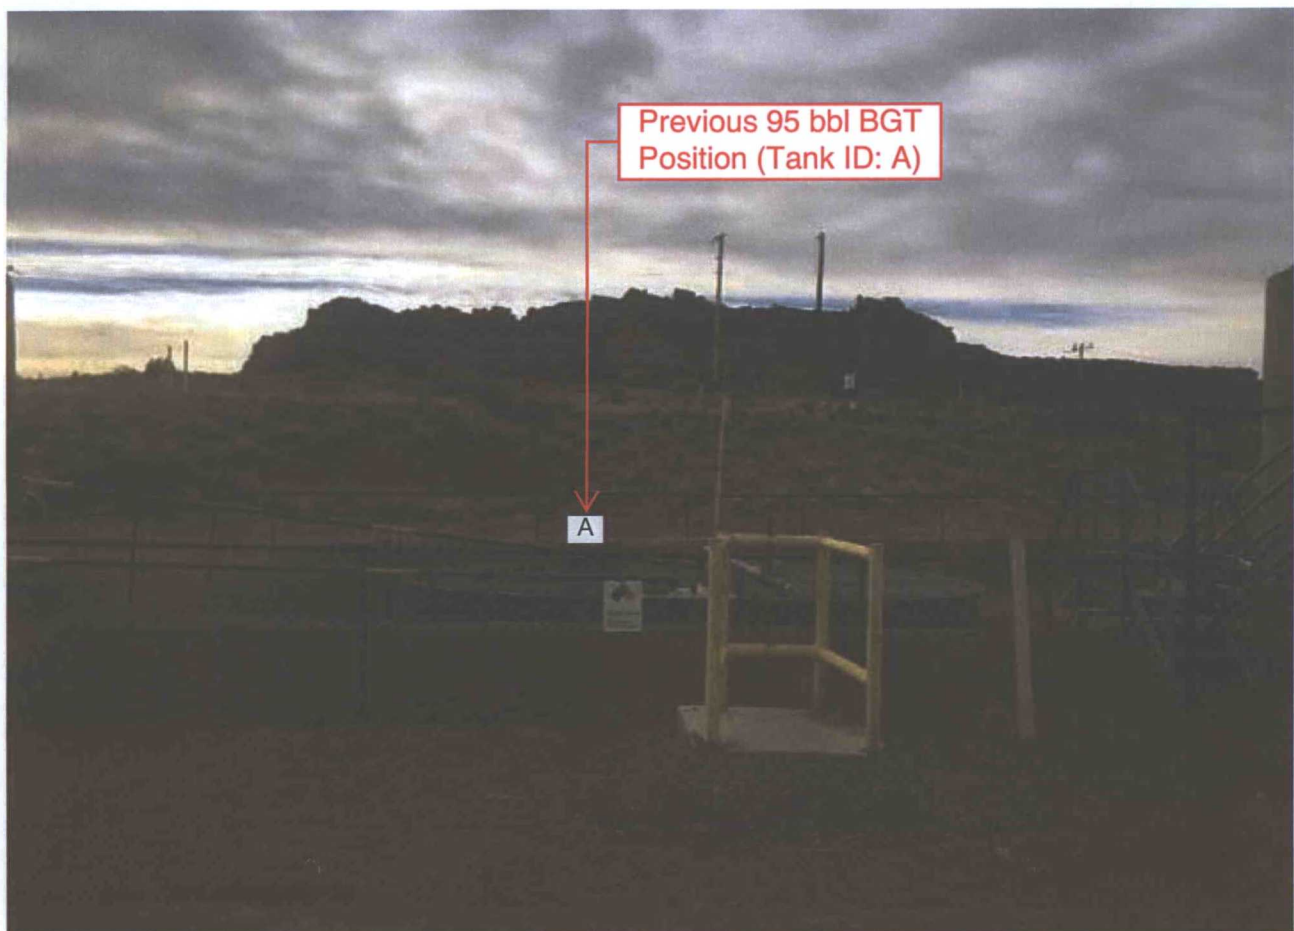
The area has been backfilled and a 105 BBL shallow low profile above-grade tank set atop BGT location. The location will be reclaimed once the well is plugged and abandoned.

Closure report on C-144 form is included including photos of reclamation completion.
