Pit, Below-Grade Tank, or
Proposed Alternative Method Permit or Closure Plan Application

BELOW-GRADE TANK CLOSURE PLAN

DRYDEN 001E

API No. 3004525566

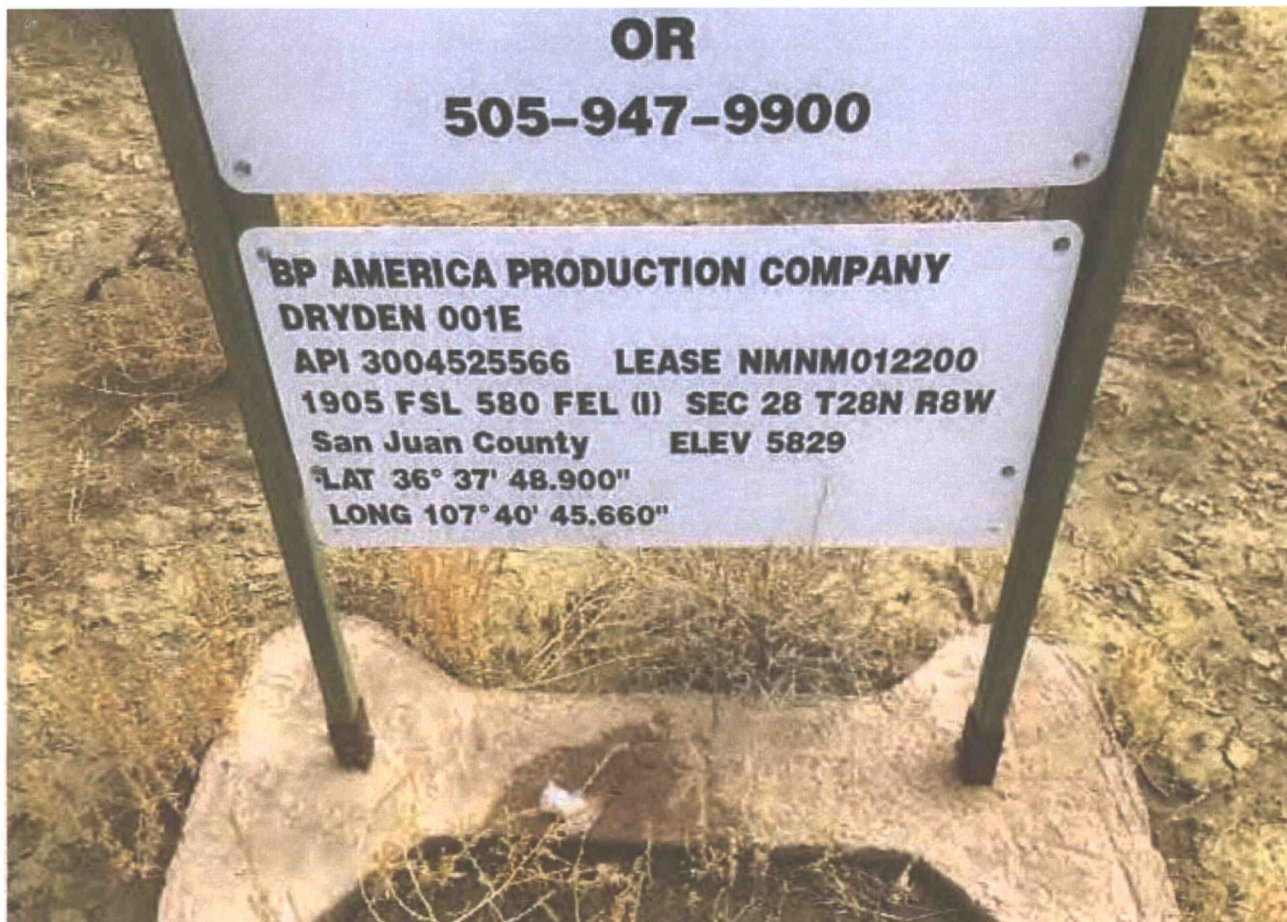
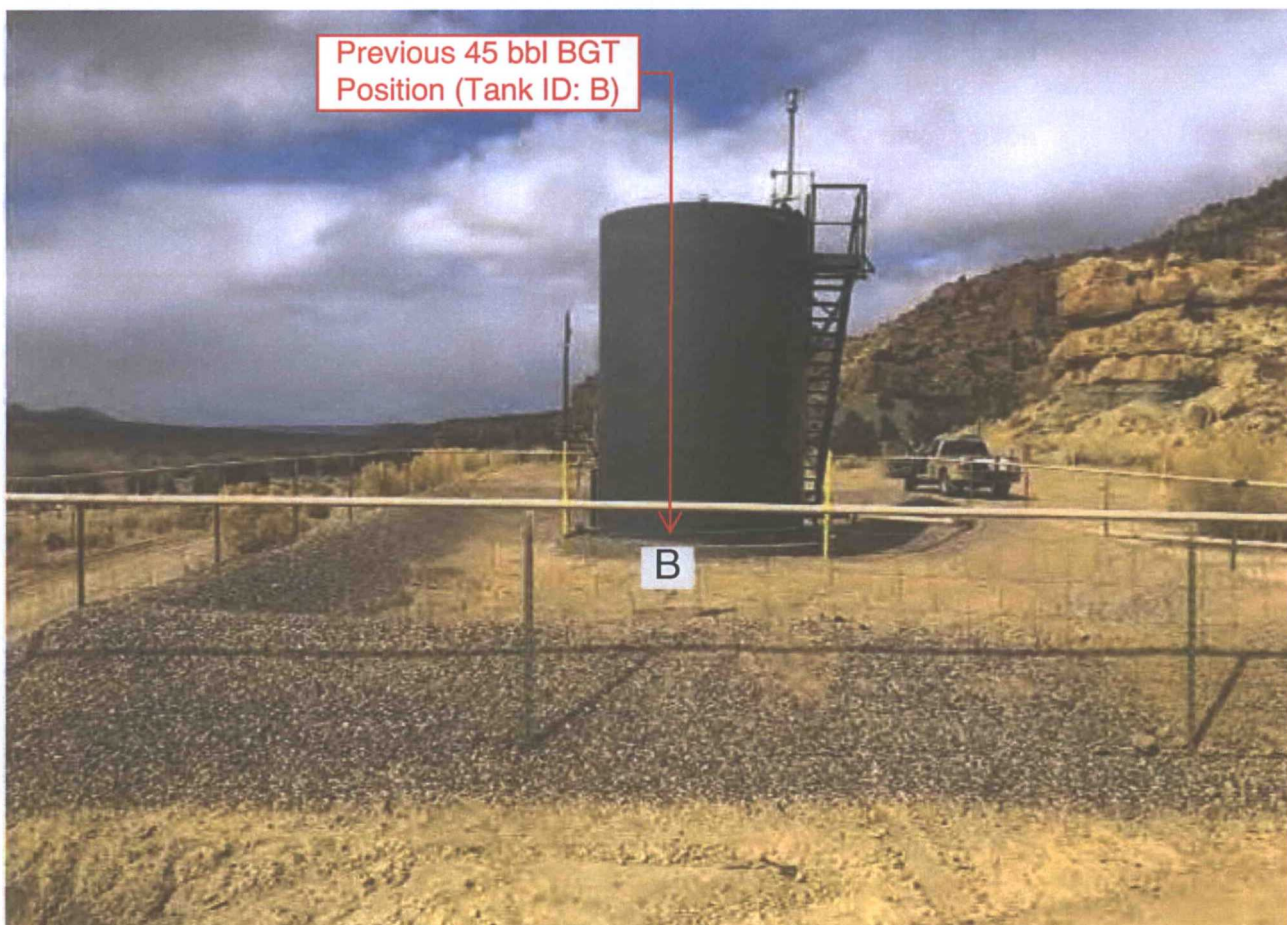
Closure report on C-144 form is included including photos of reclamation completion.
