# BP AMERICA PRODUCTION COMPANY SAN JUAN BASIN, NORTHWEST NEW MEXICO

#### BELOW-GRADE TANK CLOSURE PLAN

#### WARREN LS 003A

API No. 3004523771

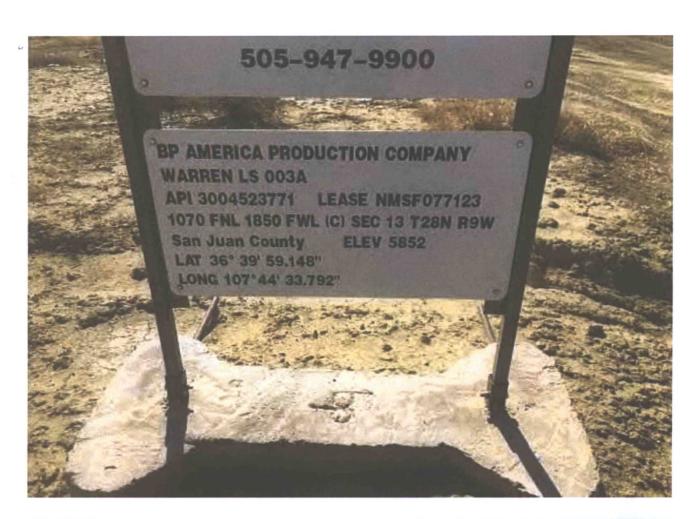
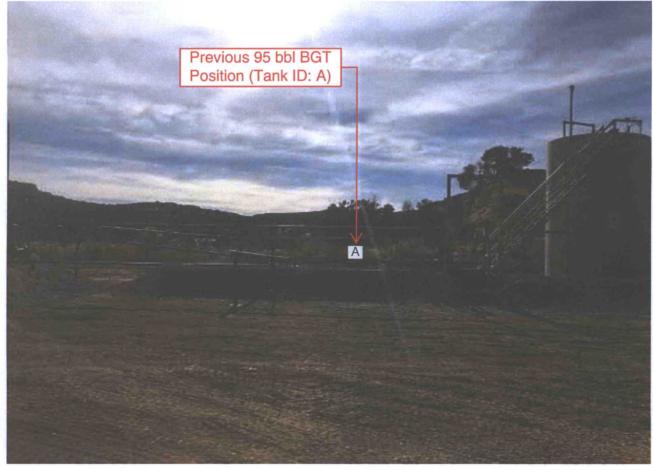
The area has been backfilled and a 105 BBL shallow low profile above-grade tank set atop BGT location. The location will be reclaimed once the well is plugged and abandoned.

Closure report on C-144 form is included including photos of reclamation completion.
