Pit, Below-Grade Tank, or
Proposed Alternative Method Permit or Closure Plan Application

BP AMERICA PRODUCTION COMPANY
SAN JUAN BASIN, NORTHWEST NEW MEXICO

BELOW-GRADE TANK CLOSURE PLAN

JONES LS 002

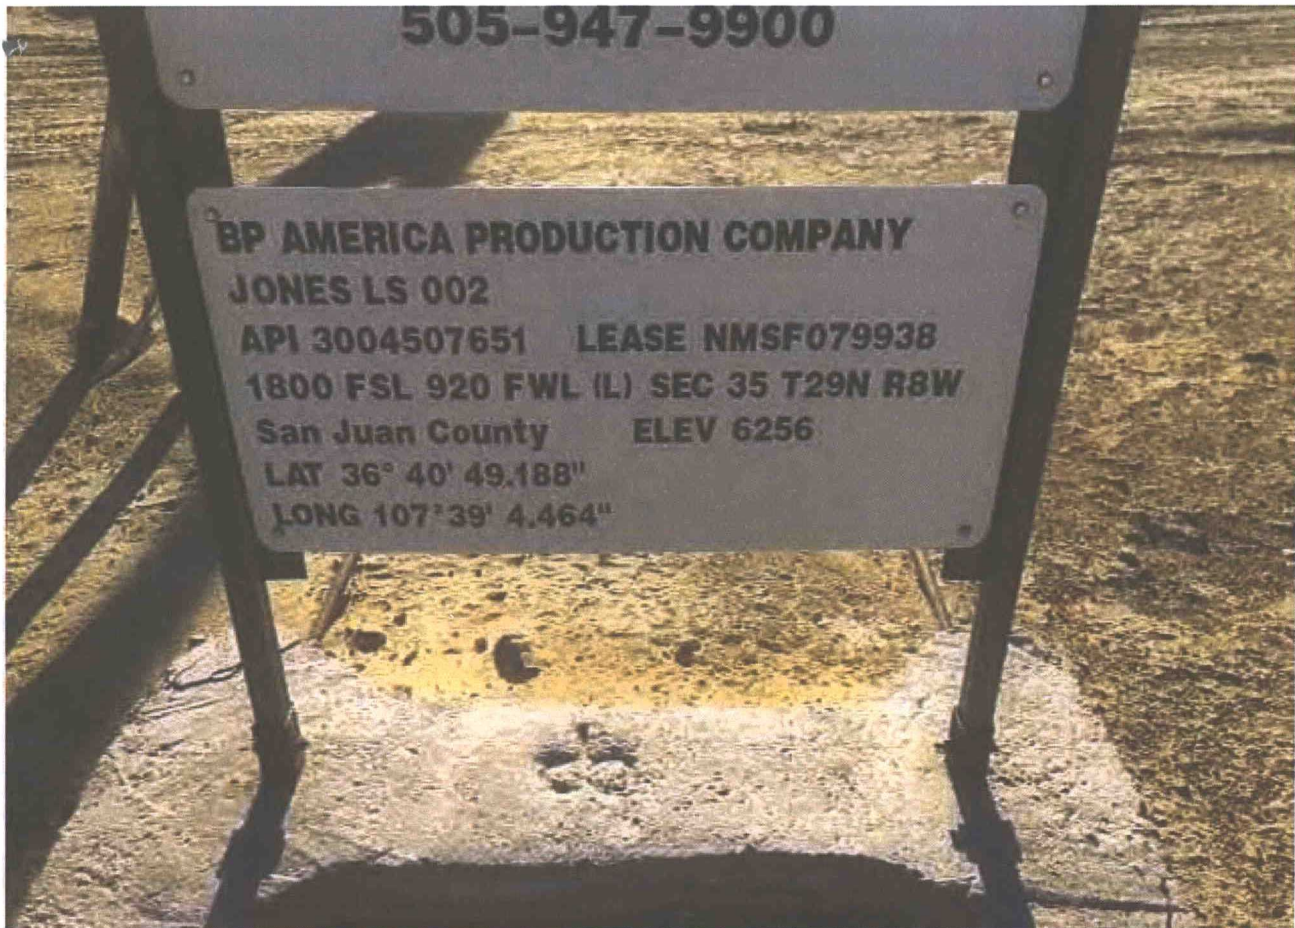
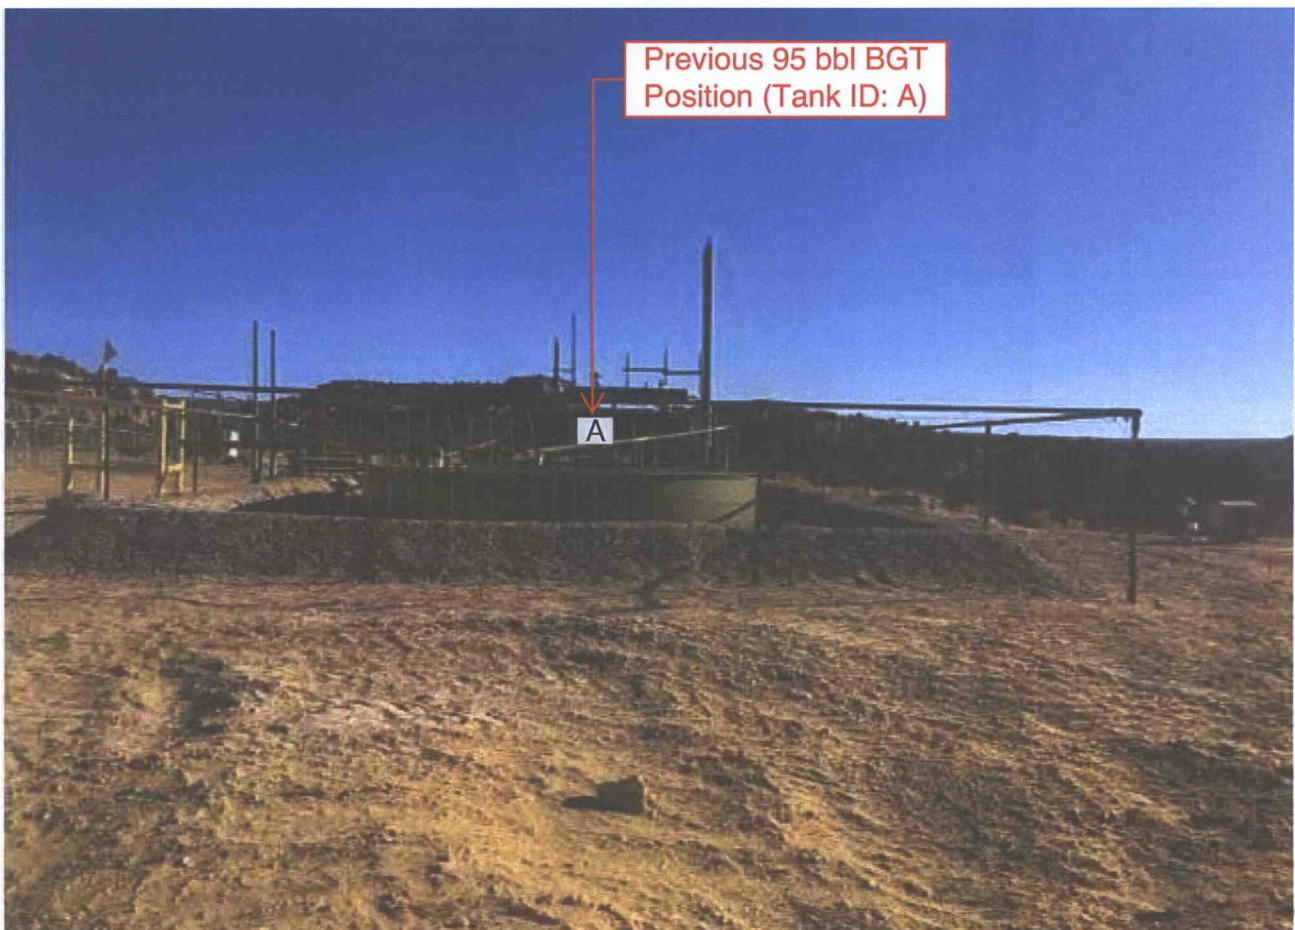
The area has been backfilled and a 105 BBL shallow low profile above-grade tank set atop BGT location. The location will be reclaimed once the well is plugged and abandoned.

Closure report on C-144 form is included including photos of reclamation completion.
