Pit, Below-Grade Tank, or
Proposed Alternative Method Permit or Closure Plan Application

BELOW-GRADE TANK CLOSURE PLAN

HUGHES C 001

API No. 3004507713

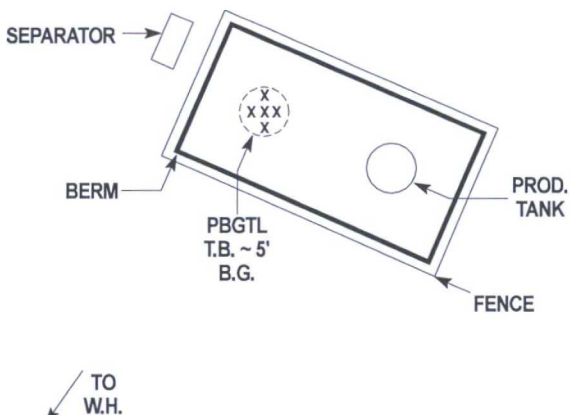
SITE SKETCH	BGT Located: off / <u>on</u> site PLOT PLAN circle: <u>attached</u>

SITE OBSERVATIONS:	LOST INTEGRITY OF EQUIPMENT: YES <u>NO</u> EXPLANATION - APPARENT EVIDENCE OF A RELEASE OBSERVED AND/OR OCCURRED: YES <u>NO</u> EXPLANATION: EQUIPMENT SET OVER RECLAIMED AREA: <u>YES</u> NO EXPLANATION - 105 BBL SHALLOW LOW PROFILE ABOVE-GRADE TANK TO BE SET ATOP BGT LOCATION. OTHER: NMOCD OR BLM REPS. NOT PRESENT TO WITNESS CONFIRMATION SAMPLING.
---------------------------	--------------------------------------------------------------------------------------------------------------------------------------------------------------------------------------------------------------------------------------------------------------------------------------------------------------------------------------------------------------------------------------

EXCAVATION DIMENSION ESTIMATION: NA ft. X NA ft. X NA ft.	EXCAVATION ESTIMATION (Cubic Yards): NA DEPTH TO GROUNDWATER: >100' NEAREST WATER SOURCE: >1,000' NEAREST SURFACE WATER: <1,000' NMOCD TPH CLOSURE STD: 1,000 ppm
--------------------------------------------------------------------------------	------------------------------------------------------------------------------------------------------------------------------------------------------------------------------------------------------------------
