Pit, Below-Grade Tank, or
Proposed Alternative Method Permit or Closure Plan Application

BELOW-GRADE TANK CLOSURE PLAN

JONES LS 002

API No. 3004507651

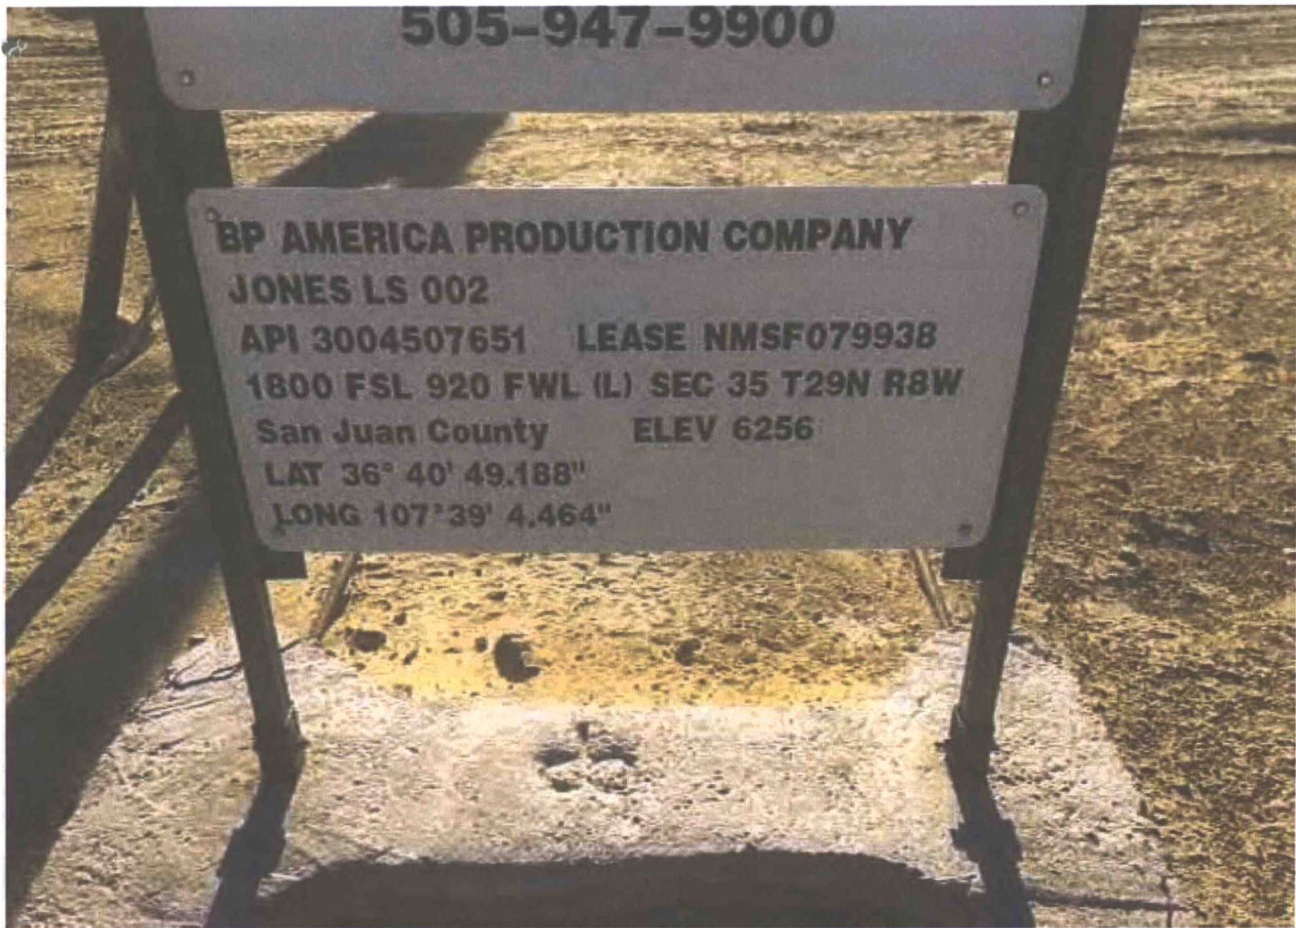
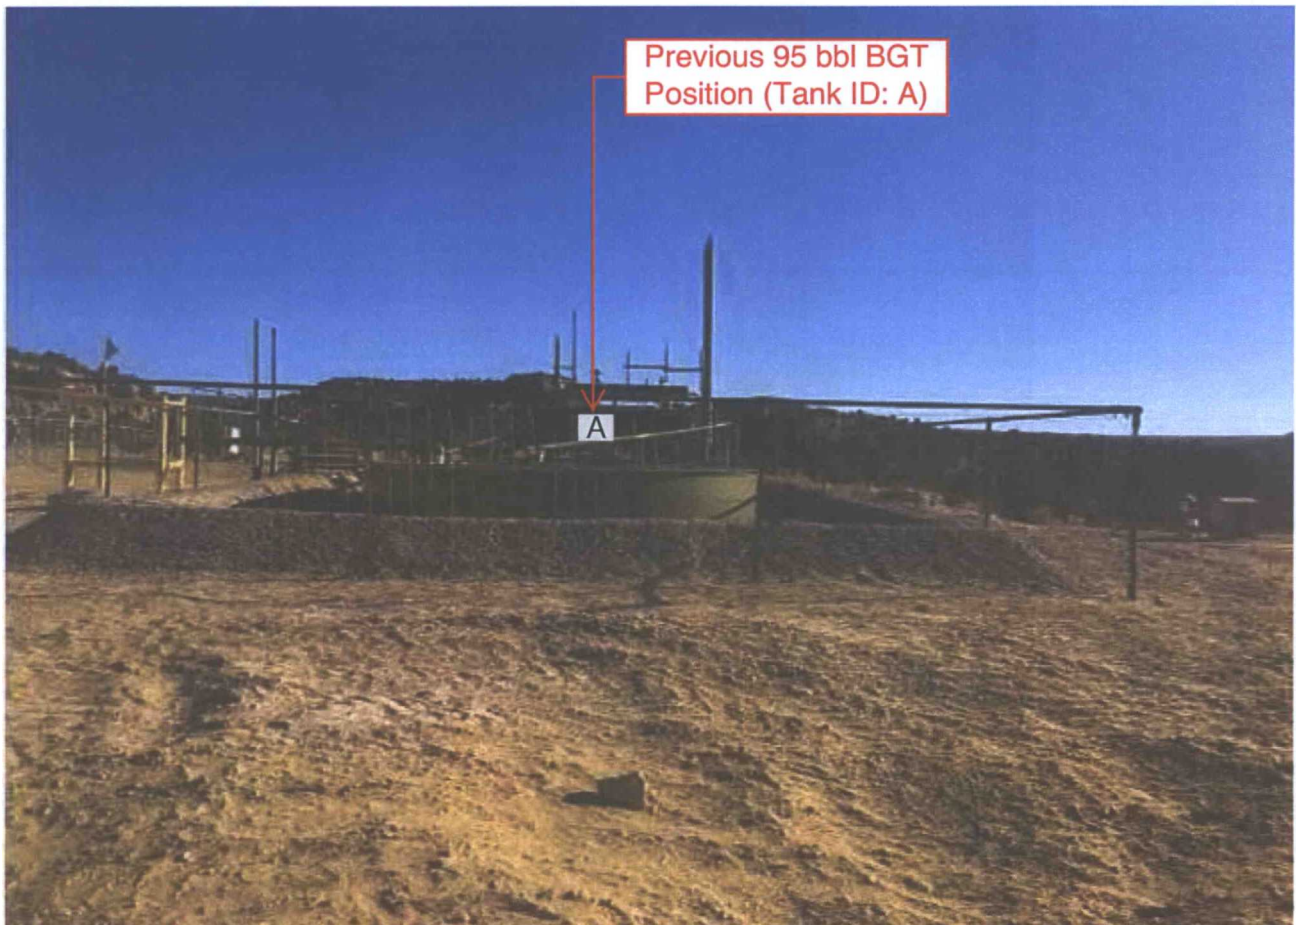
The area has been backfilled and a 105 BBL shallow low profile above-grade tank set atop BGT location. The location will be reclaimed once the well is plugged and abandoned.

Closure report on C-144 form is included including photos of reclamation completion.
