Proposed Alternative Method Permit or Closure Plan Application

1.
Operator: BP America Production Company OGRID #: 778
Address: 200 Energy Court, Farmington, NM 87401
Facility or well name: JONES LS 002
API Number: 3004507651 OCD Permit Number: _____
U/L or Qtr/Qtr L Section 35 Township 29N Range 08W County: San Juan
Center of Proposed Design: Latitude 36.68034 Longitude -107.65173 NAD83
Surface Owner: ☒ Federal ☐ State ☐ Private ☐ Tribal Trust or Indian Allotment

3.
☒ **Below-grade tank:** Subsection I of 19.15.17.11 NMAC **TANK B**
Volume: 21 bbl Type of fluid: Produced Water
Tank Construction material: Steel
☐ Secondary containment with leak detection ☐ Visible sidewalls, liner, 6-inch lift and automatic overflow shut-off
☐ Visible sidewalls and liner ☐ Visible sidewalls only ☒ Other Single wall/ Double bottom; sidewalls not visible
Liner type: Thickness _____ mil ☐ HDPE ☐ PVC ☐ Other _____

JONES LS 002

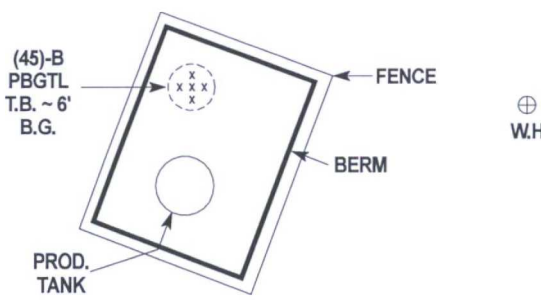
SITE SKETCH BGT Located: off <u>on</u> site PLOT PLAN circle: <u>attached</u>

SOIL DESCRIPTION: SOIL TYPE: <u>SAND</u> / SILTY SAND / SILT / SILTY CLAY / CLAY / GRAVEL / <u>OTHER</u> BEDROCK (SANDSTONE) SOIL COLOR: PALE TO DARK YELLOWISH ORANGE PLASTICITY (CLAYS): NON PLASTIC / SLIGHTLY PLASTIC / COHESIVE / MEDIUM PLASTIC / HIGHLY PLASTIC COHESION (ALL OTHERS): <u>NON COHESIVE</u> / SLIGHTLY COHESIVE / COHESIVE / <u>HIGHLY COHESIVE</u> DENSITY (COHESIVE CLAYS & SILTS): SOFT / FIRM / STIFF / VERY STIFF / HARD CONSISTENCY (NON COHESIVE SOILS): <u>LOOSE</u> / FIRM / DENSE / <u>VERY DENSE</u> HC ODOR DETECTED: YES <u>NO</u> EXPLANATION - MOISTURE: DRY / <u>SLIGHTLY MOIST</u> / MOIST / WET / SATURATED / SUPER SATURATED SAMPLE TYPE: GRAB / <u>COMPOSITE</u> - # OF PTS. 5 ANY AREAS DISPLAYING WETNESS: YES <u>NO</u> EXPLANATION - DISCOLORATION/STAINING OBSERVED: YES <u>NO</u> EXPLANATION -		
SITE OBSERVATIONS: LOST INTEGRITY OF EQUIPMENT: YES <u>NO</u> EXPLANATION - APPARENT EVIDENCE OF A RELEASE OBSERVED AND/OR OCCURRED: YES <u>NO</u> EXPLANATION: EQUIPMENT SET OVER RECLAIMED AREA: YES <u>NO</u> EXPLANATION - OTHER: NMOC OR BLM REPS. NOT PRESENT TO WITNESS CONFIRMATION SAMPLING. BGT INSTALLED BY EXCAVATING INTO SHALLOW BEDROCK SANDSTONE BETWEEN 1 FT. - 5 FT. BELOW GRADE. EXCAVATION DIMENSION ESTIMATION: NA ft. X NA ft. X NA ft. EXCAVATION ESTIMATION (Cubic Yards): NA DEPTH TO GROUNDWATER: >100' NEAREST WATER SOURCE: >1,000' NEAREST SURFACE WATER: >1,000' NMOC TPH CLOSURE STD: 5,000 ppm

OVM CALIB. READ. = NA ppm RF = 1.00 OVM CALIB. GAS = NA ppm TIME: NA am/pm DATE: NA
NOTES: BGT = BELOW-GRADE TANK; E.D. = EXCAVATION DEPRESSION; B.G. = BELOW GRADE; B = BELOW; T.H. = TEST HOLE; ~ = APPROX.; W.H. = WELL HEAD; T.B. = TANK BOTTOM; PBGTL = PREVIOUS BELOW-GRADE TANK LOCATION; SPD = SAMPLE POINT DESIGNATION; R.W. = RETAINING WALL; NA = NOT APPLICABLE OR NOT AVAILABLE; SW - SINGLE WALL; DW - DOUBLE WALL; SB - SINGLE BOTTOM; DB - DOUBLE BOTTOM.		MISCELL. NOTES WO: REF #: P-914 VID: VHIXONEVB2 PJ #: Permit date(s): 06/14/10 OCD Appr. date(s): 12/27/17 Tank ID: B OVM = Organic Vapor Meter ppm = parts per million BGT Sidewalls Visible: Y / <u>N</u> BGT Sidewalls Visible: Y / N BGT Sidewalls Visible: Y / N Magnetic declination: 10° E
NOTES: GOOGLE EARTH IMAGERY DATE: 10/5/2016. ONSITE: 01/22/17

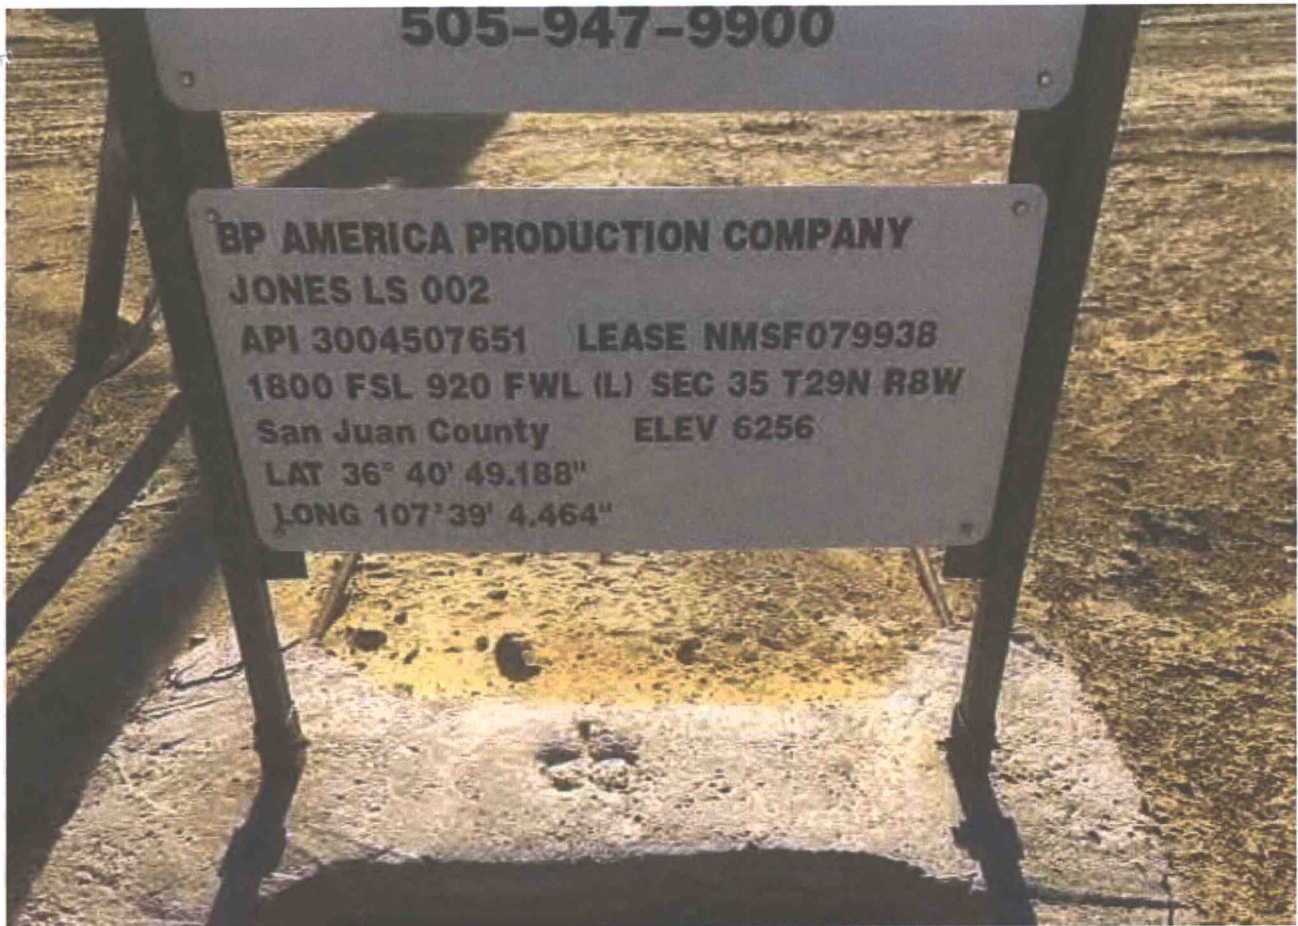
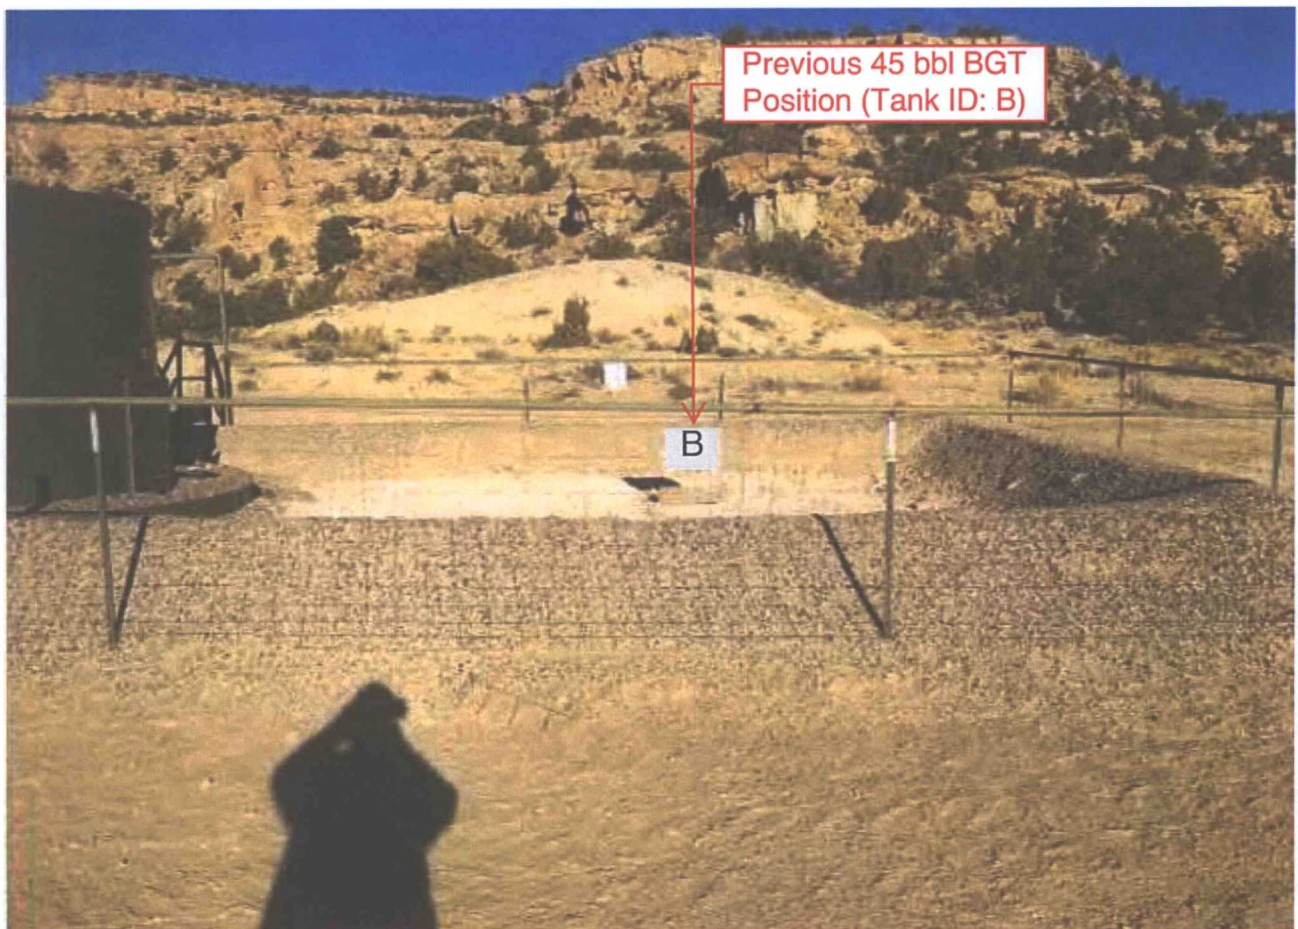
The area has been backfilled and BGT location's surface condition is clear, but within the site's operational area. The location will be reclaimed once the well is plugged and abandoned.

10. BP shall reclaim the BGT location and all areas associated with the BGT including associated access roads to a safe and stable condition that blends with the surrounding undisturbed area. BP shall substantially restore the impacted surface area to the condition that existed prior to oil and gas operations by placement of the soil cover as provided in Subsection H of 19.15.17.13 NMAC, re-contour the location and associated areas to a contour that approximates the original contour and blends with the surrounding topography and re-vegetate according to Subsection I of 19.15.17.13 NMAC.
