Pit, Below-Grade Tank, or  
Proposed Alternative Method Permit or Closure Plan Application

BELOW-GRADE TANK CLOSURE PLAN

**GARTNER A 005A**

**API No. 3004522368**

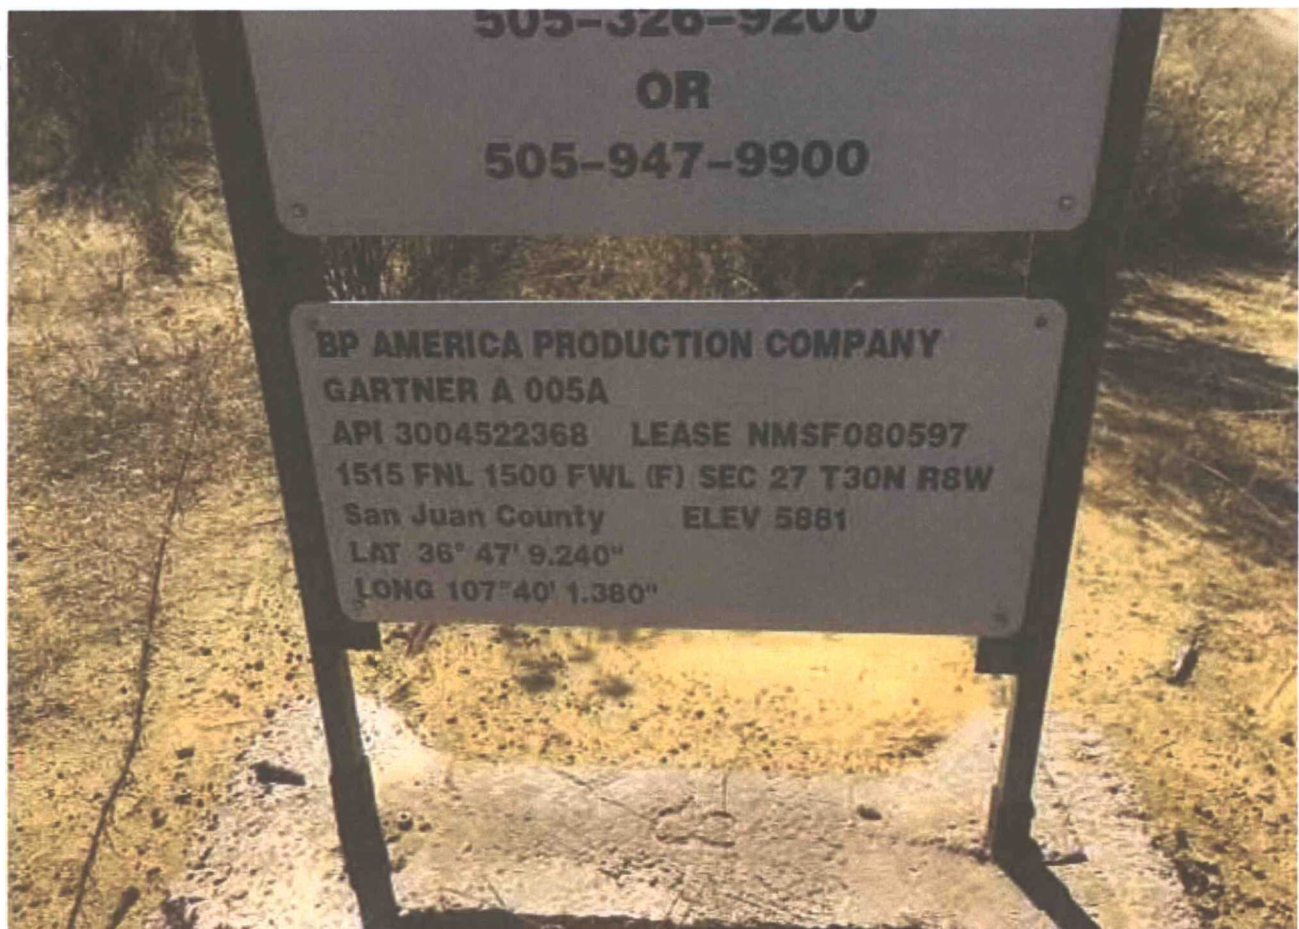
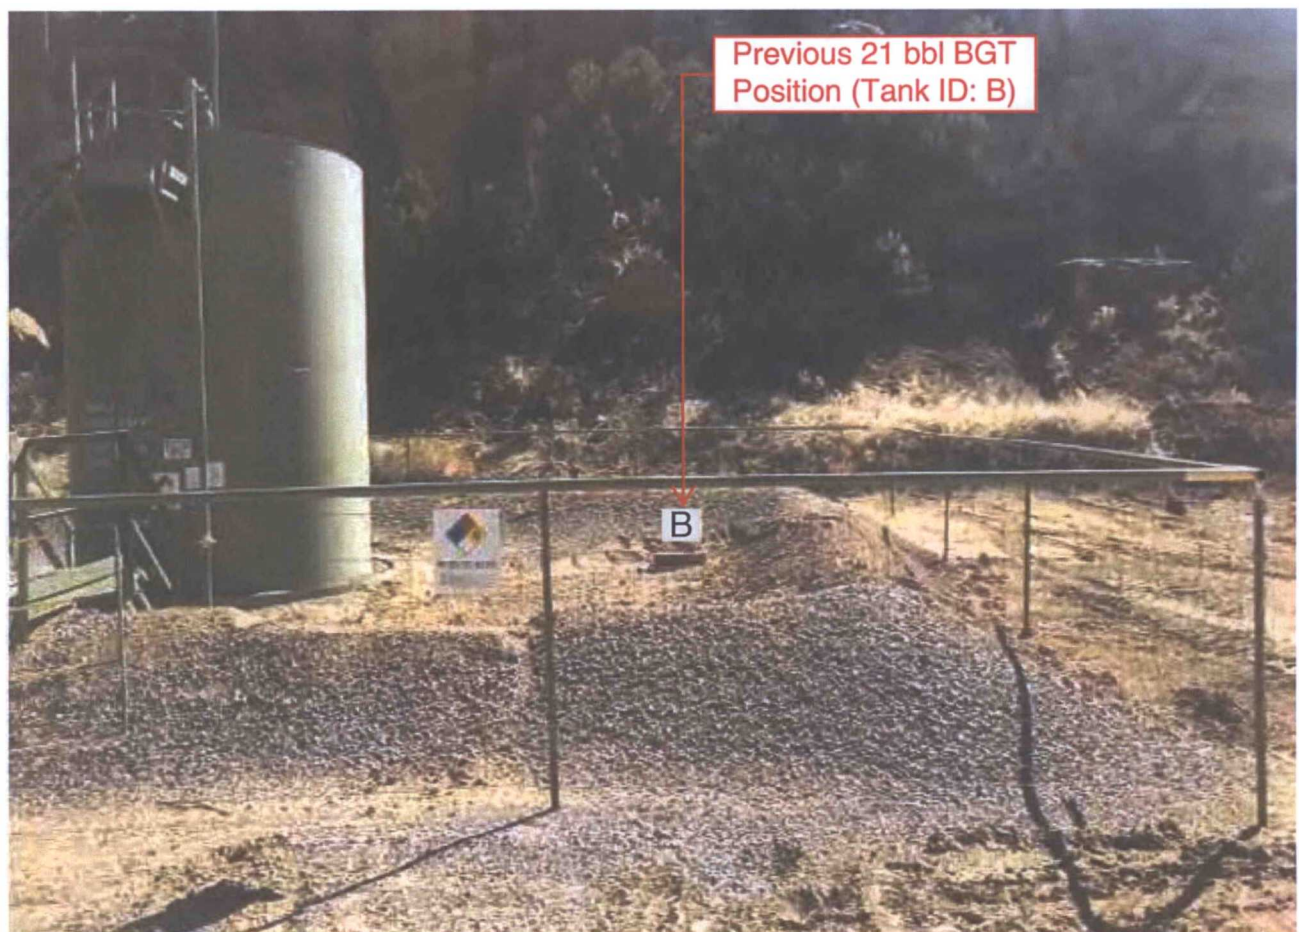
**The area has been backfilled and BGT location's surface condition is clear, but within the site's operational area.. The location will be reclaimed once the well is plugged and abandoned.**
