Pit, Below-Grade Tank, or
Proposed Alternative Method Permit or Closure Plan Application

BELOW-GRADE TANK CLOSURE PLAN

NEBU 016

API No. 3003907925

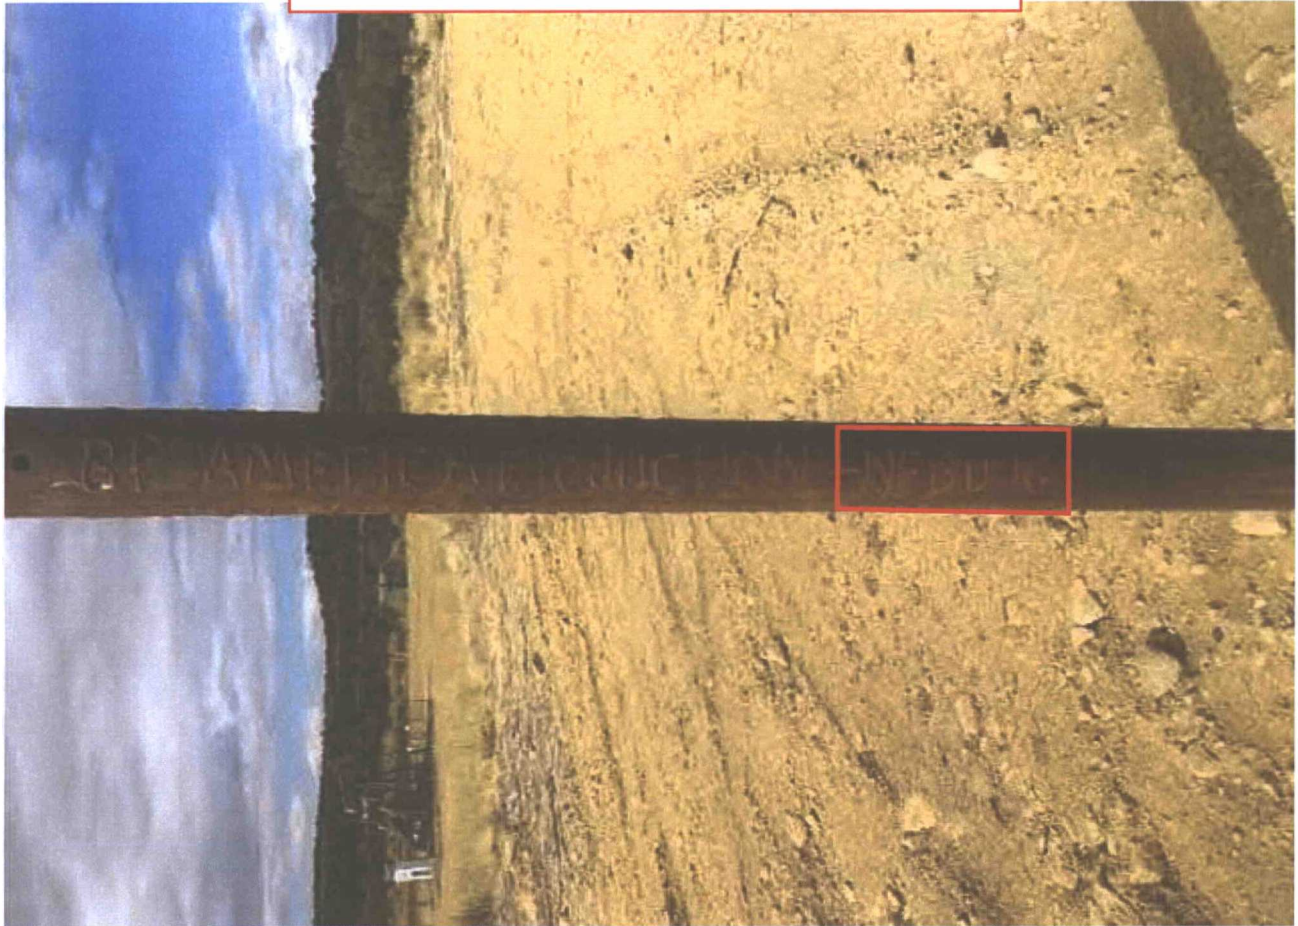
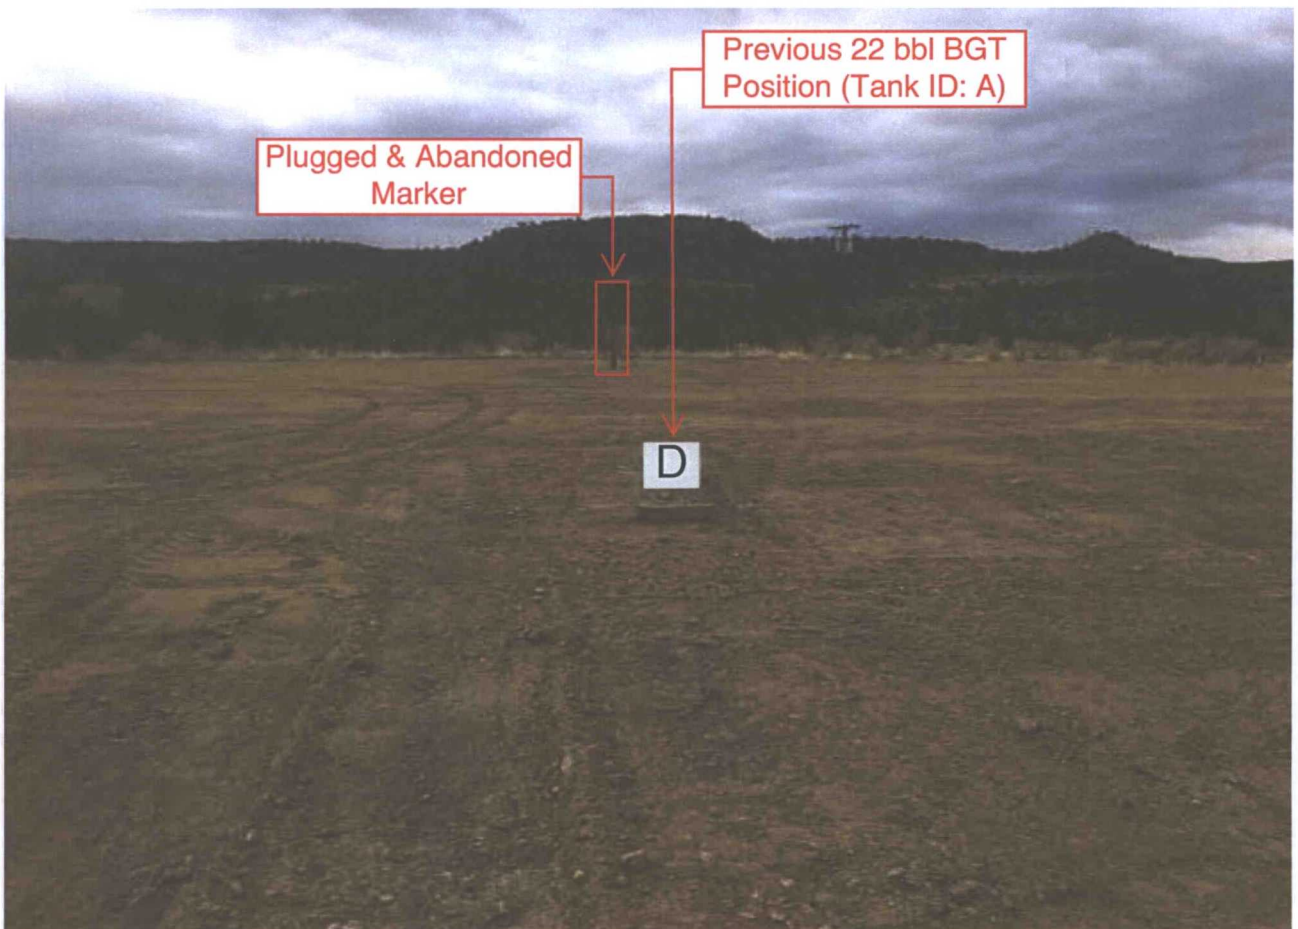
NORTHEAST BLANCO UNIT 016

Sampling results indicate a release has not occurred. Attached is a laboratory report and field report. The location has been reclaimed as it was plugged and abandoned.

10. BP shall reclaim the BGT location and all areas associated with the BGT including associated access roads to a safe and stable condition that blends with the surrounding undisturbed area. BP shall substantially restore the impacted surface area to the condition that existed prior to oil and gas operations by placement of the soil cover as provided in Subsection H of 19.15.17.13 NMAC, re-contour the location and associated areas to a contour that approximates the original contour and blends with the surrounding topography and re-vegetate according to Subsection I of 19.15.17.13 NMAC.
