Pit, Below-Grade Tank, or
Proposed Alternative Method Permit or Closure Plan Application

BELOW-GRADE TANK CLOSURE PLAN

LUDWICK LS 012

API No. 3004509293

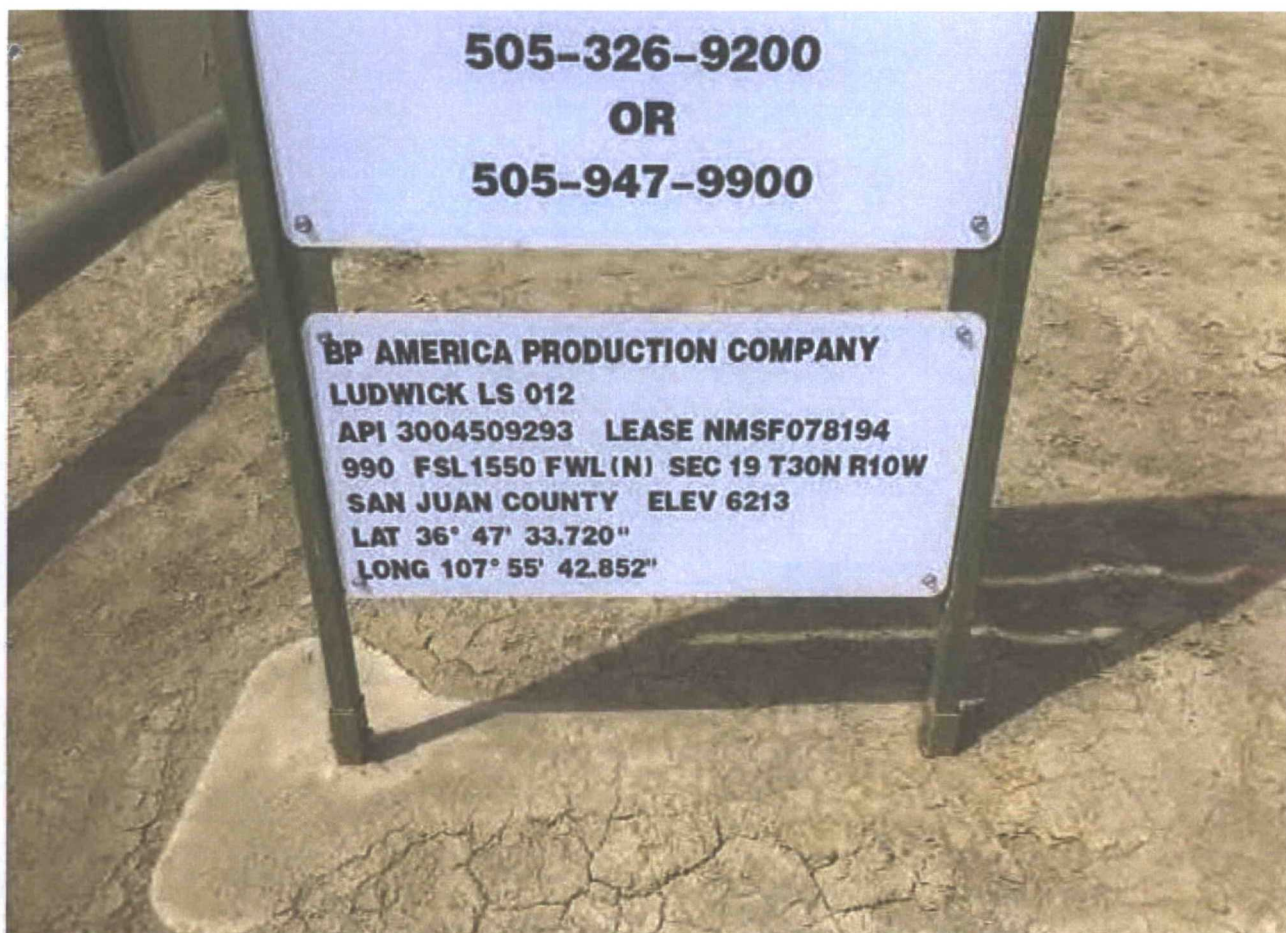
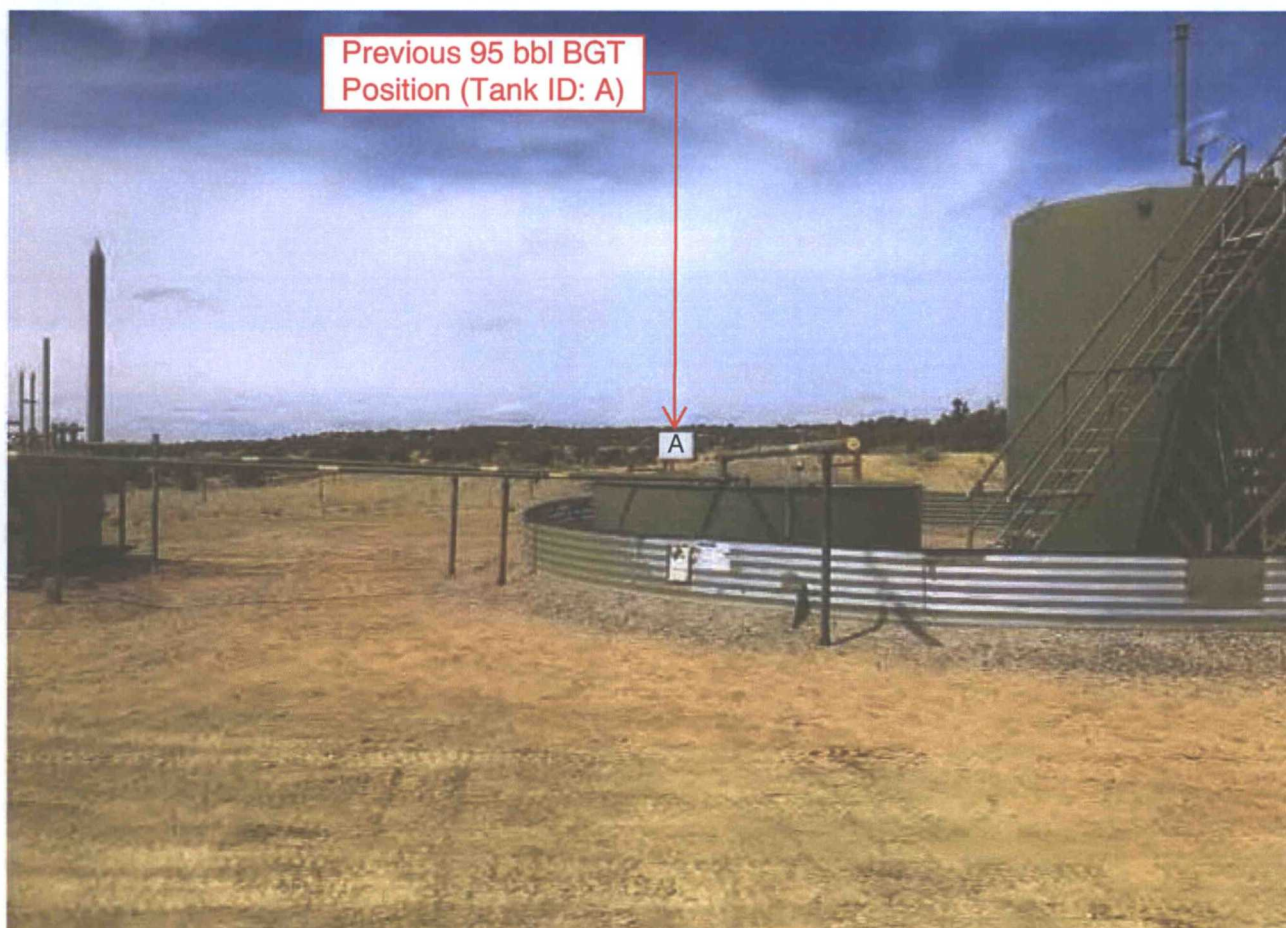
Closure report on C-144 form is included including photos of reclamation completion.
