BELOW-GRADE TANK CLOSURE PLAN

GCU 189E

API No. 3004524839

Unit Letter K Section 36 T 29N R 13W

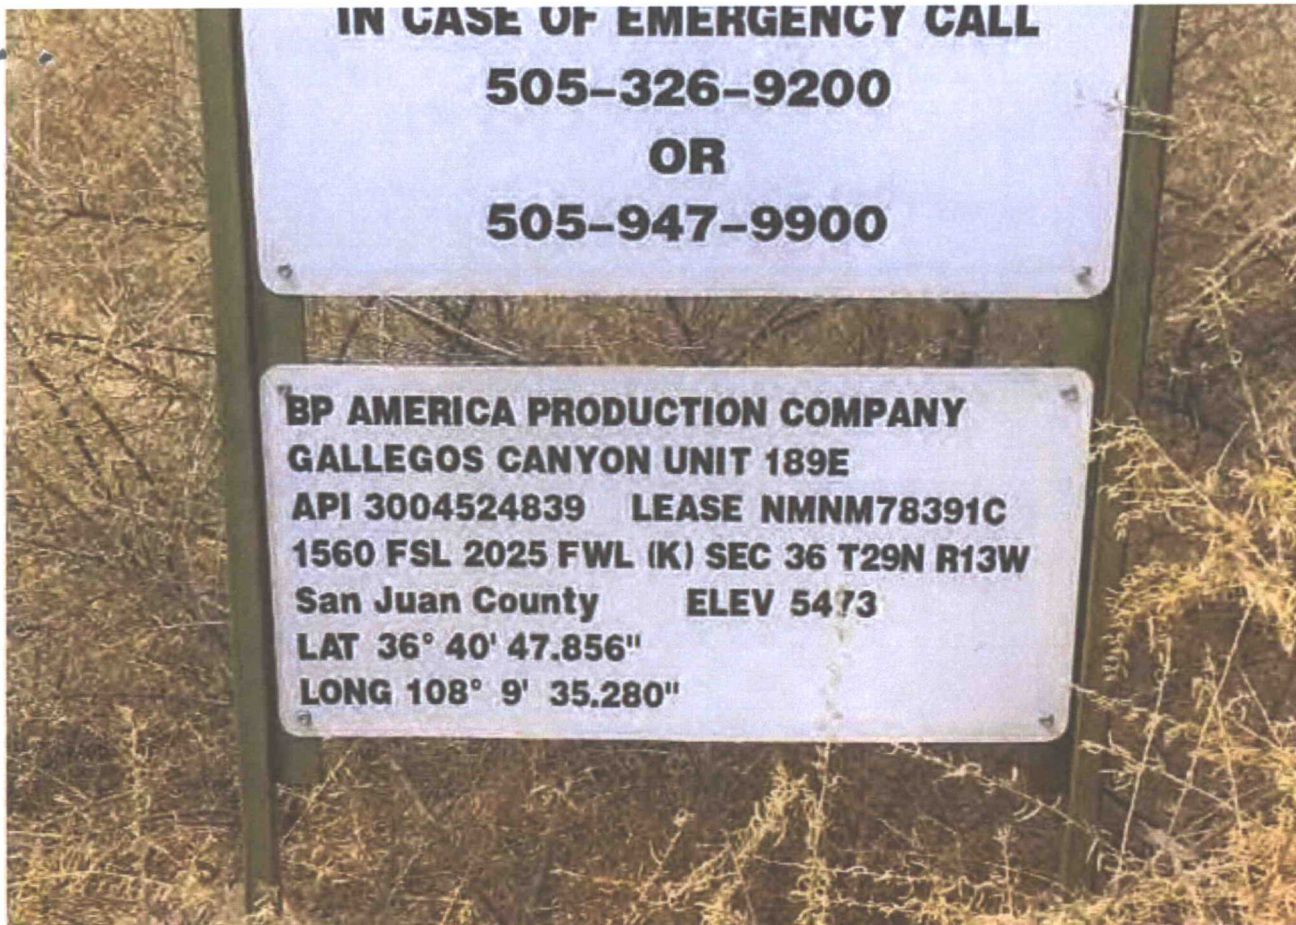
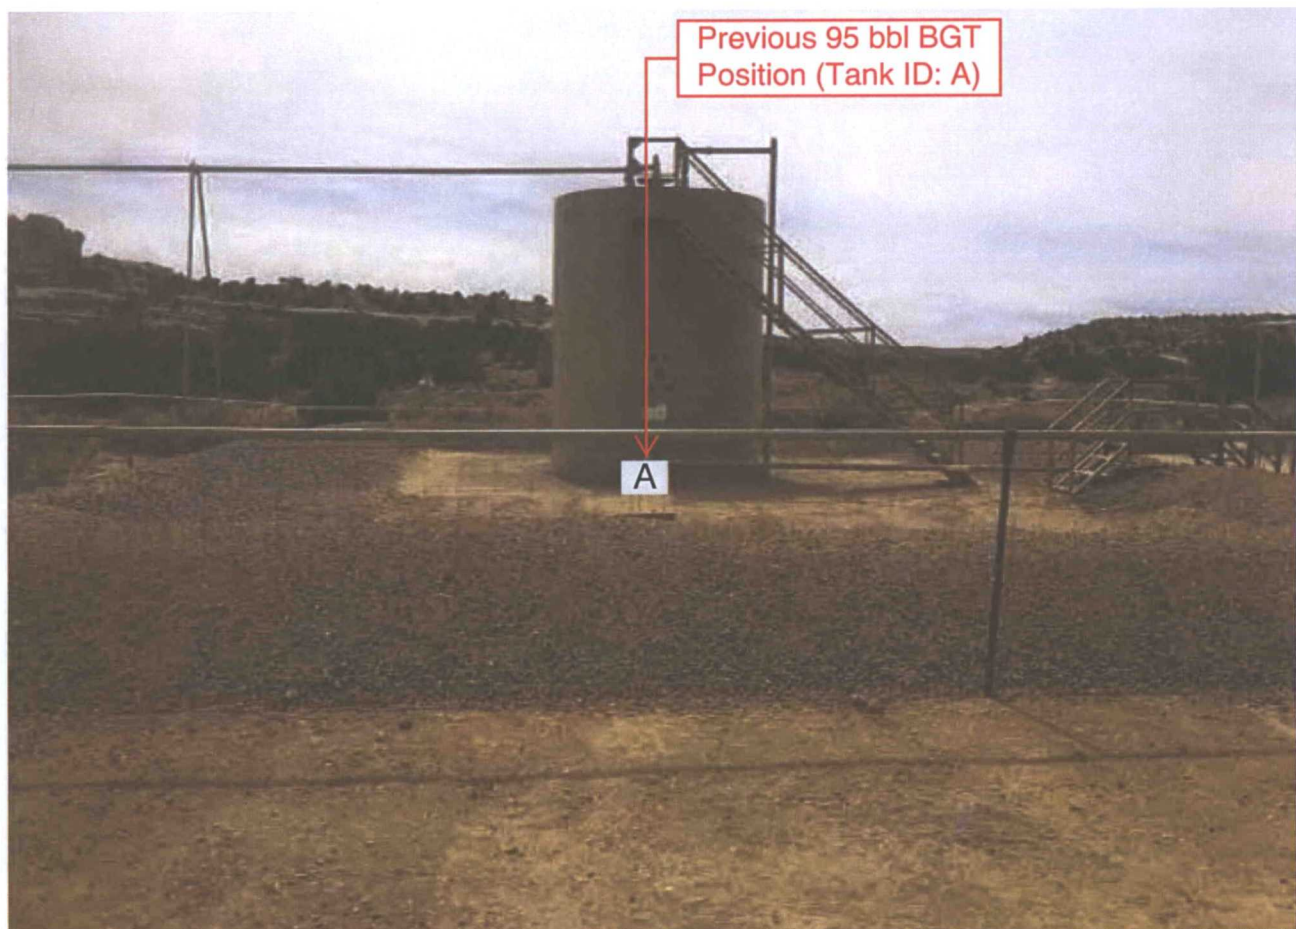
The area has been backfilled and the BGT location's surface condition is clear, but within the site's operational area. The location will be reclaimed once the well is plugged and abandoned.
