Pit, Below-Grade Tank, or  
Proposed Alternative Method Permit or Closure Plan Application

**BELOW-GRADE TANK CLOSURE PLAN**

**NEIL A 021**

**API No. 3004527811**

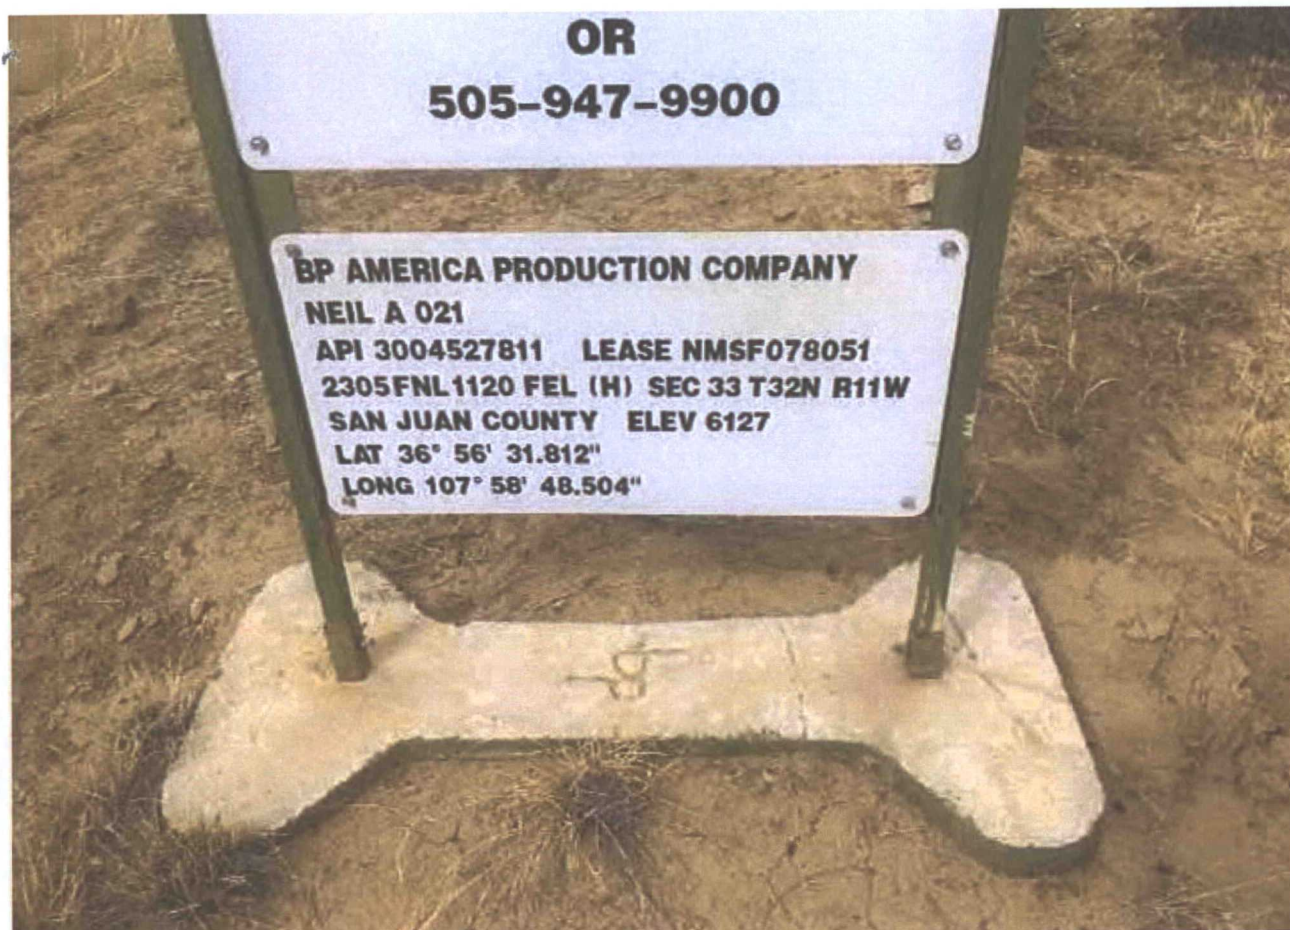
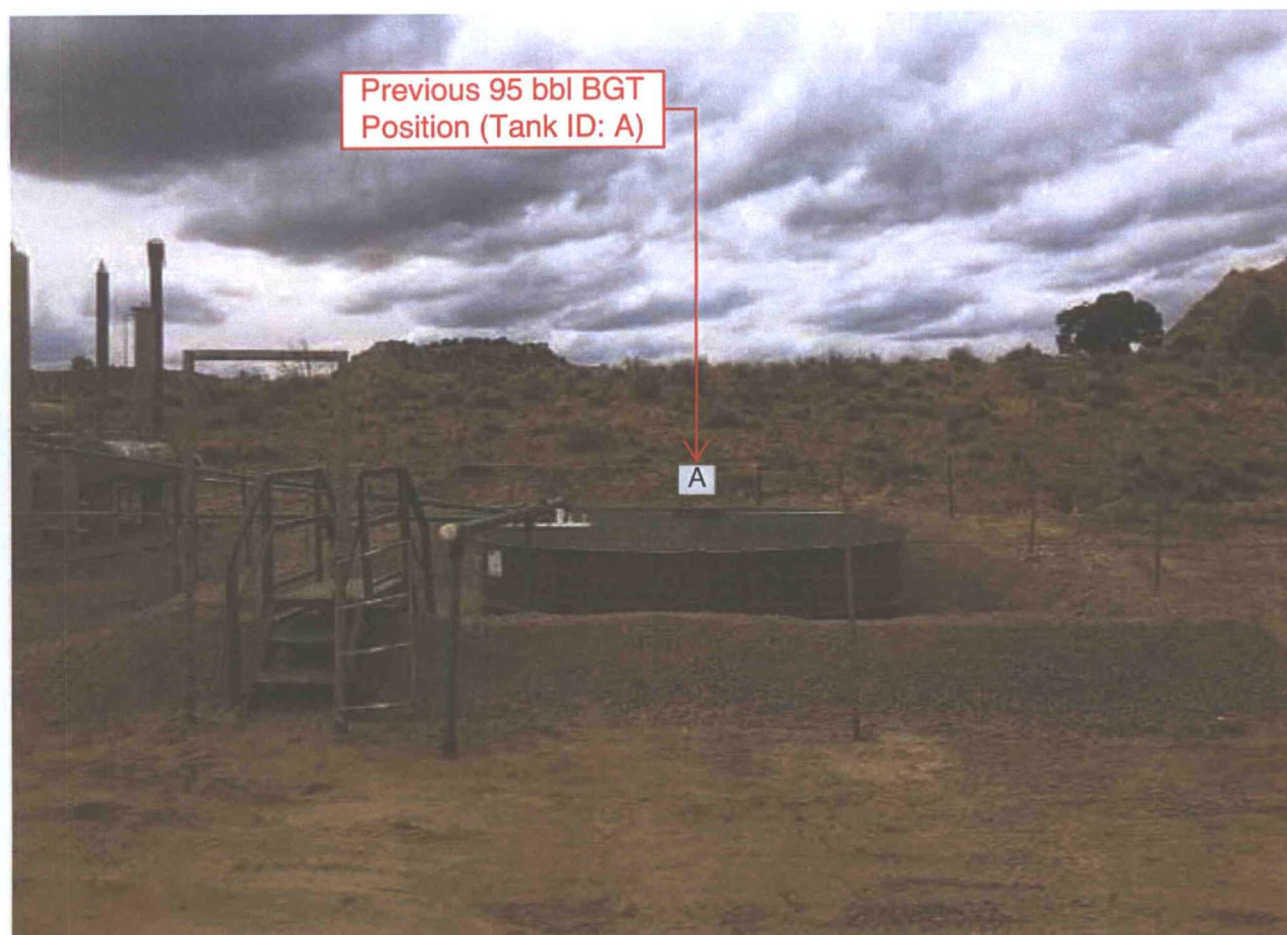
**The area has been backfilled and a 105 BBL shallow low profile above-grade tank set atop BGT location. The location will be reclaimed once the well is plugged and abandoned.**
