Pit, Below-Grade Tank, or
Proposed Alternative Method Permit or Closure Plan Application

BELOW-GRADE TANK CLOSURE PLAN

MUDGE B 058

API No. 3004527815

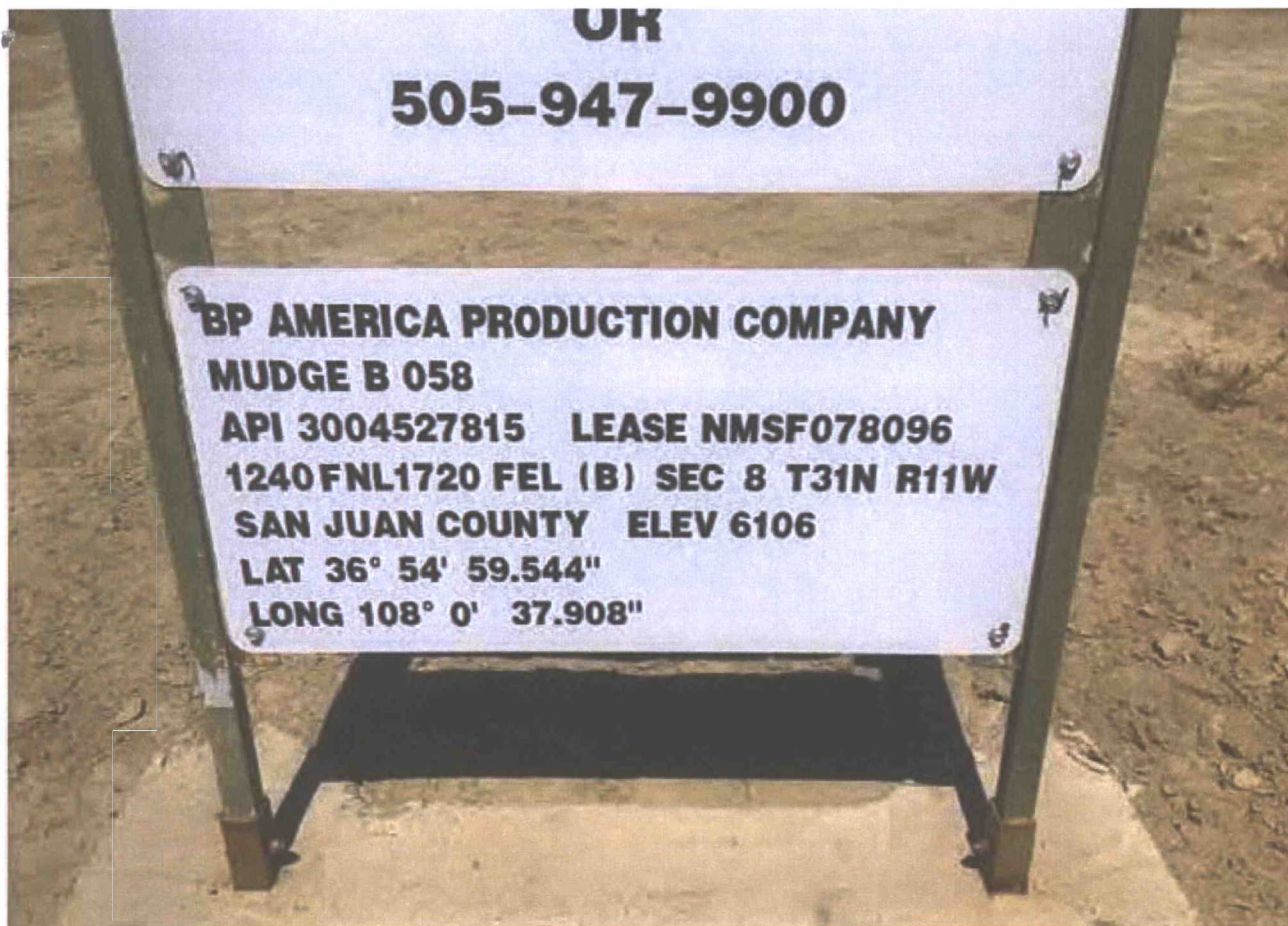
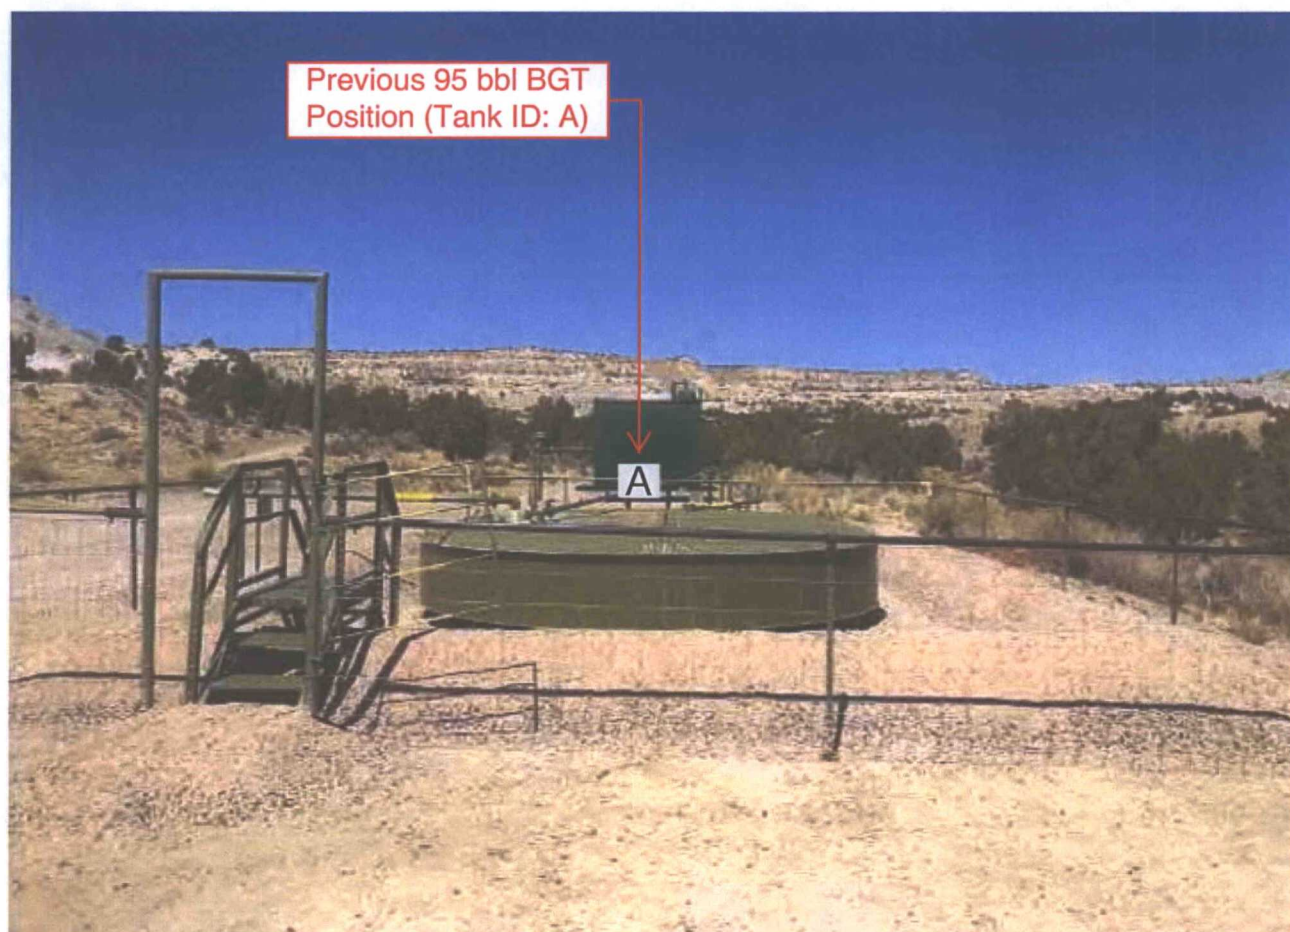
The area has been backfilled and a 105 BBL shallow low profile above-grade tank set atop BGT location. The location will be reclaimed when the well is plugged and abandoned.

Closure report on C-144 form is included including photos of reclamation completion.
