Pit, Below-Grade Tank, or
Proposed Alternative Method Permit or Closure Plan Application

BELOW-GRADE TANK CLOSURE PLAN

FIELDS A 022

API No. 3004527941

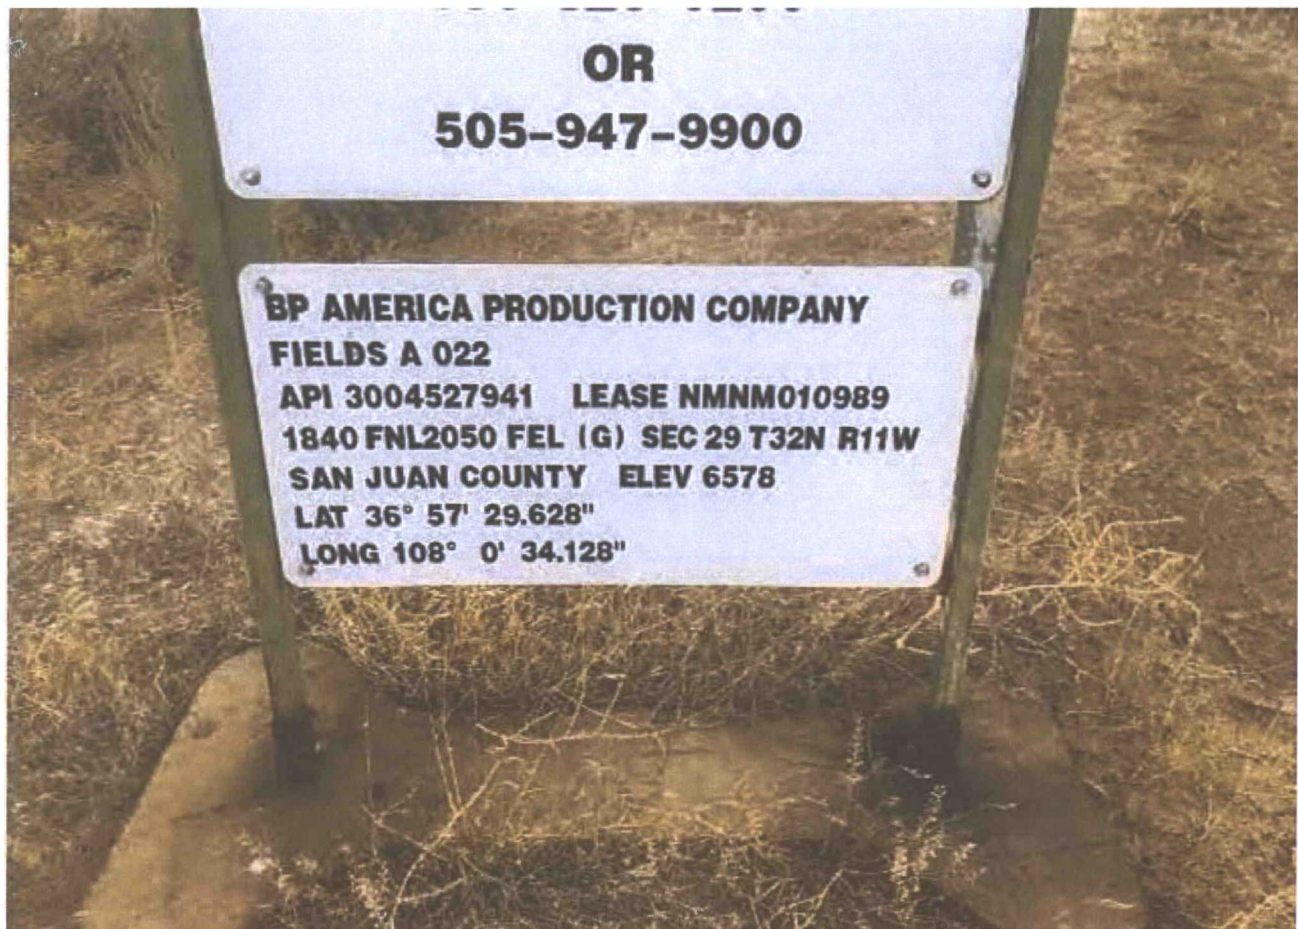
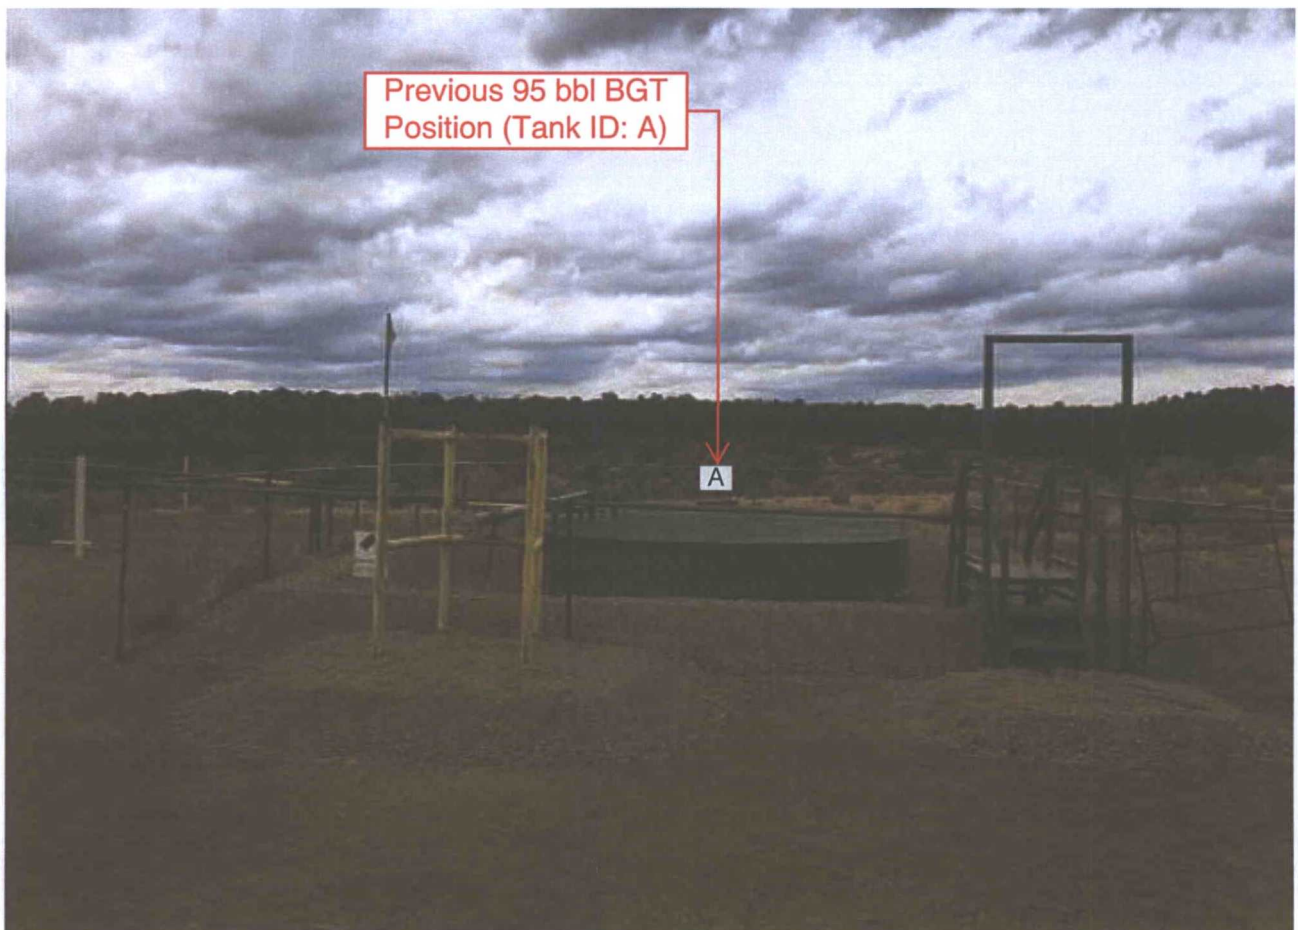
The area has been backfilled and a shallow low profile above-grade tank set atop the BGT location. The location will be reclaimed when the well is plugged and abandoned.
