Pit, Below-Grade Tank, or
Proposed Alternative Method Permit or Closure Plan Application

BELOW-GRADE TANK CLOSURE PLAN

ARNAUD A 003

API No. 3004528184

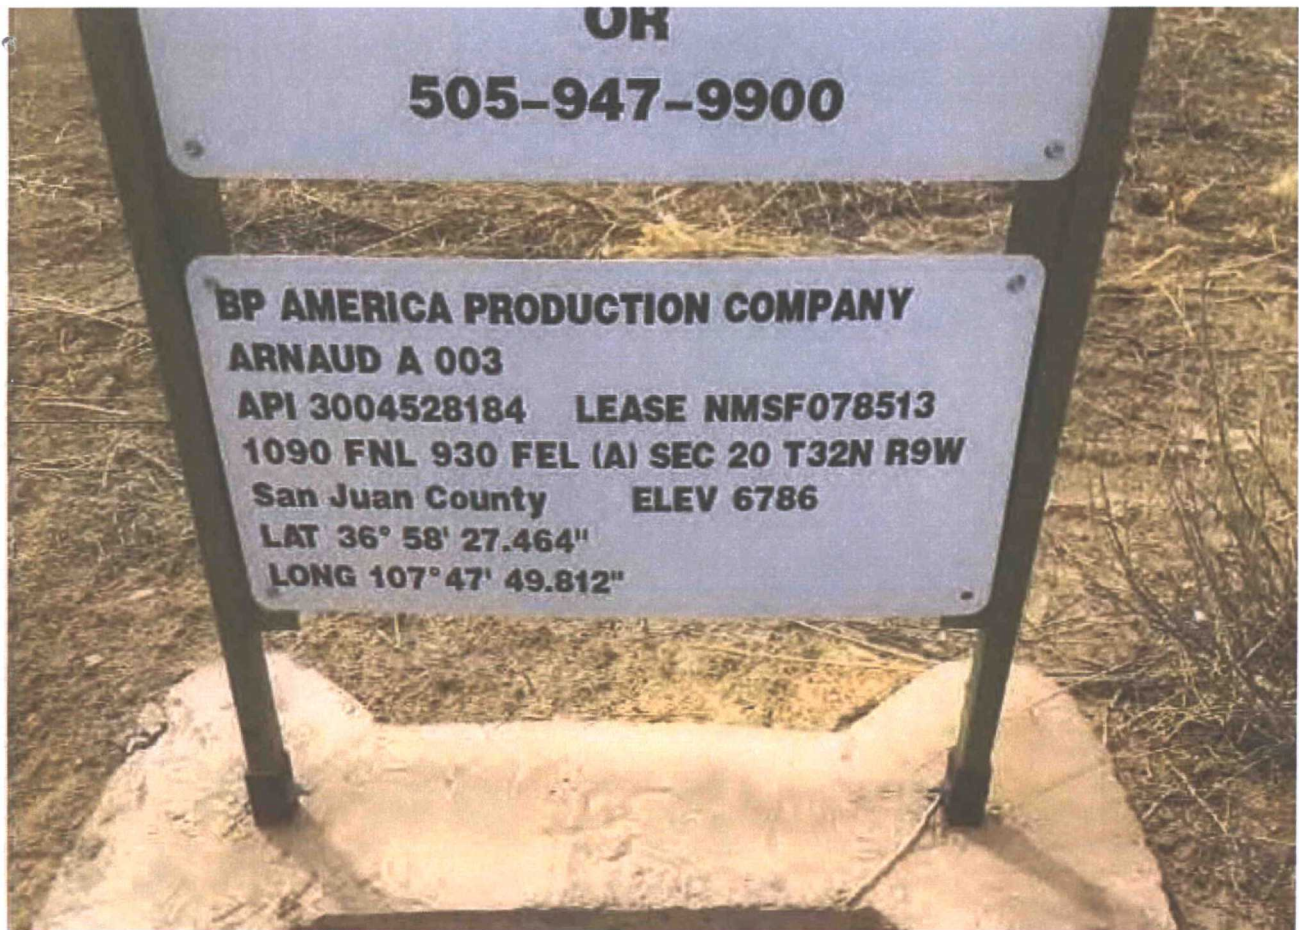
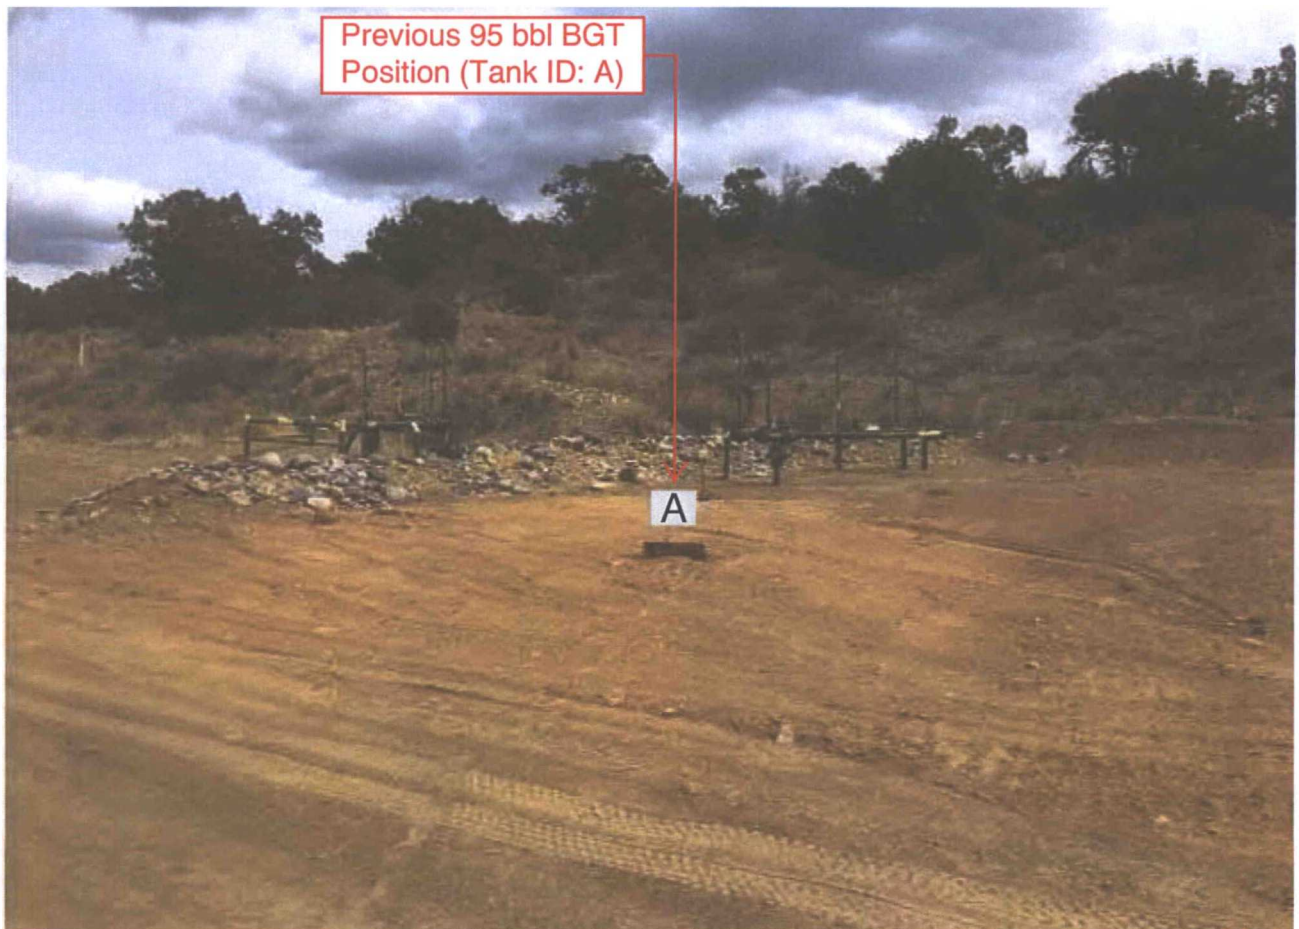
The area has been backfilled and BGT location's surface condition is clear, but within the site's operational area. The location will be reclaimed once the well is plugged and abandoned.

Closure report on C-144 form is included including photos of reclamation completion.
