Pit, Below-Grade Tank, or
Proposed Alternative Method Permit or Closure Plan Application

BELOW-GRADE TANK CLOSURE PLAN

BURNHAM GC B 001

API No. 3004529227

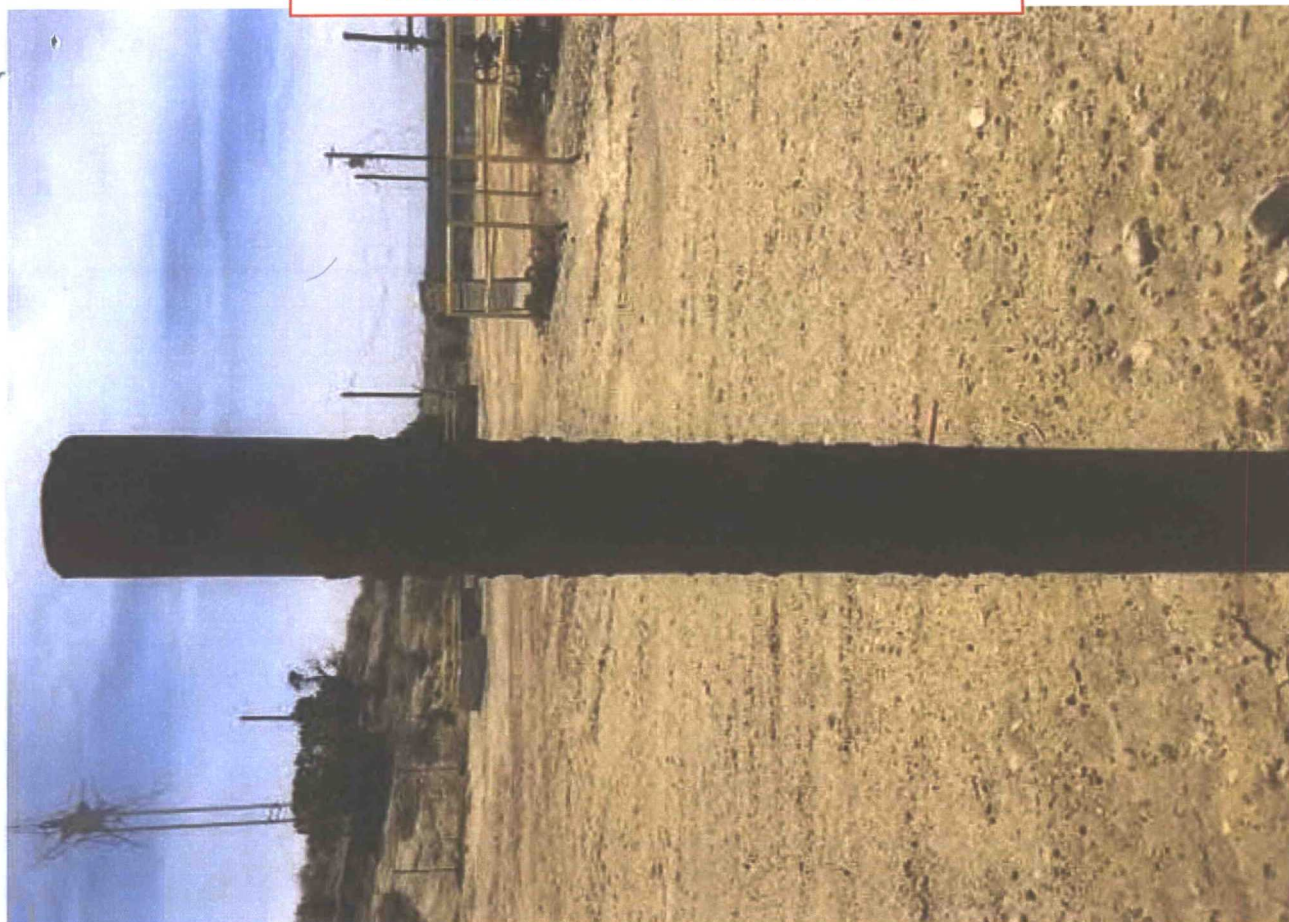
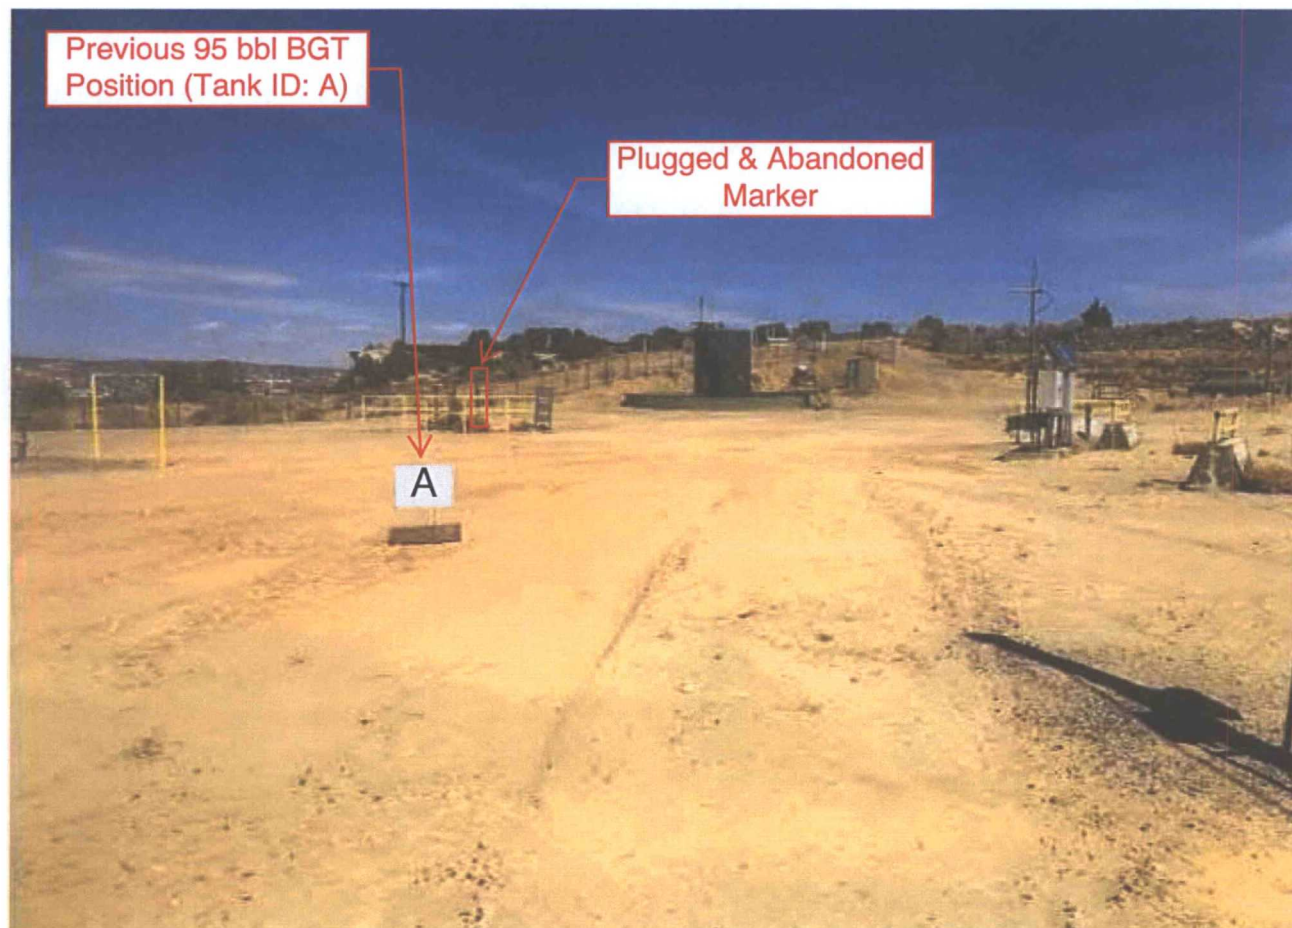
BURNHAM GAS COM B 001

The area has been backfilled and the location has been reclaimed as the well has been plugged and abandoned.
