Pit, Below-Grade Tank, or
Proposed Alternative Method Permit or Closure Plan Application

BELOW-GRADE TANK CLOSURE PLAN

GCU 102

API No. 3004508378

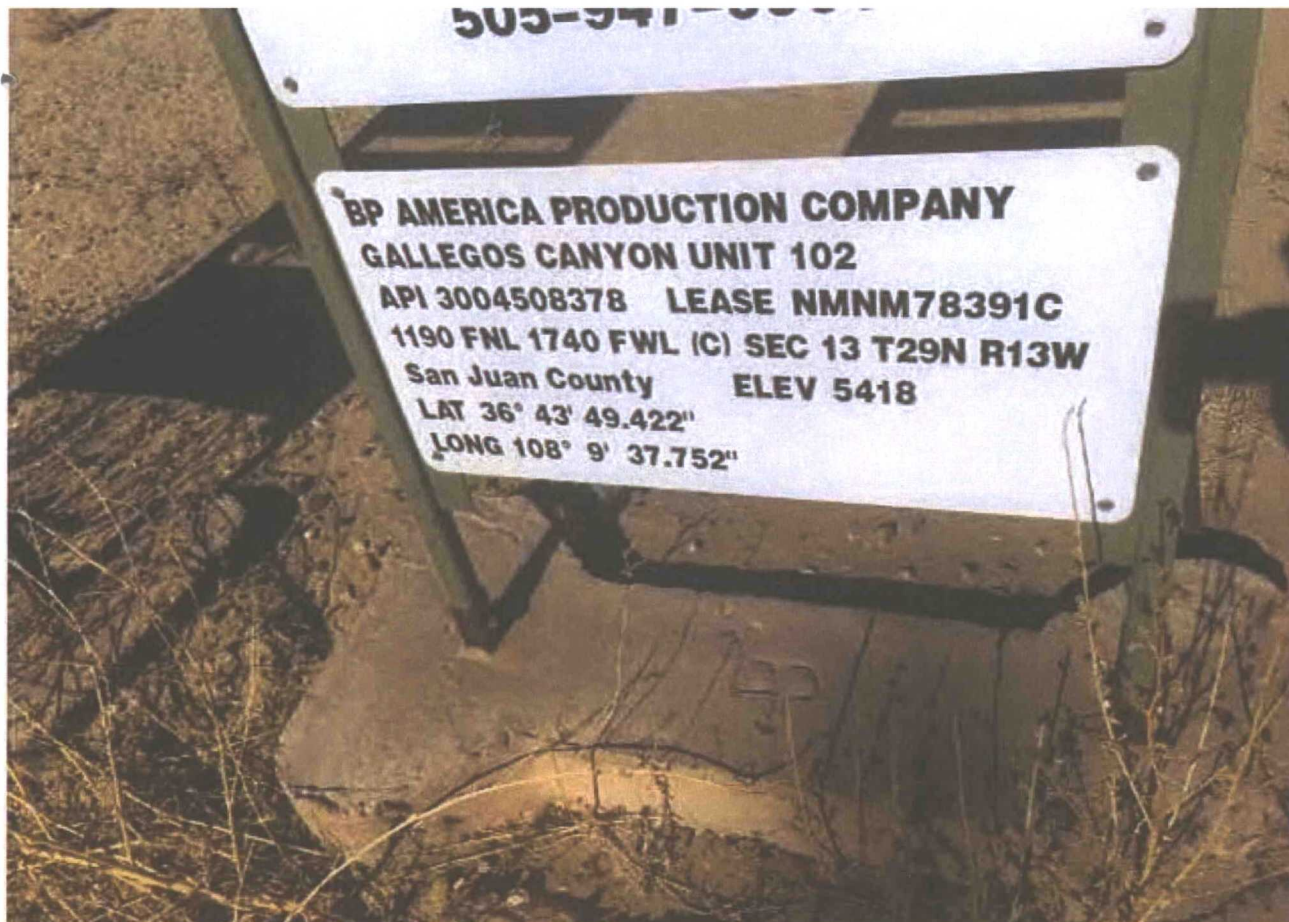
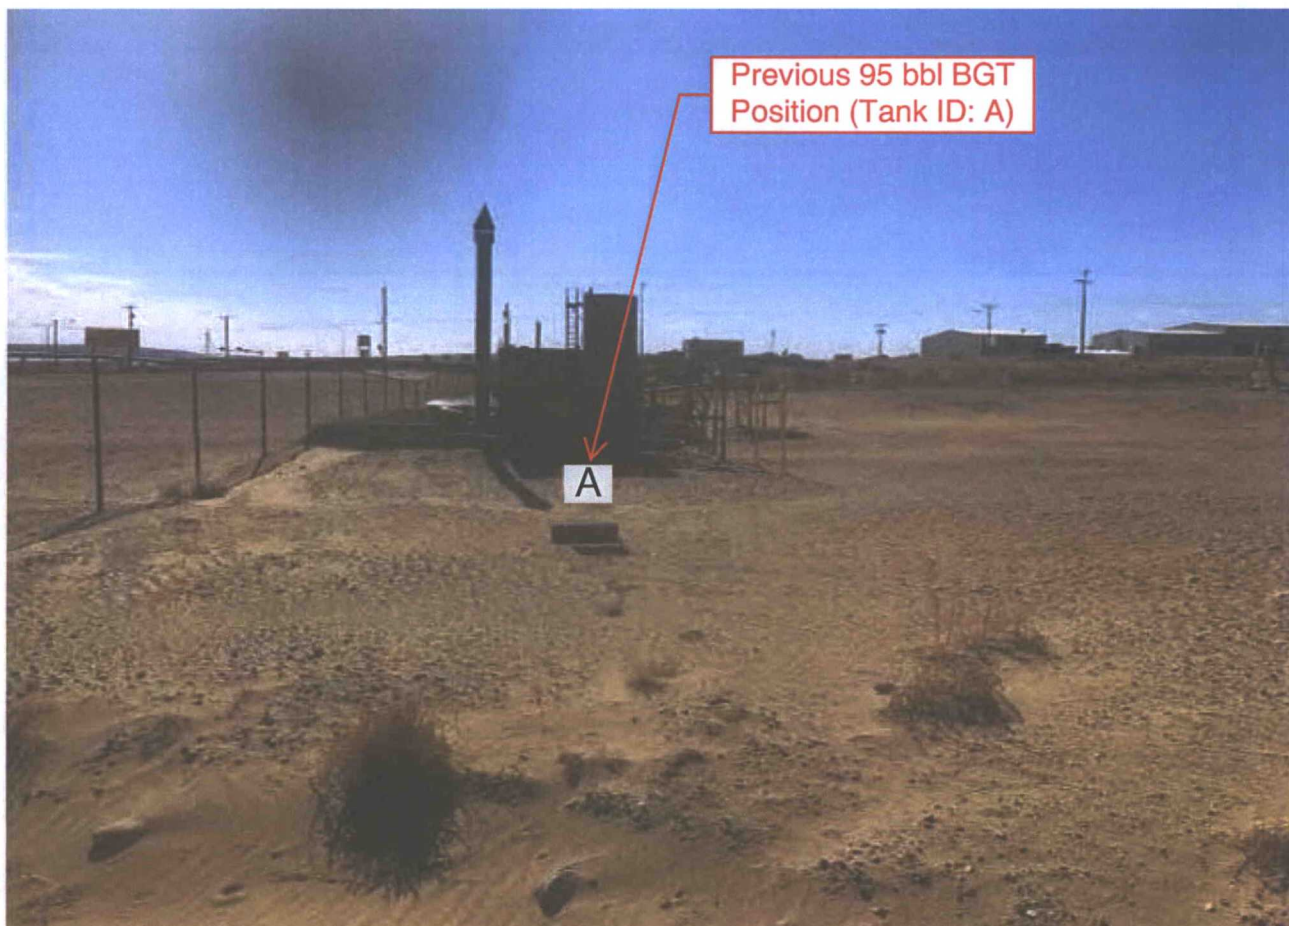
A

Previous 95 bbl BGT
Position (Tank ID: A)

10. BP shall reclaim the BGT location and all areas associated with the BGT including associated access roads to a safe and stable condition that blends with the surrounding undisturbed area. BP shall substantially restore the impacted surface area to the condition that existed prior to oil and gas operations by placement of the soil cover as provided in Subsection H of 19.15.17.13 NMAC, re-contour the location and associated areas to a contour that approximates the original contour and blends with the surrounding topography and re-vegetate according to Subsection I of 19.15.17.13 NMAC.
