**BP AMERICA PRODUCTION COMPANY**  
**SAN JUAN BASIN, NORTHWEST NEW MEXICO**

**BELOW-GRADE TANK CLOSURE PLAN**

**GCU 191**

**API No. 3004511590**

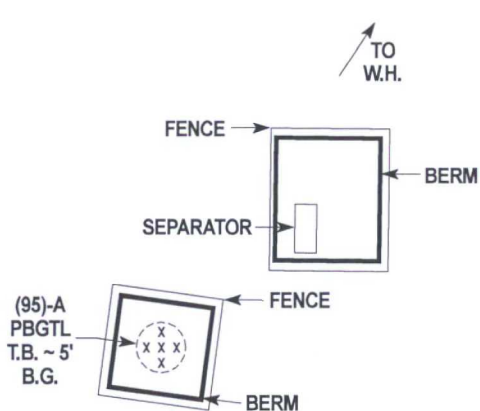
<b>SITE SKETCH</b>	BGT Located : off / <b>on</b> site PLOT PLAN circle: <b>attached</b>

<b>SOIL DESCRIPTION:</b>	SOIL TYPE: <b>SAND</b> / SILTY SAND / SILT / SILTY CLAY / CLAY / GRAVEL / OTHER SOIL COLOR: <b>MOSTLY DARK YELLOWISH ORANGE</b> COHESION (ALL OTHERS): <b>NON COHESIVE</b> / SLIGHTLY COHESIVE / COHESIVE / HIGHLY COHESIVE CONSISTENCY (NON COHESIVE SOILS): LOOSE / <b>FIRM</b> / DENSE / VERY DENSE MOISTURE: DRY / <b>SLIGHTLY MOIST</b> / MOIST / WET / SATURATED / SUPER SATURATED SAMPLE TYPE: GRAB / <b>COMPOSITE</b> # OF PTS. <b>5</b> DISCOLORATION/STAINING OBSERVED: <b>YES</b> / NO EXPLANATION - <b>BROWNISH BLACK AT OUTER PERIMETER OF BGT FOOTPRINT.</b> PLASTICITY (CLAYS): NON PLASTIC / SLIGHTLY PLASTIC / COHESIVE / MEDIUM PLASTIC / HIGHLY PLASTIC DENSITY (COHESIVE CLAYS & SILTS): SOFT / FIRM / STIFF / VERY STIFF / HARD HC ODOR DETECTED: <b>YES</b> / NO EXPLANATION - <b>APPARENT VERY STRONG BENEATH BGT ONLY (NOT DISCOLORED).</b> ANY AREAS DISPLAYING WETNESS: YES / <b>NO</b> EXPLANATION -

<b>SITE OBSERVATIONS:</b>	LOST INTEGRITY OF EQUIPMENT: YES / <b>NO</b> EXPLANATION - APPARENT EVIDENCE OF A RELEASE OBSERVED AND/OR OCCURRED: <b>YES</b> / NO EXPLANATION: <b>APPARENT HYDROCARBON ODOR, POSSIBLY BGT OVERFLOW(S)?</b> EQUIPMENT SET OVER RECLAIMED AREA: YES / <b>NO</b> EXPLANATION - OTHER: <b>NMOCD OR BLM REPS. NOT PRESENT TO WITNESS CONFIRMATION SAMPLING.</b>
---------------------------	---

EXCAVATION DIMENSION ESTIMATION: <b>NA</b> ft. X <b>NA</b> ft. X <b>NA</b> ft. EXCAVATION ESTIMATION (Cubic Yards): <b>NA</b> DEPTH TO GROUNDWATER: <b>&lt;50'</b> NEAREST WATER SOURCE: <b>&gt;1,000'</b> NEAREST SURFACE WATER: <b>&lt;1,000'</b> NMOCD TPH CLOSURE STD: <b>100</b> ppm
--

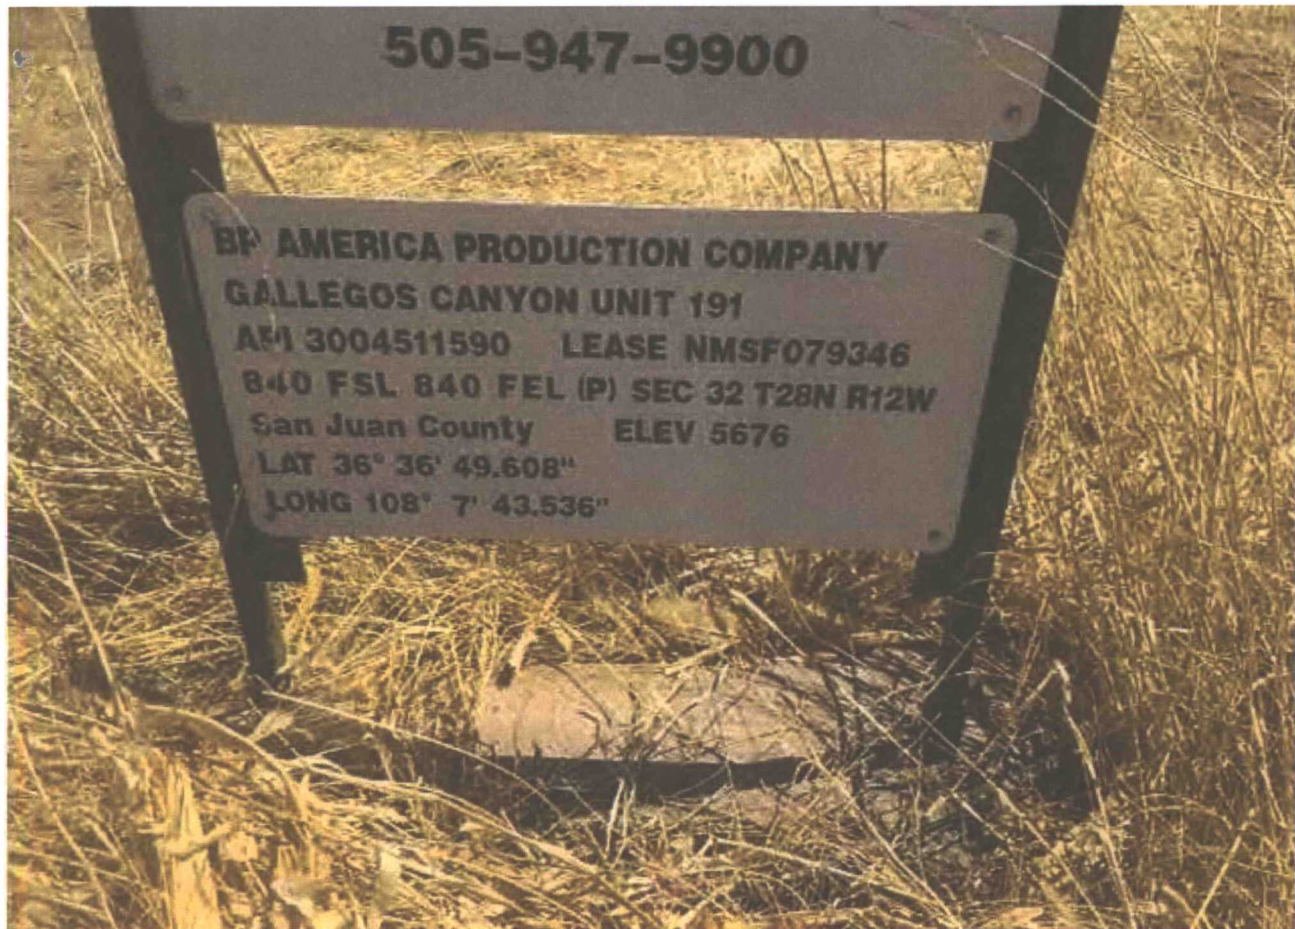
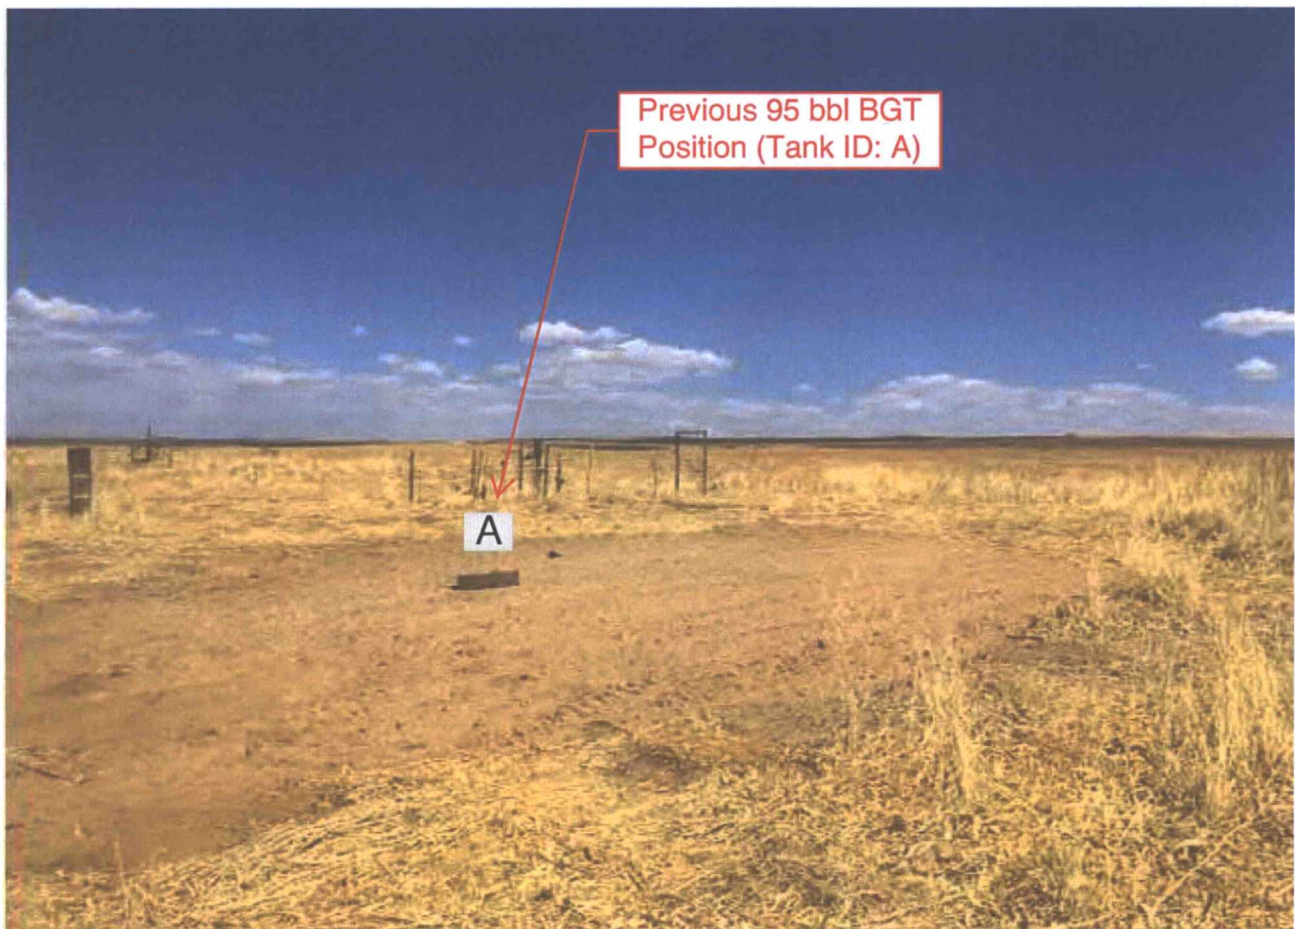
**Closure report on C-144 form is included including photos of reclamation completion.**

**The area has been backfilled and BGT location's surface condition is clear, but within the site's operational area. The location will be reclaimed once the well is plugged and abandoned.**
